# 博士論文

## INITIATION MECHANISM OF HEAVY RAINFALL-INDUCED SHALLOW LANDSLIDES ON STEEP SLOPES WITH IMPERMEABLE BEDROCK

YANG HUFENG

島根大学大学院総合理工学研究科博士後期課程

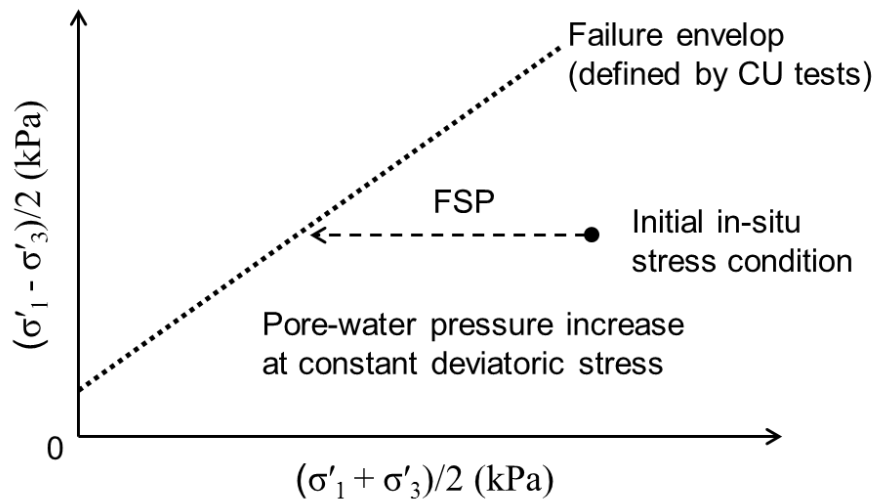
Fig. 3.3 The concept of the pore-water pressure controlled (PPC) triaxial test (modified from Ng, 2007)

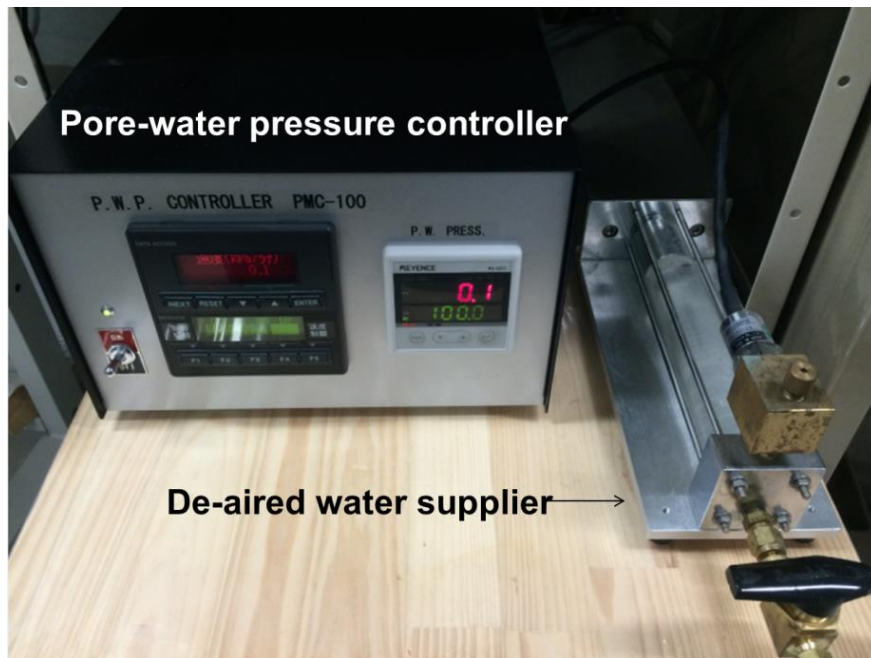
Fig. 3.4 Pore-water pressure controller system

other part is the pore-water pressure controller, which is used to control the increase rate of pore-water pressure by controlling the movement rate of the steel piston in de-aired water tank.

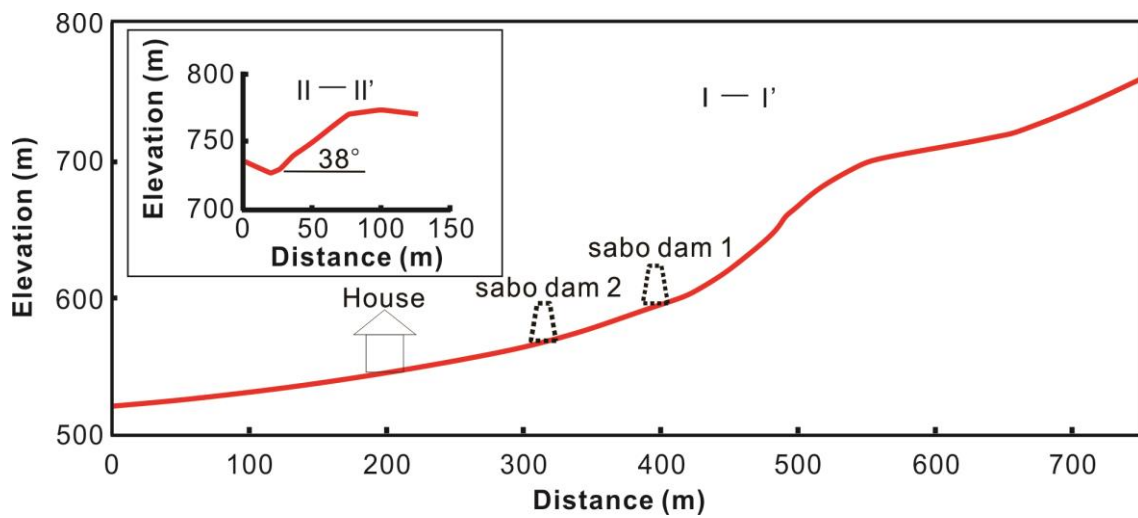
Fig. 4.10 Longitudinal profiles of the gully and slope

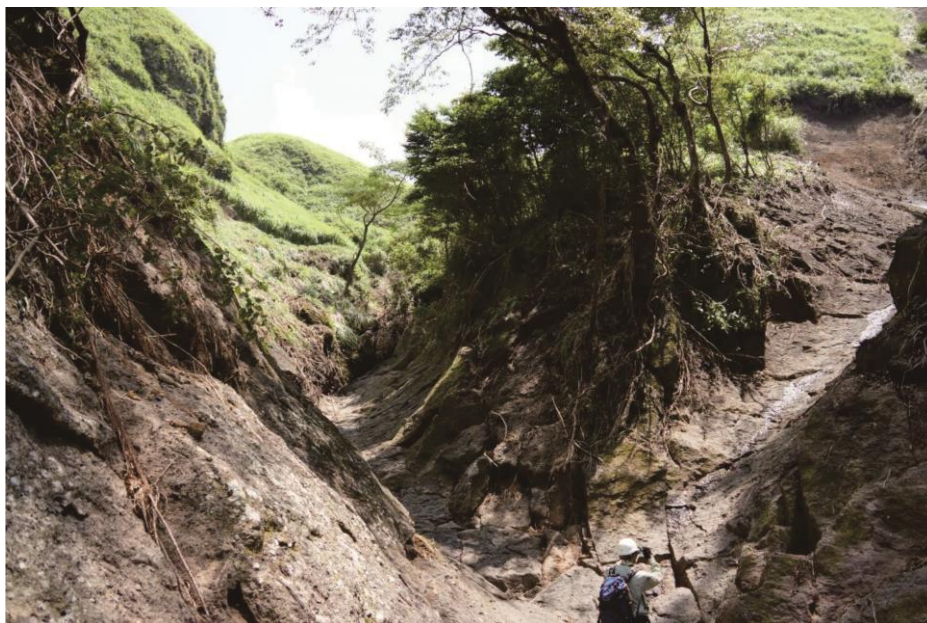
Fig. 4.11 Exposed bedrock in gullies

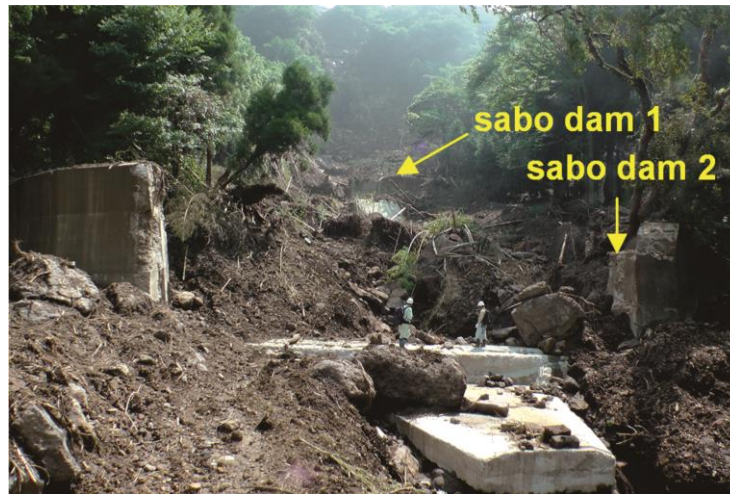
Fig. 4.12 Sabo dams destroyed by debris flow

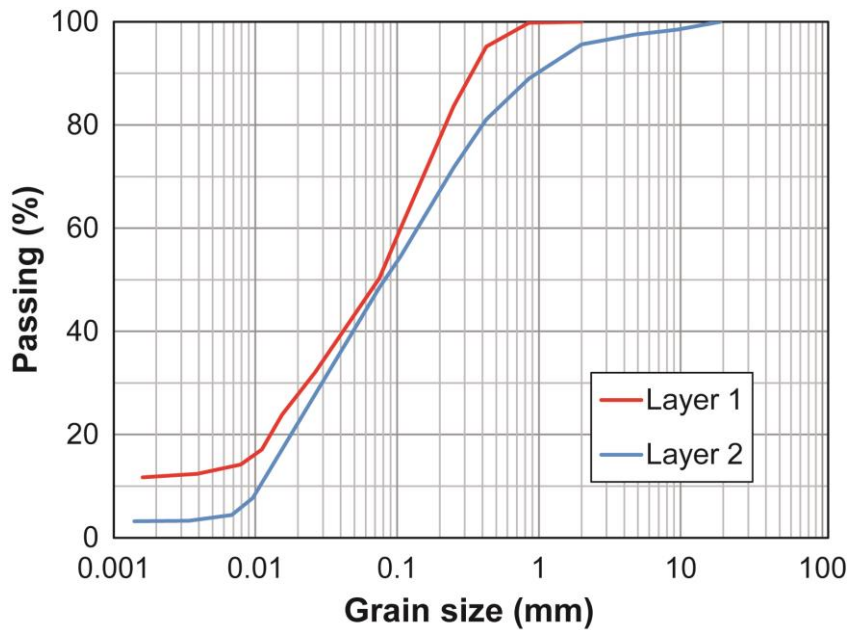
Fig. 4.15 Grain size distributions of soil samples from different layers

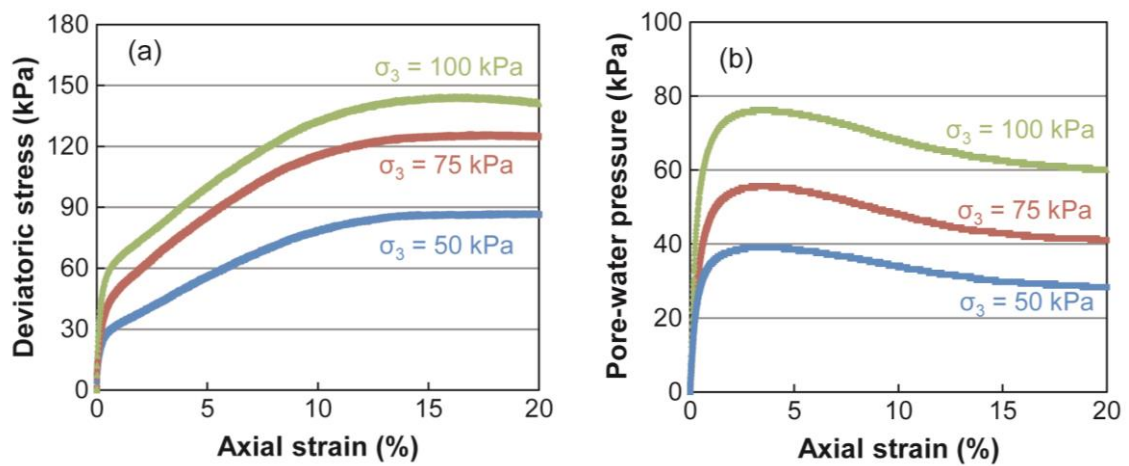
Fig. 4.16 (a) stress-strain relationship; (b) relationship between pore-water pressure and axial strain for the consolidated-undrained triaxial compression tests

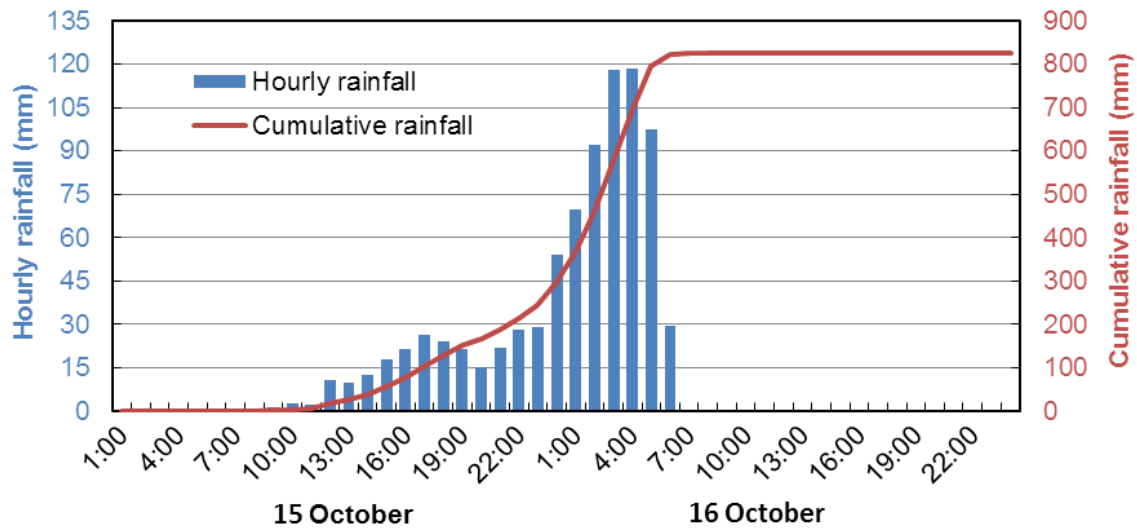
Fig. 5.6 Hourly and cumulative rainfall in Izu Oshima on 15 and 16 October 2013

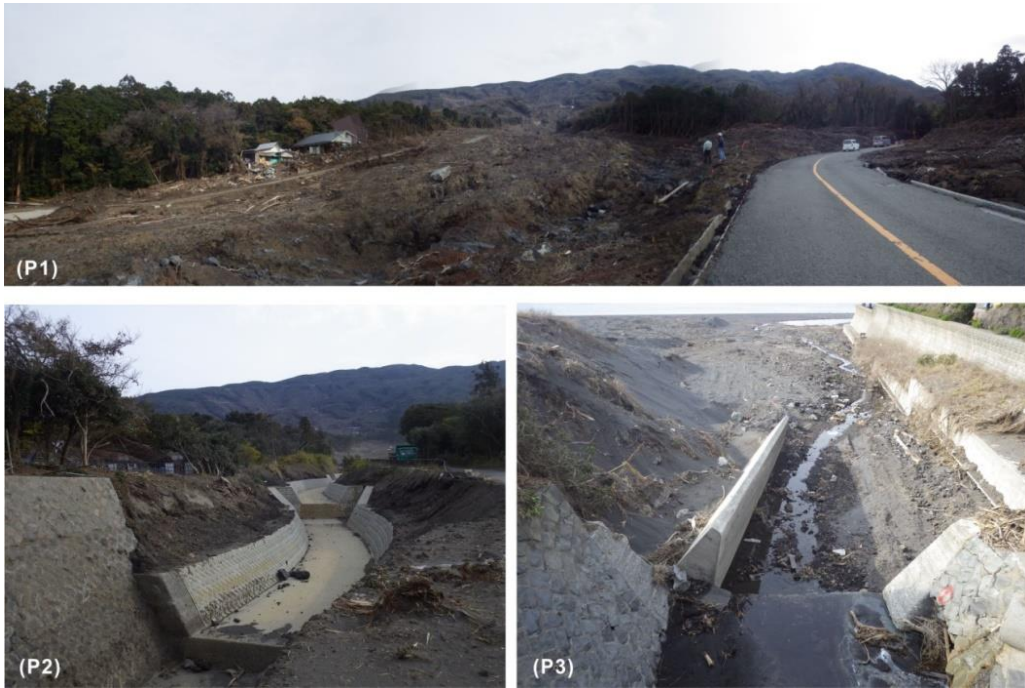
Fig. 5.8 Photographs after debris flows. The locations are marked on Fig. 5.7.

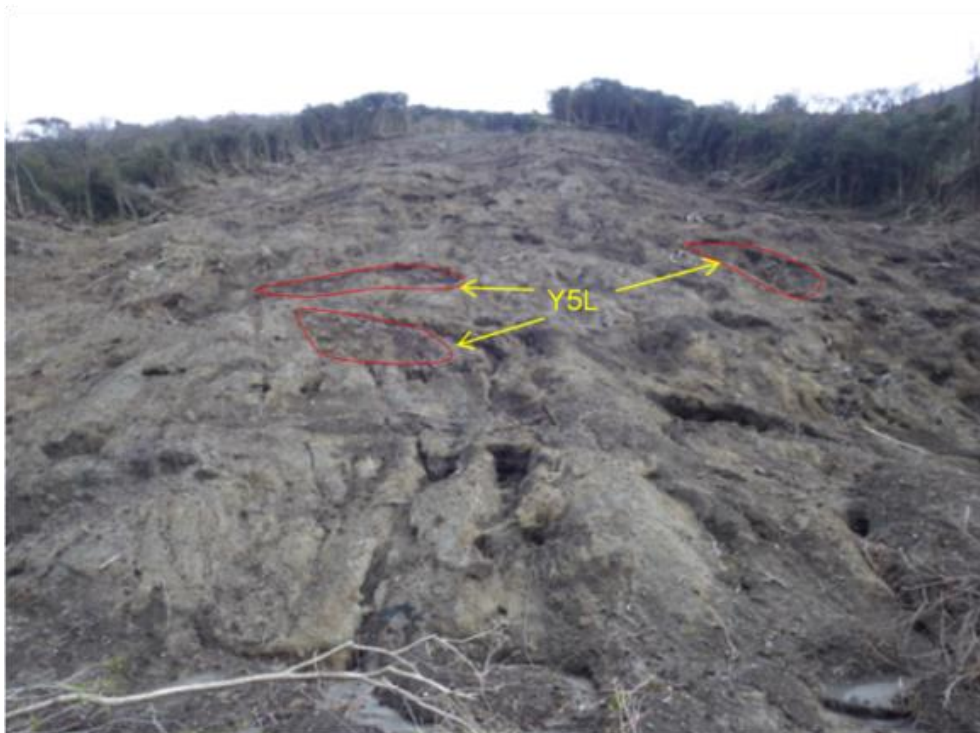
Fig. 5.11 Exposed slope after shallow landslide. Basalt (Y5L) is exposed in places.

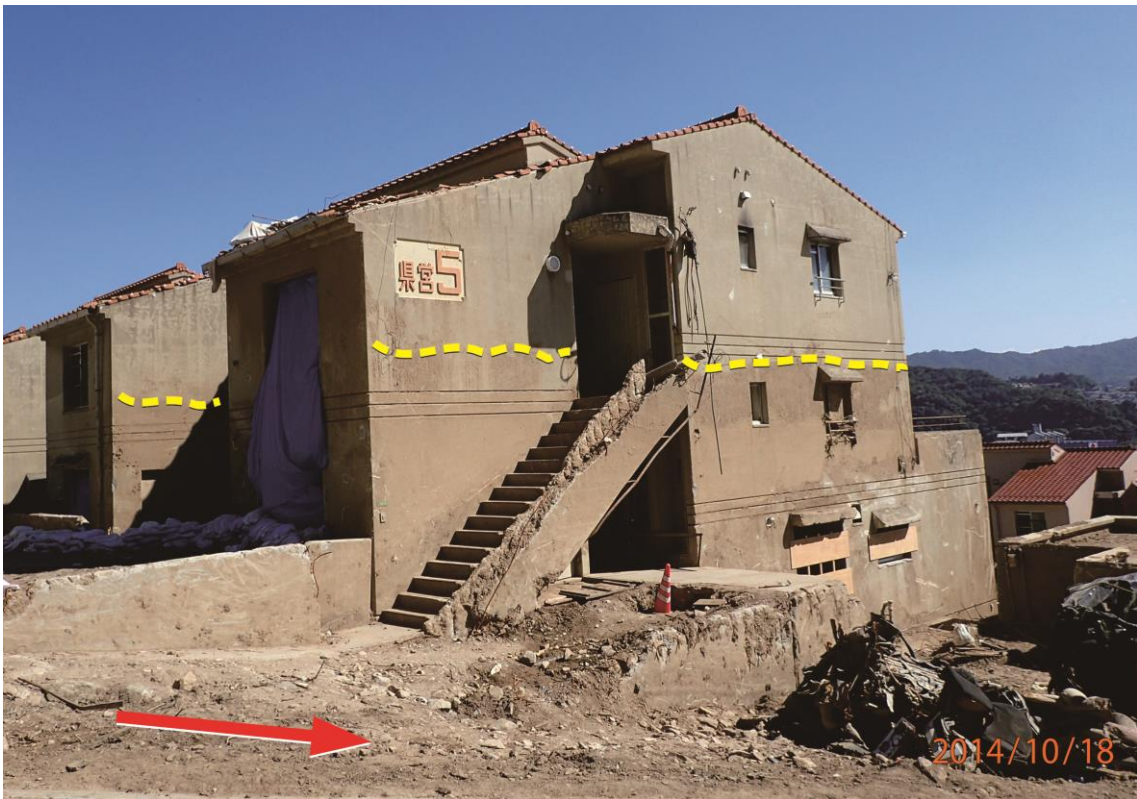
Fig. 6.8 The damaged prefectural housing at the pathway of the Midori-ga-oka debris flow. From the muddy trace on the wall, the flow depth of debris flow was about two-floors high.

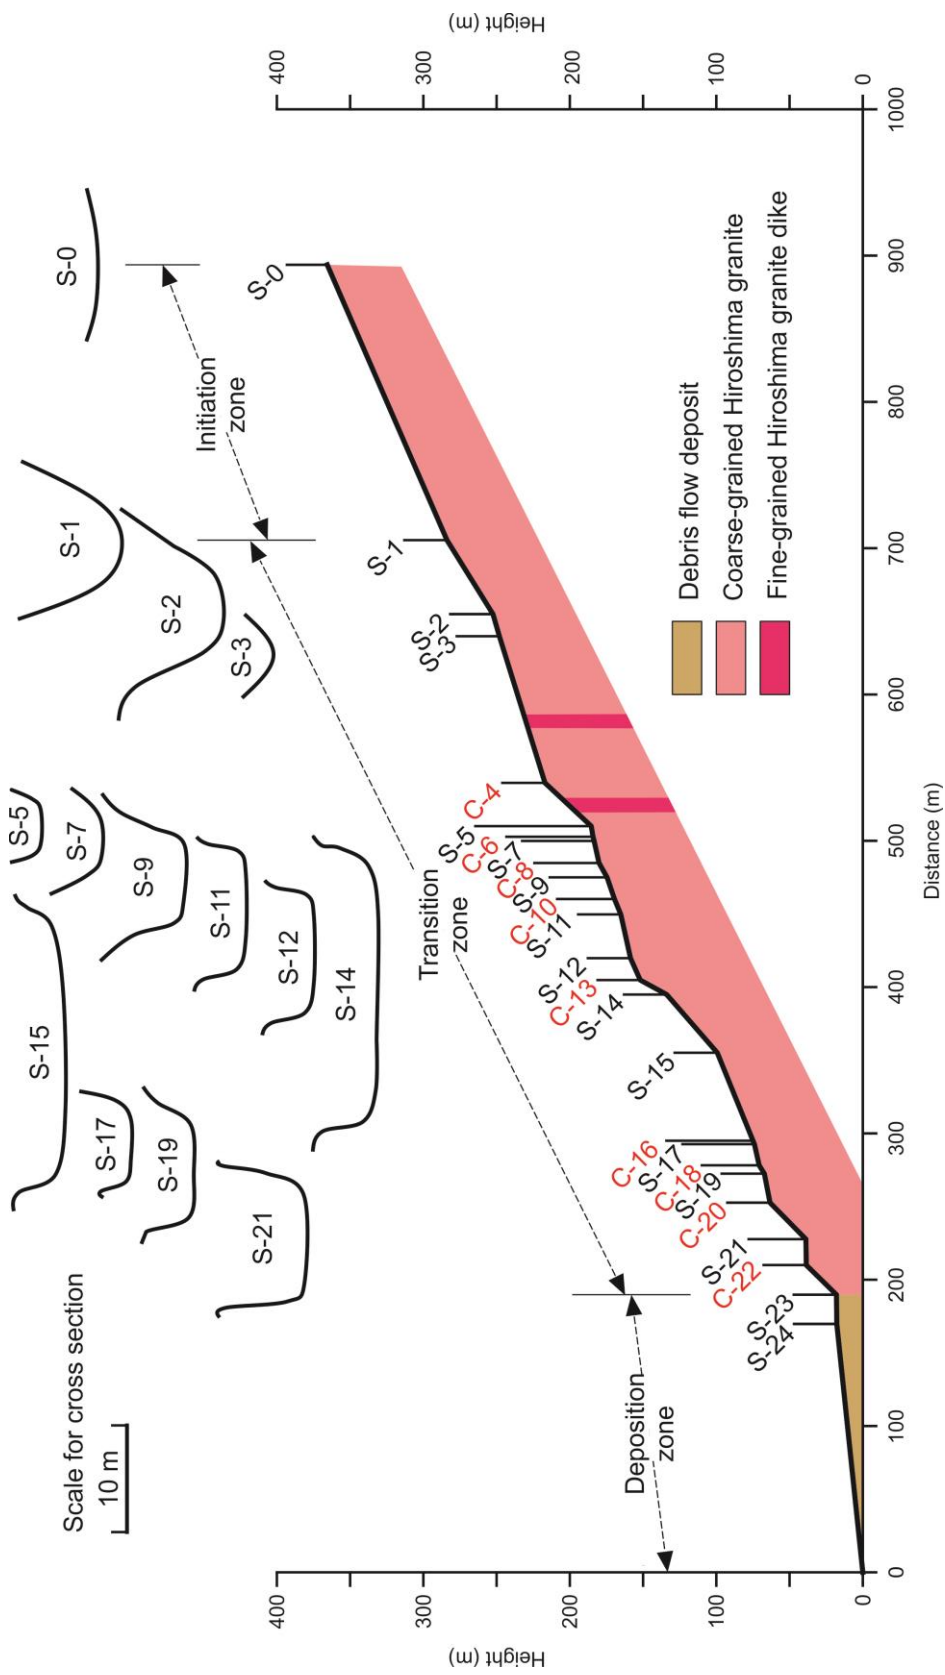
Fig. 6.11 Longitudinal section and cross sections of the Abu-no-sato debris flow gully
