# **Internal erosion and piping failure of landslide dams**

**OKEKE, Chukwueloka Austin Udechukwu**

**Department of Geoscience  
Interdisciplinary Graduate School of Science and  
Engineering  
Shimane University, Japan**

**September, 2016**

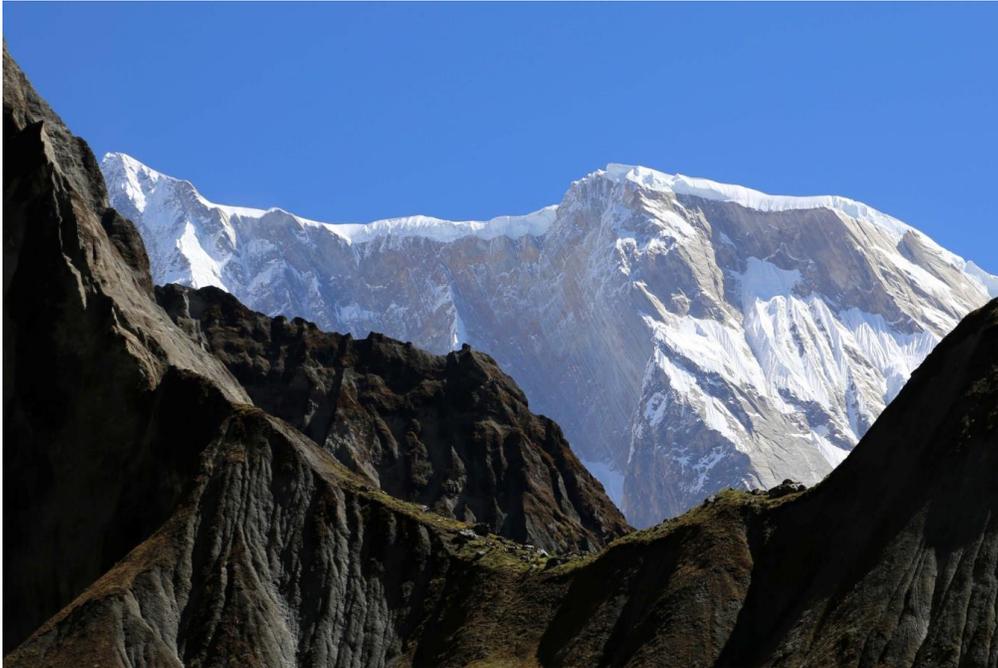
**Figure 1.3** Source area of the May 2012 rock fall and avalanche into the Seti River Gorge in the Nepal Himalaya. The rocks in the source area are highly tilted metamorphosed sedimentary rocks which are covered with snow (Image source: NASA earth observatory file image)

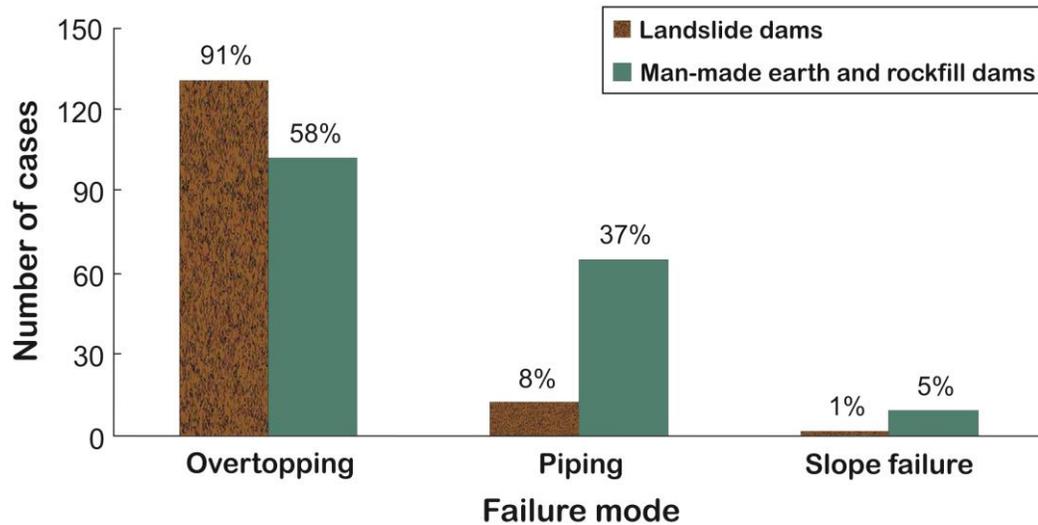
**Figure 1.14** Comparison of failure modes of landslide dams (144 cases) and man-made earth and rockfill dams (176 cases) based on historical cases inventoried by Peng and Zhang (2012)

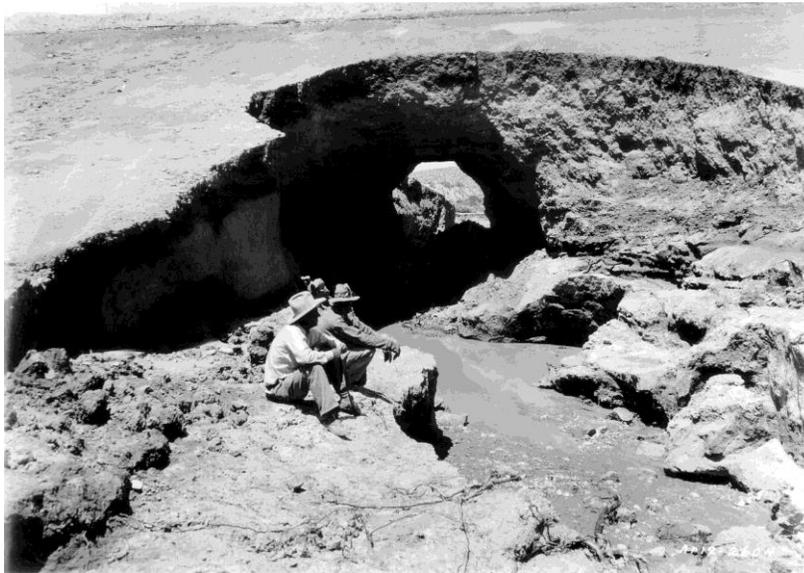
**Figure 1.15** The May 1937 piping failure of a dam in Arizona (USA) comprised of dispersive soil (Image source: USDA NEH 633.13)

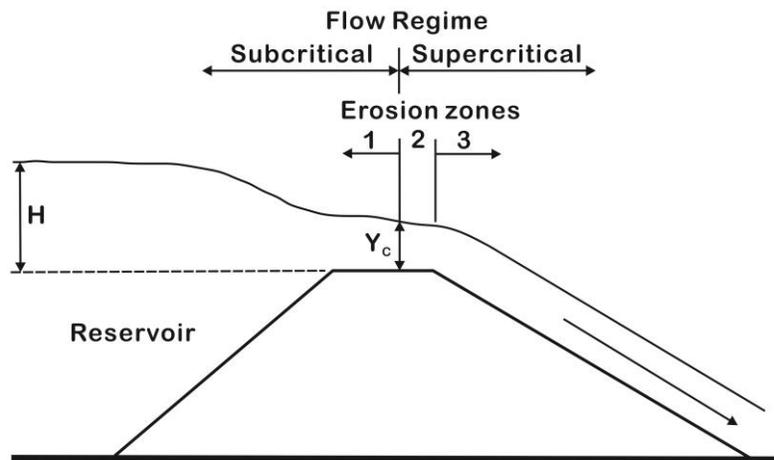
**Figure 1.16** Hydraulic flow regimes and erosion zones during overtopping (after Powledge in Singh 1996)

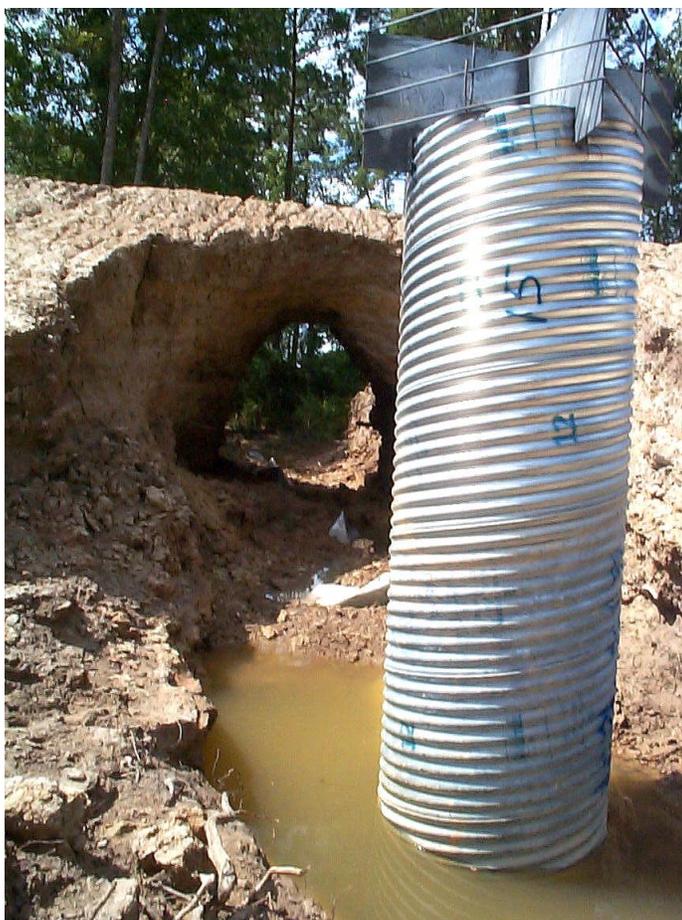
**Figure 2.1** The 2002 piping failure of the Lonesome Dove Reservoir levee in Louisiana, USA (Image source: USDA NEH [633.13](#))

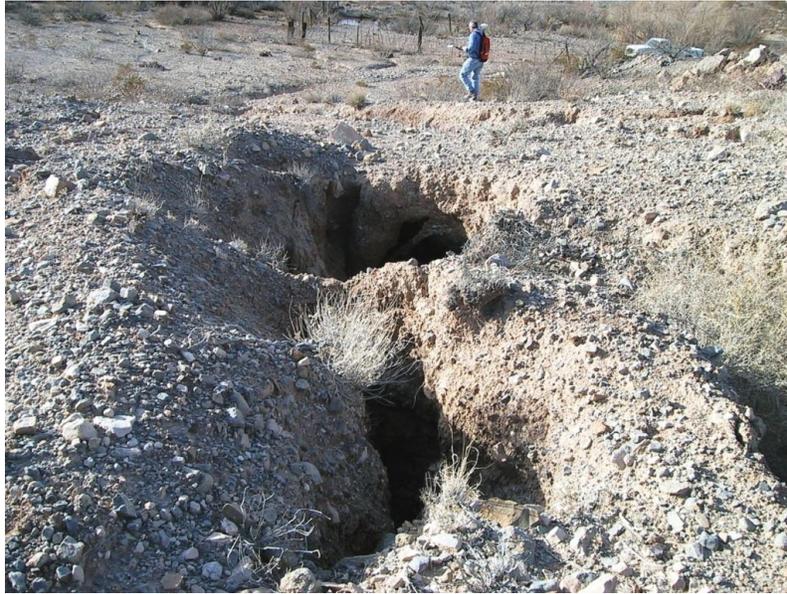
**Figure 2.2** Formation of jugholes in an auxiliary spillway of Diablo Arroyo Site 1, Hudspeth County, in the Trans-Pecos area of Chihuahua desert, USA (Image source: USDA NEH [633.13](#))

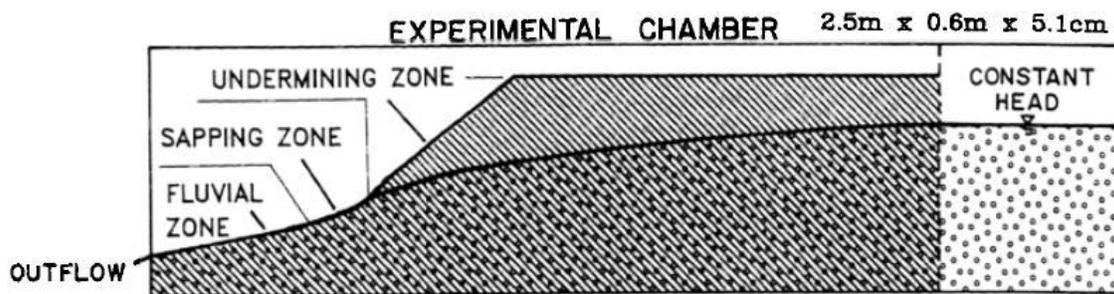
**Figure 2.4** Experimental groundwater sapping chamber, showing the three major sapping zones. Ruled areas are sand, circles represent saturated zone. Permeable screen (dashed line) permits water to flow from constant head reservoir into sand (Howard and McLane 1988).

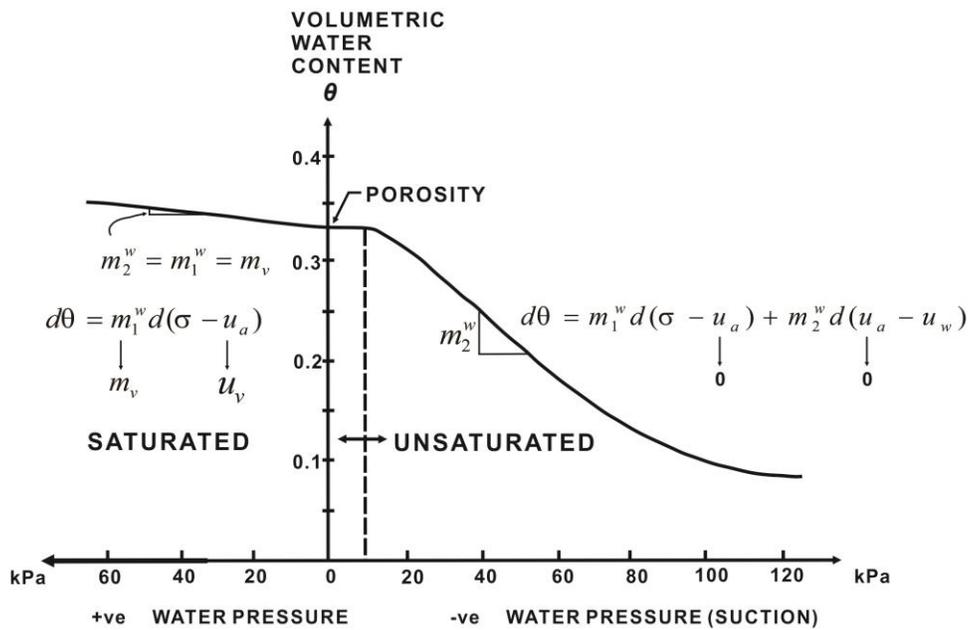
**Figure 2.5** Moisture content retention curve and  $m_2^w$  for unsaturated-saturated soil (Lam et al. 1987)

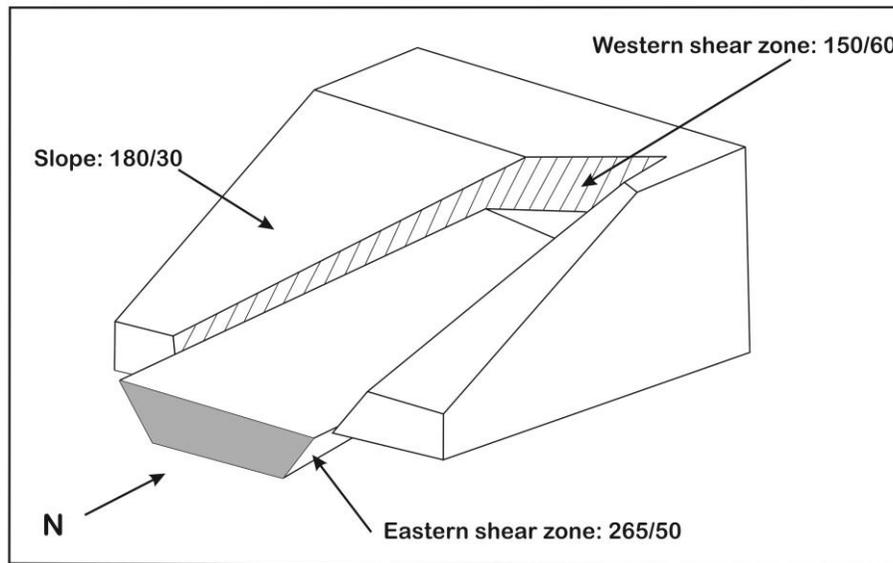
**Figure 2.9** A conceptual representation of the type of initial mass movement (*block slide-wedge failure*) that formed the Usoi Dam in the Murghab River (Hanisch and Söder 2000).

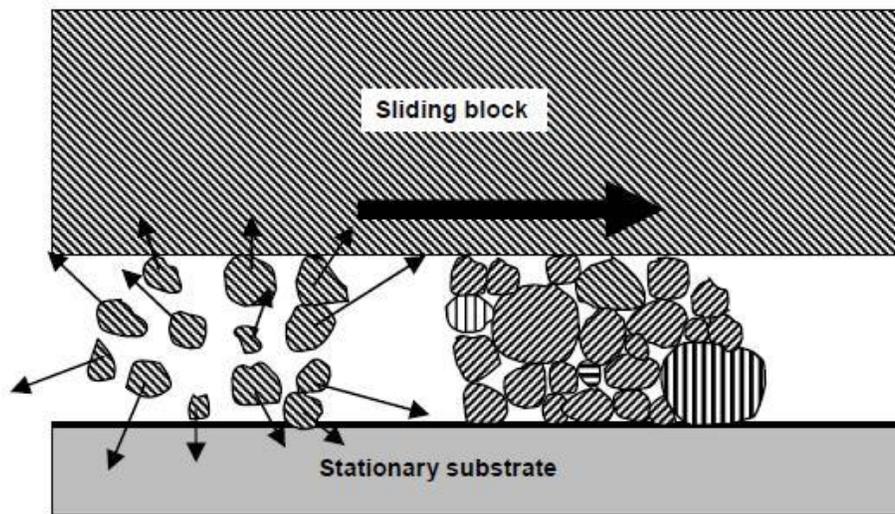
**Figure 2.10** Schematic diagram of the fragmentation process that occurs in block slides. The fragmenting particles bear the weight of the blocks, reducing the normal stress between the block and its substrate and increasing the frictional resistance to motion. This phenomenon has been viewed as an important factor contributing to the stability of many landslide dams due to the ability of the block slides to preserve their original stratigraphy, and hence, increases the resistance to fail by piping or overtopping (Davies and McSaveney 2011).

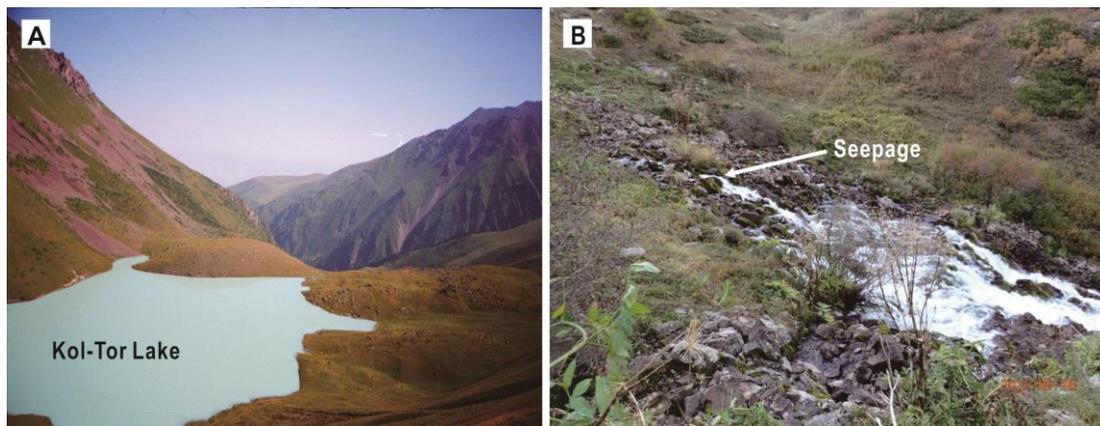
**Figure 3.3** A Upstream lake impounded by the Kol-Tor landslide dam B Seepage/spring at the downstream area of the dam.

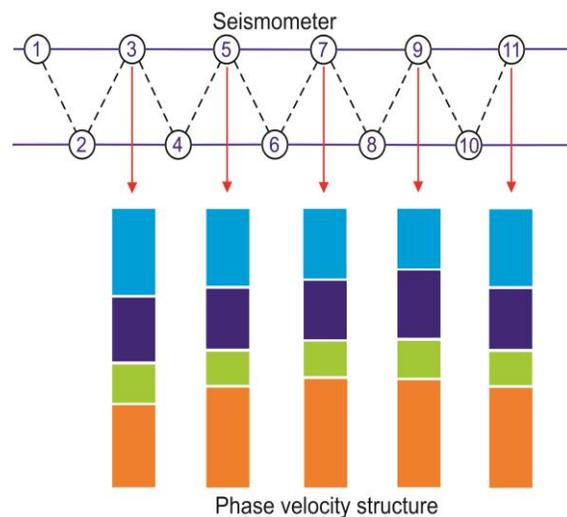
**Figure 3.4** Microtremor measurements using an array of nested triangles comprised of 12 geophones (Wang et al. 2015)

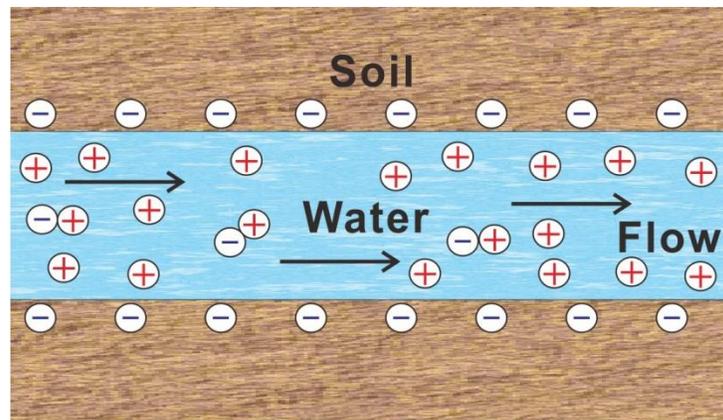
**Figure 3.5** Schematic diagram of streaming potential in the pore space of a saturated soil (Wang et al. 2015)

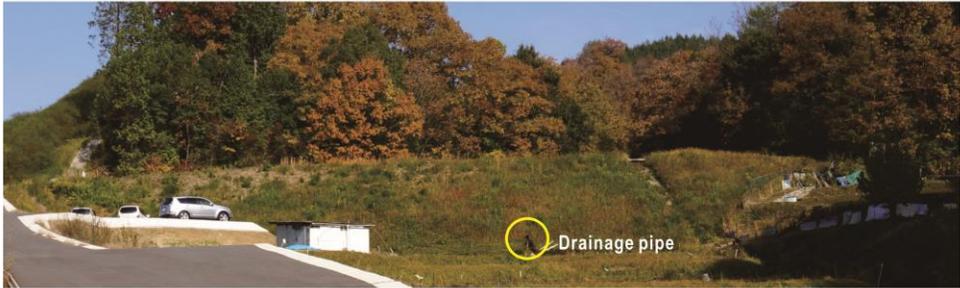
Figure 3.8 Phase velocity depth-profile of Miyoshi irrigation dam

The microtremor chain array survey was performed along a survey line on the Miyoshi dam crest. The array size was fixed at 1.5 m while the time for each measurement was fixed at 30 minutes. Several measurements were made during the investigation to minimize noisy SPAC coherencies caused by frequent traffic disturbance from the nearby expressway. Figure 3.8 shows the front view of the dam and the phase velocity profile along the dam crest. It should be noted that the surveyed line on the dam crest started from the right bank of the dam and terminated at the spillway channel, shown in Figure 3.8a. The phase velocities of the dam materials generally vary from 100 to 900 m/s. The uppermost layers of the dam exhibited low phase velocities that ranged from 100 to 140 m/s which may indicate the moderately consolidated nature of the materials. Based on the result, we found that phase velocities in the range of 100 to 120 m/s corresponded to the depth where the drainage pipe was located (i.e. towards the left bank of the dam; Figure 3.8b). This may reflect the loose nature of the surrounding sediments apparently caused by high seepage gradient forces given that the upstream lake is mostly at its maximum level all through the year. Furthermore, the geometry of the dam can be delineated by the high phase velocity values of 540~900 m/s characteristic of the right abutment. Therefore, the result of this preliminary investigation demonstrated the reliability of the MTM chain array method in the evaluation of internal structure of landslide dams.

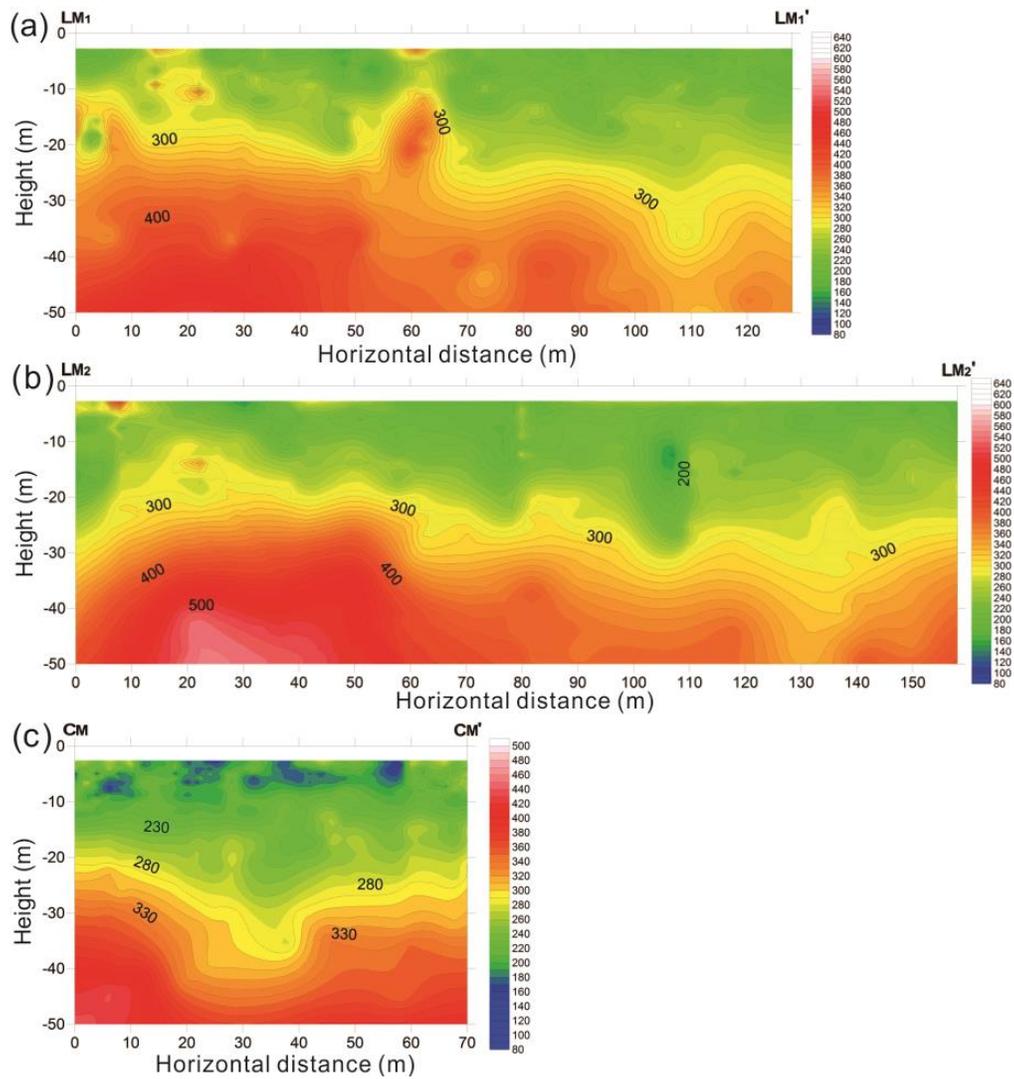
**Figure 3.15** Phase velocity profile along survey lines  $LM_1 - LM_1'$ ,  $LM_2 - LM_2'$ , and  $CM - CM'$  at Higashi-Takezawa landslide dam

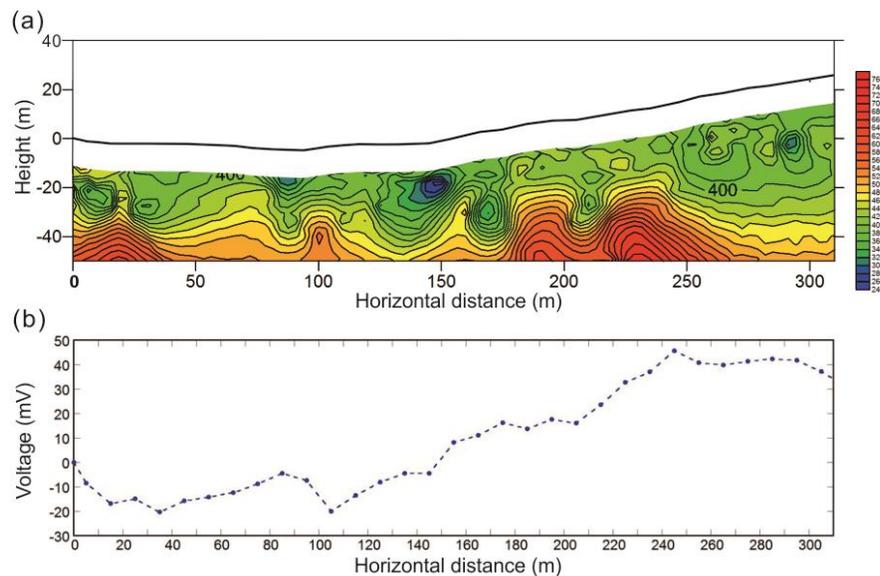
**Figure 3.20** Phase velocity and self-potential profiles along the surveyed lines at Kol-Tor landslide dam

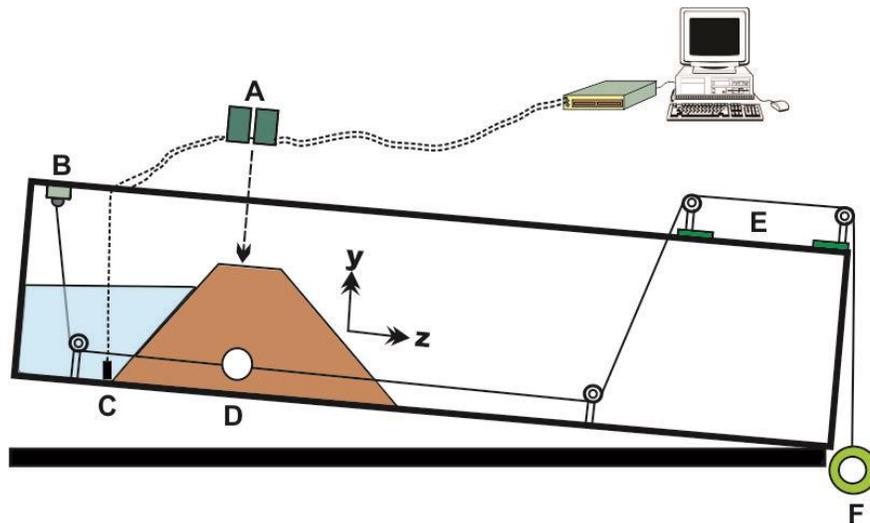
**Figure 4.2** Experimental setup with sensor positions. A Laser displacement sensors B Linear displacement transducer C Upstream lake level sensor D Ball target E Pulleys F Suspended weight of 2.21 N.

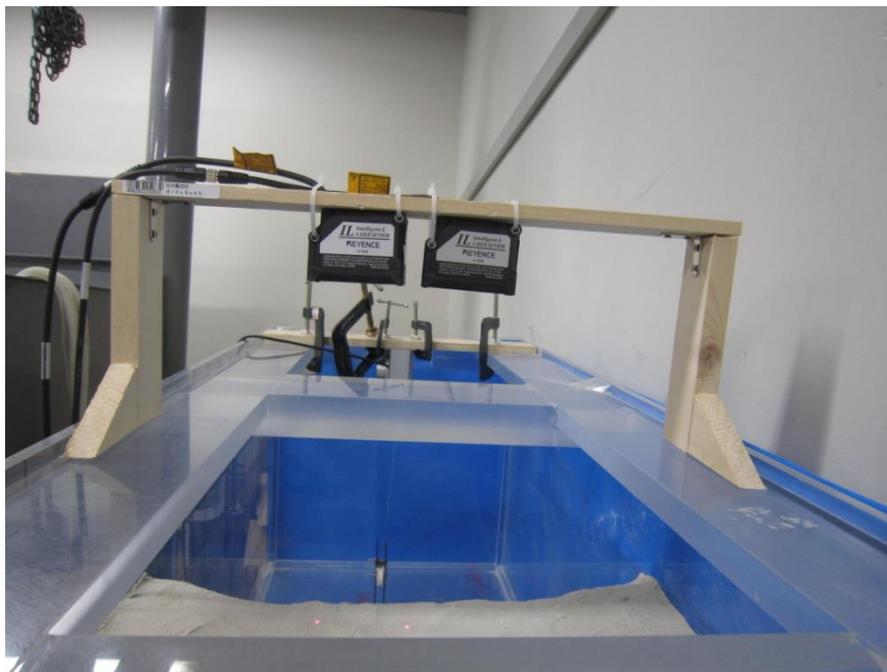
**Figure 4.3** Location of laser displacement sensors used in monitoring crest settlement and the dynamic changes in the dam height as a result of internal erosion and piping.

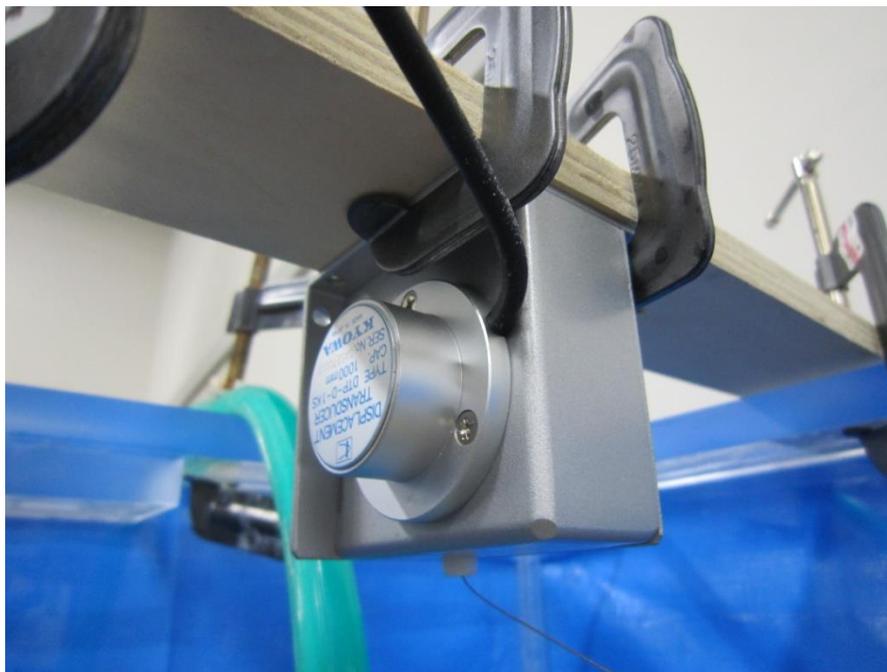
**Figure 4.4** Location of the linear displacement transducer inside the flume tank.

A linear displacement transducer (*model: DTPS-D-1KS*) was used to monitor the onset of internal erosion through to the development of a continuous piping hole in the dams. The transducer has a measuring range of 1.0 m and maximum response speed of 0.2 m/s. The transducer was fixed at the upper end of the flume tank, and a thin metallic wire attached to the sensor head was connected to a plastic ball of similar weight to the materials used in the experiments. The ball was buried at the center of the dam crest, while the outer end of the metallic wire, suspended by a known weight, passed through four stationary pulleys (Figure 4.4).

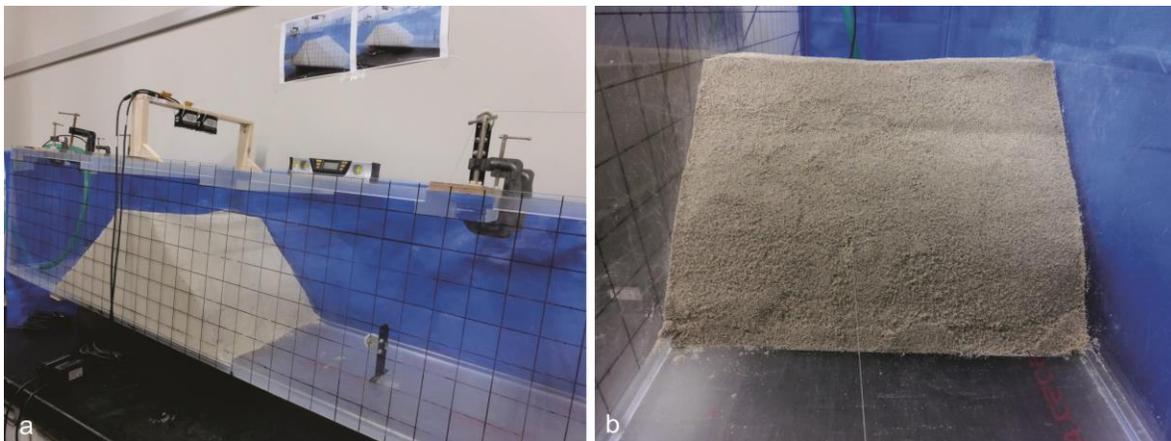
**Figure 4.10** **a** Side view of the flume tank. **b** Front view of a dam showing the downstream slope prior to commencement of an experiment.

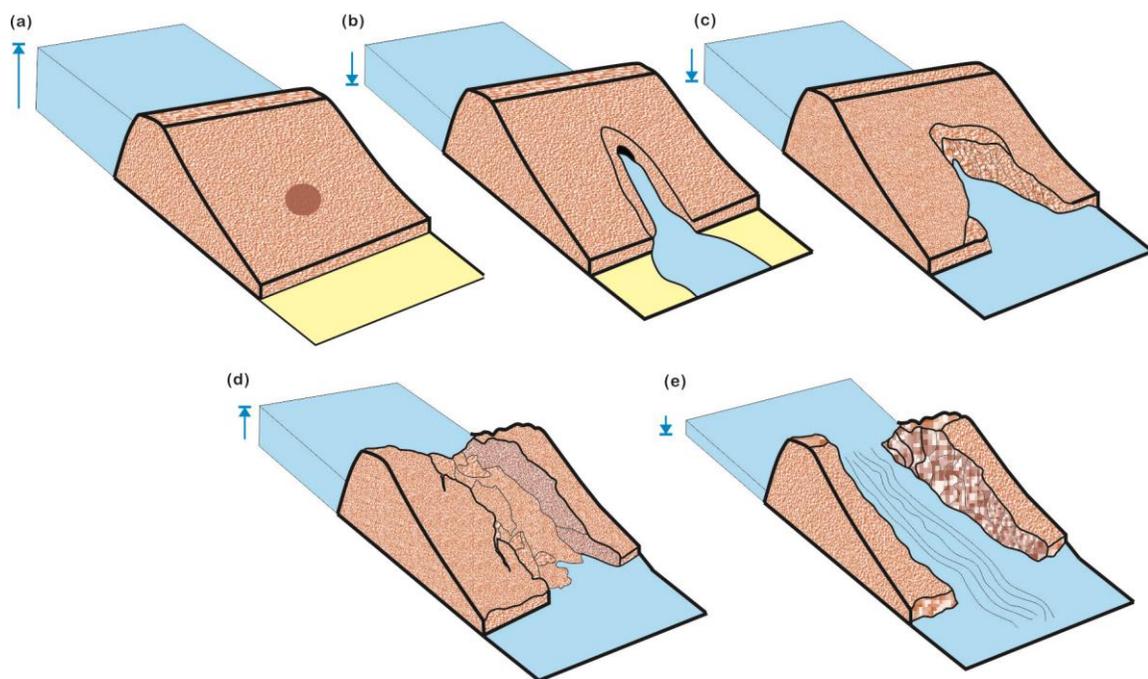
**Figure 4.11** Evolution of the breaching process (a) Wet spot at the downstream slope (b) Formation and growth of a piping hole (c) Pipe progression and enlargement (d) Pipe roof collapse (e) Final breach profile of the dam (Okeke et al. 2013).

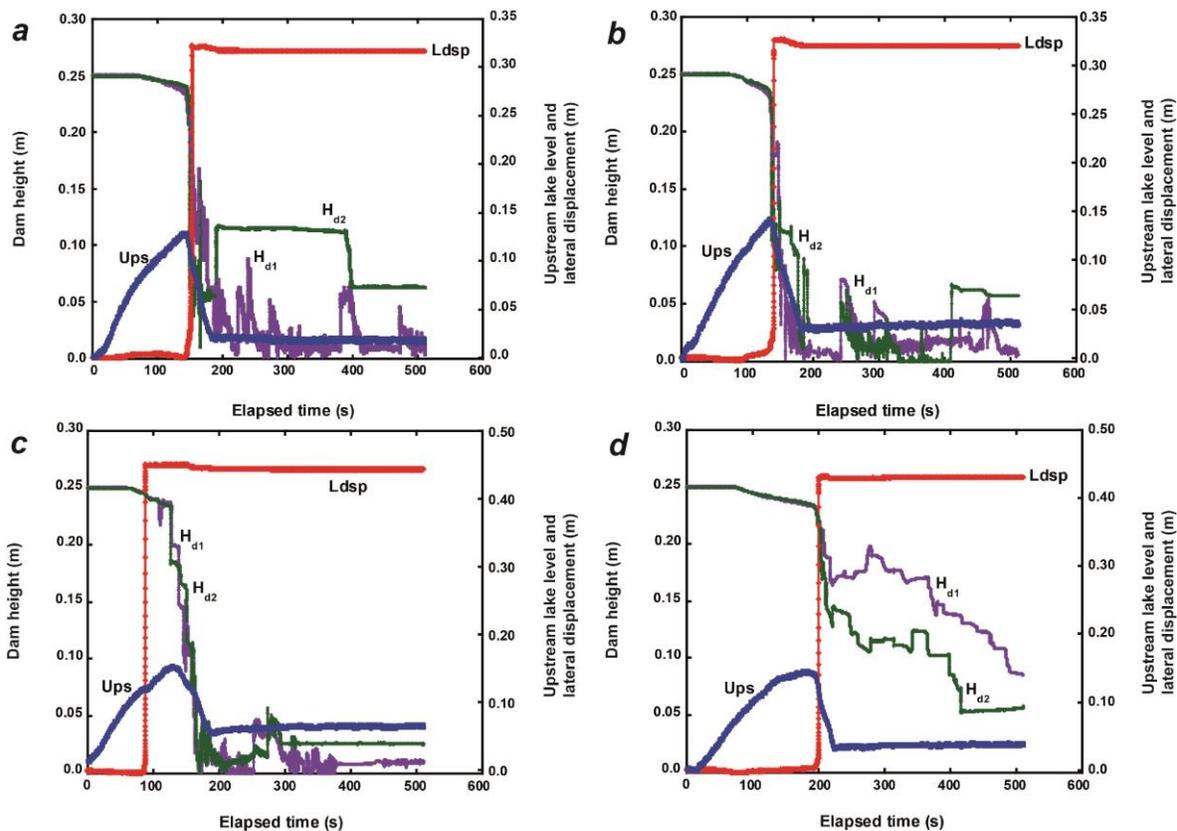
**Figure 4.12** Hydrological trends and mechanisms of breach evolution in dams composed of dam mixes: (a) A (b) B (c) C (d) D.

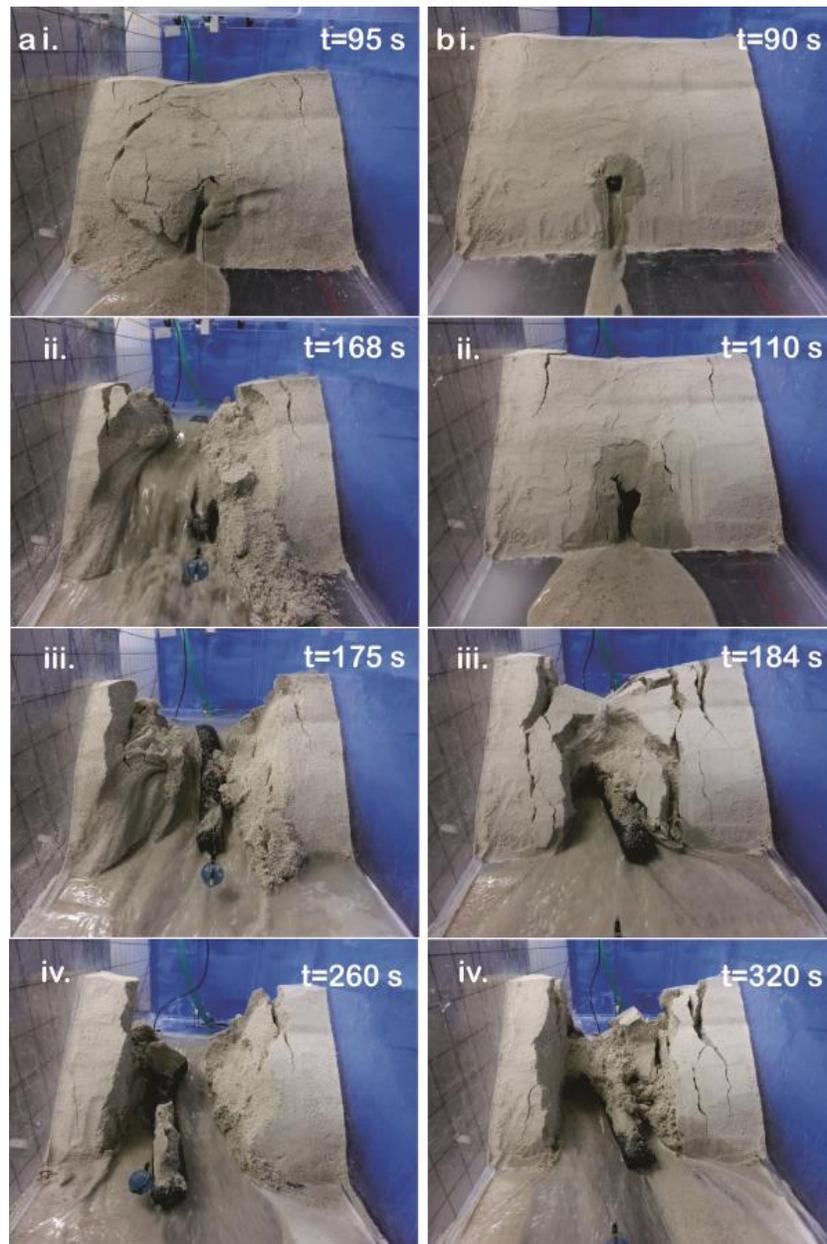
**Figure 4.13** Failure mechanisms of dams built with (a) dam mix A and (b) dam mix D showing piping and subsequent collapse of the dam crest.

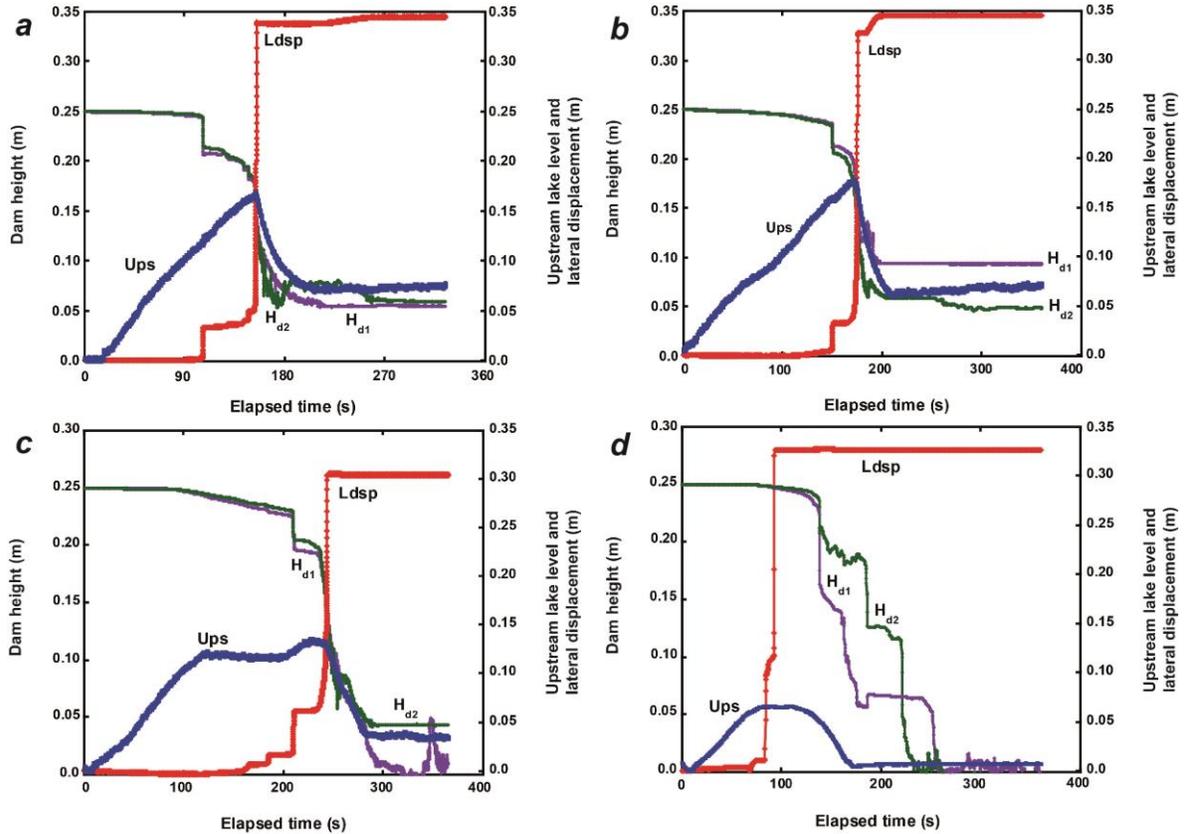
**Figure 4.14** Hydrological trends and mechanisms of breach evolution in dams composed of dam mixes: (a) *E* (b) *F* (c) *G* (d) *H*.

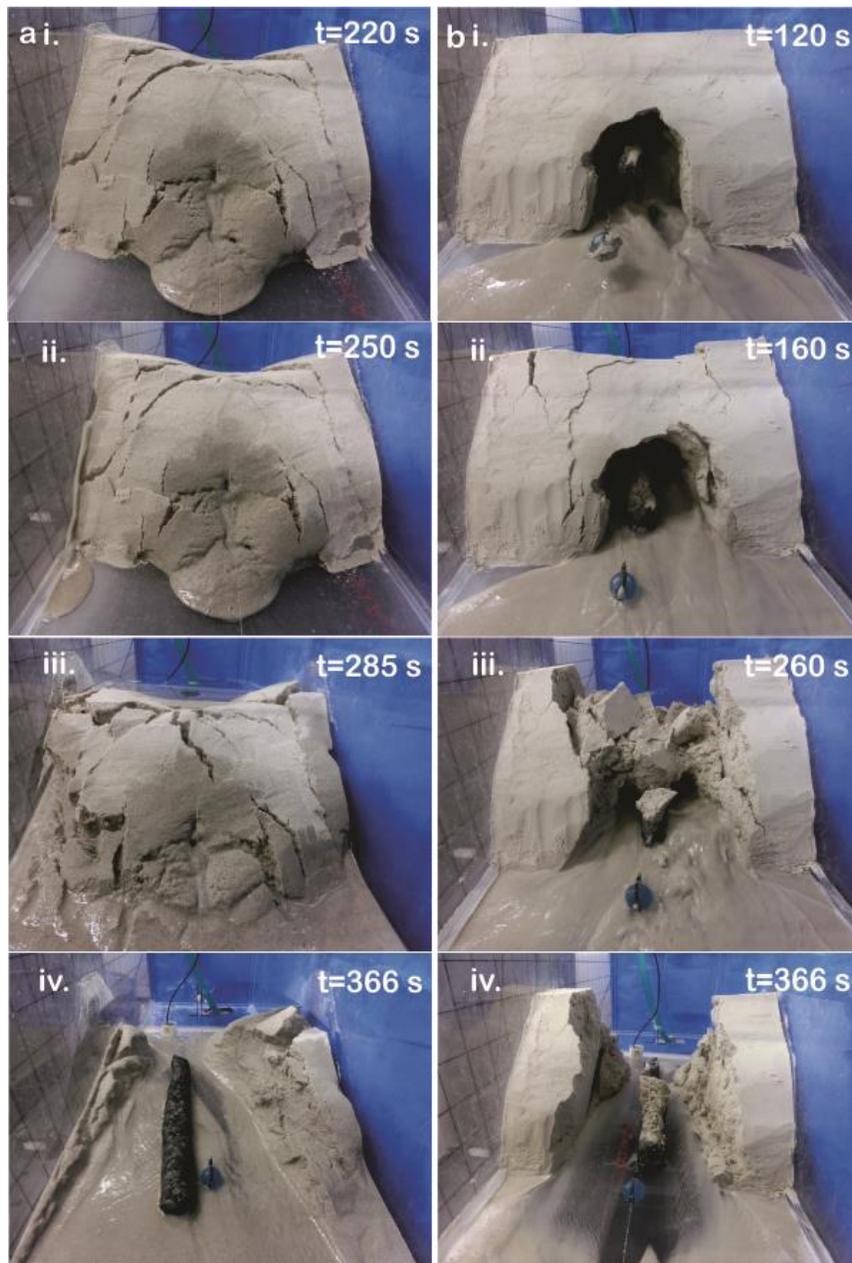
**Figure 4.15** Failure mechanisms of dams built with (a) dam mix *G* and (b) dam mix *H* showing hydraulic cracking, downstream face saturation and piping

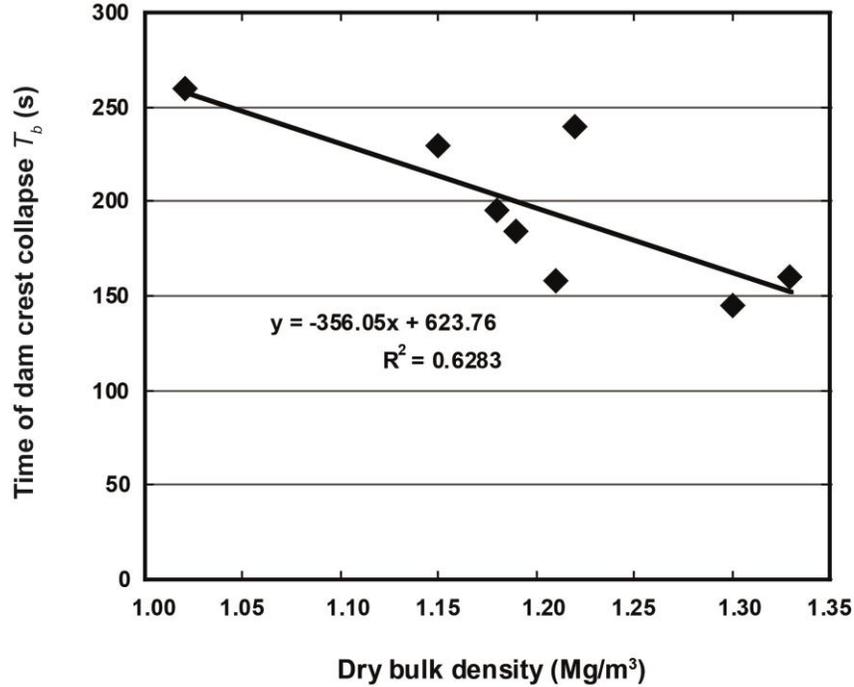
**Figure 4.16** Relationship between time of dam crest collapse  $T_b$  and dry bulk density.

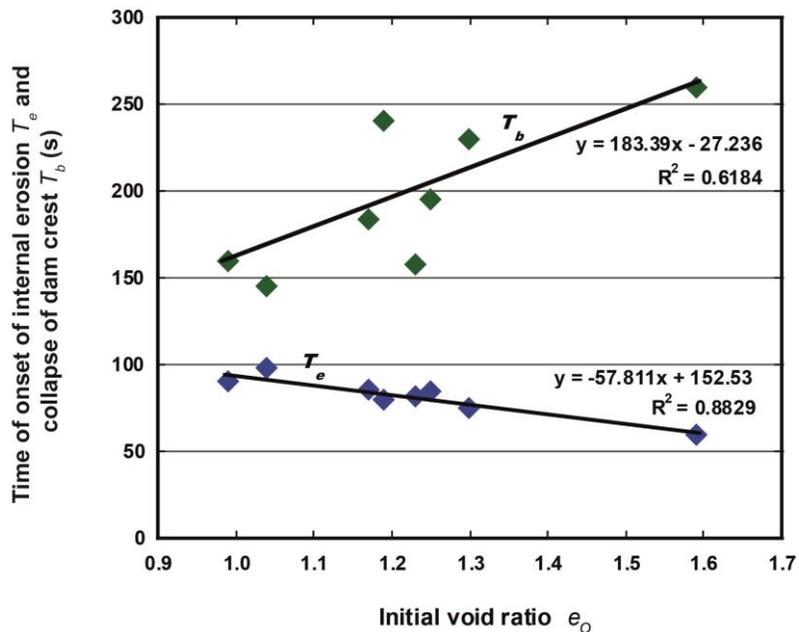
**Figure 4.17** Relationships between time of onset of internal erosion  $T_e$ , time of collapse of dam crest  $T_b$  and initial void ratio  $e_o$ .

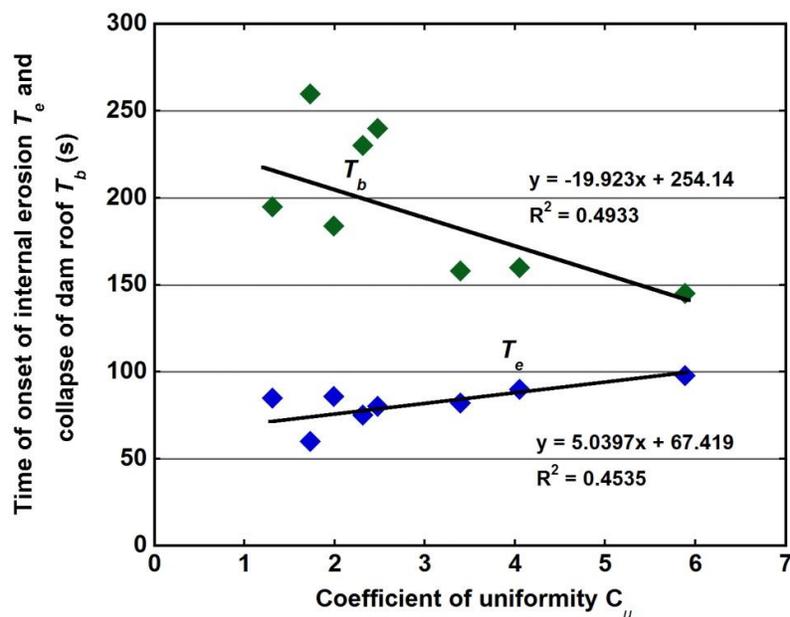
**Figure 4.18** Relationship time of onset of internal erosion  $T_e$ , time of collapse of dam crest  $T_b$  and coefficient of uniformity.

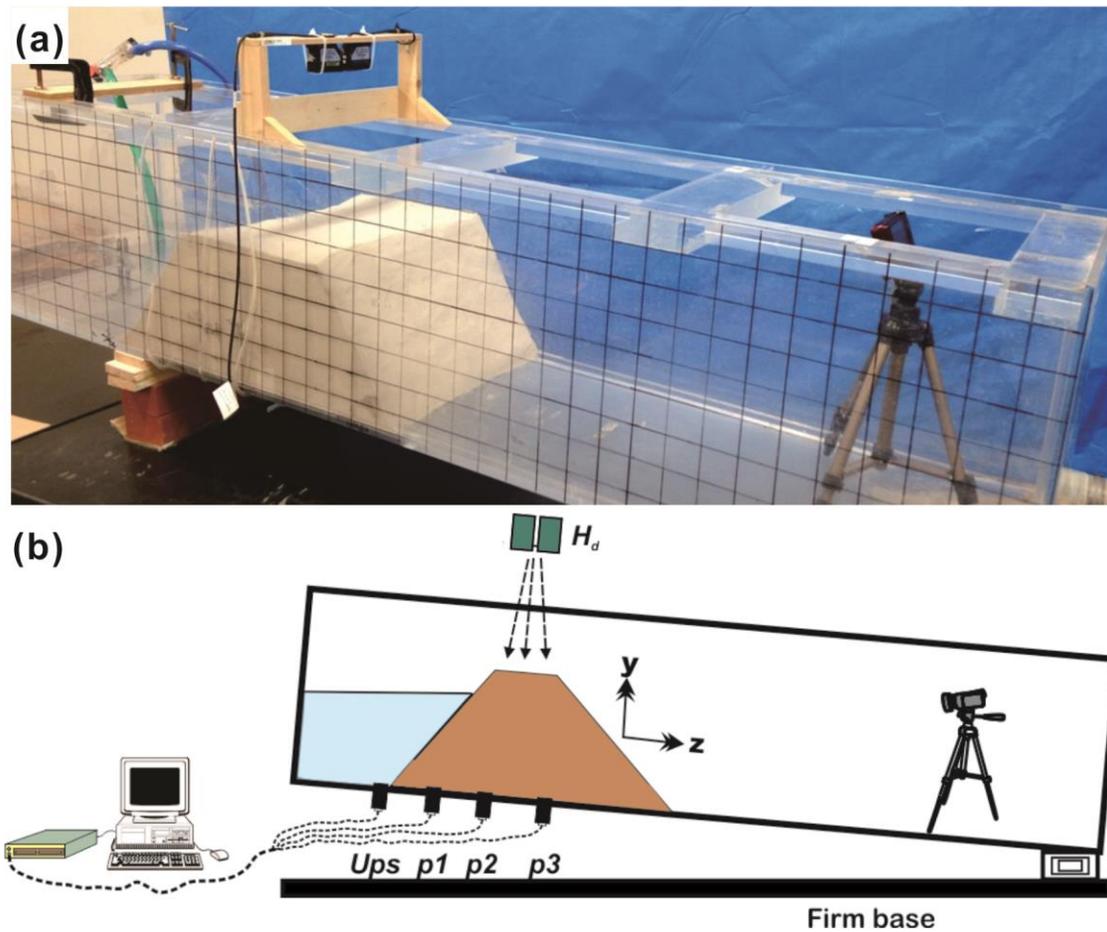
**Figure 5.1** (a) Side view of the flume tank before the commencement of an experiment (b) Experimental setup.  $H_d$  Laser displacement sensors  $Ups$  Upstream water level probe  $p1$ ,  $p2$ , and  $p3$  Pore-water pressure sensors.

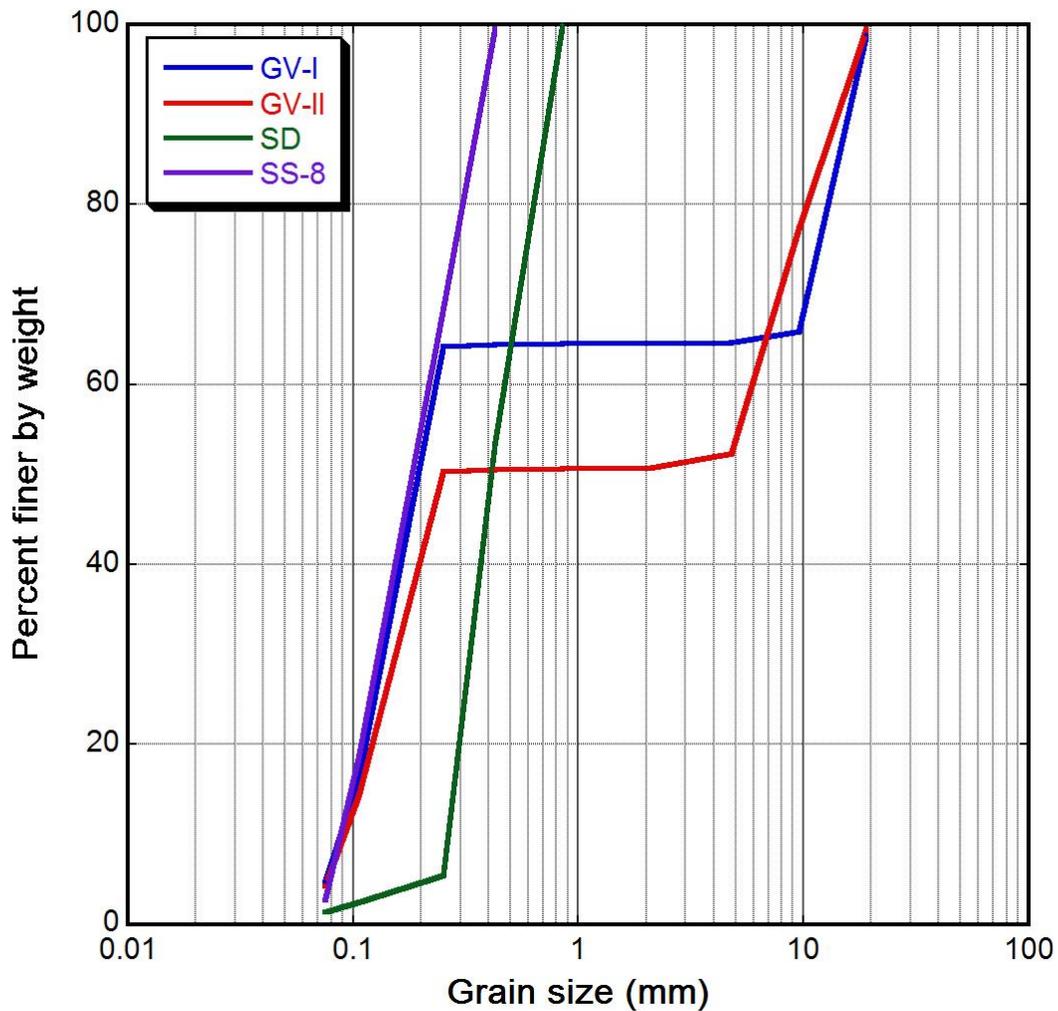
**Figure 5.2** Grain size distribution curves of the dam materials. *GV-I* Gravelly dam I, *GV-II* Gravelly dam II, *SD* Sandfill dam, *SS-8* Silica sand no. 8.

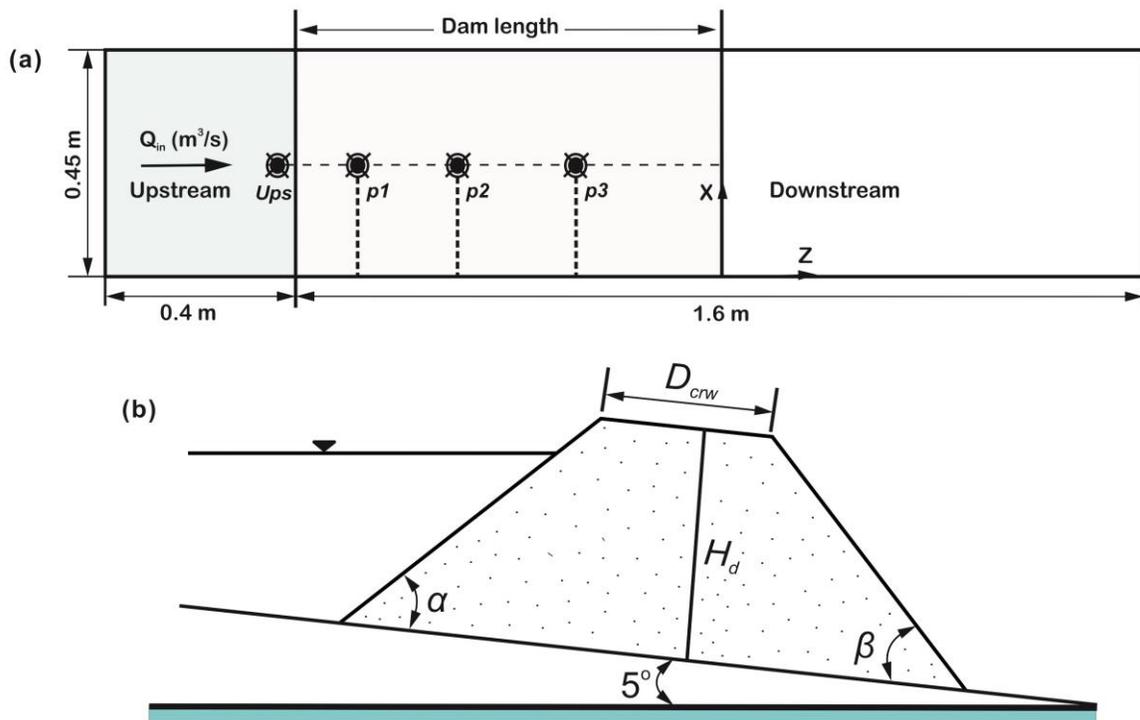
**Figure 5.3** (a) Plan view of the flume tank indicating the position of the dam model and monitoring sensors (b) Schematic diagram of the dam geometry (not to scale).

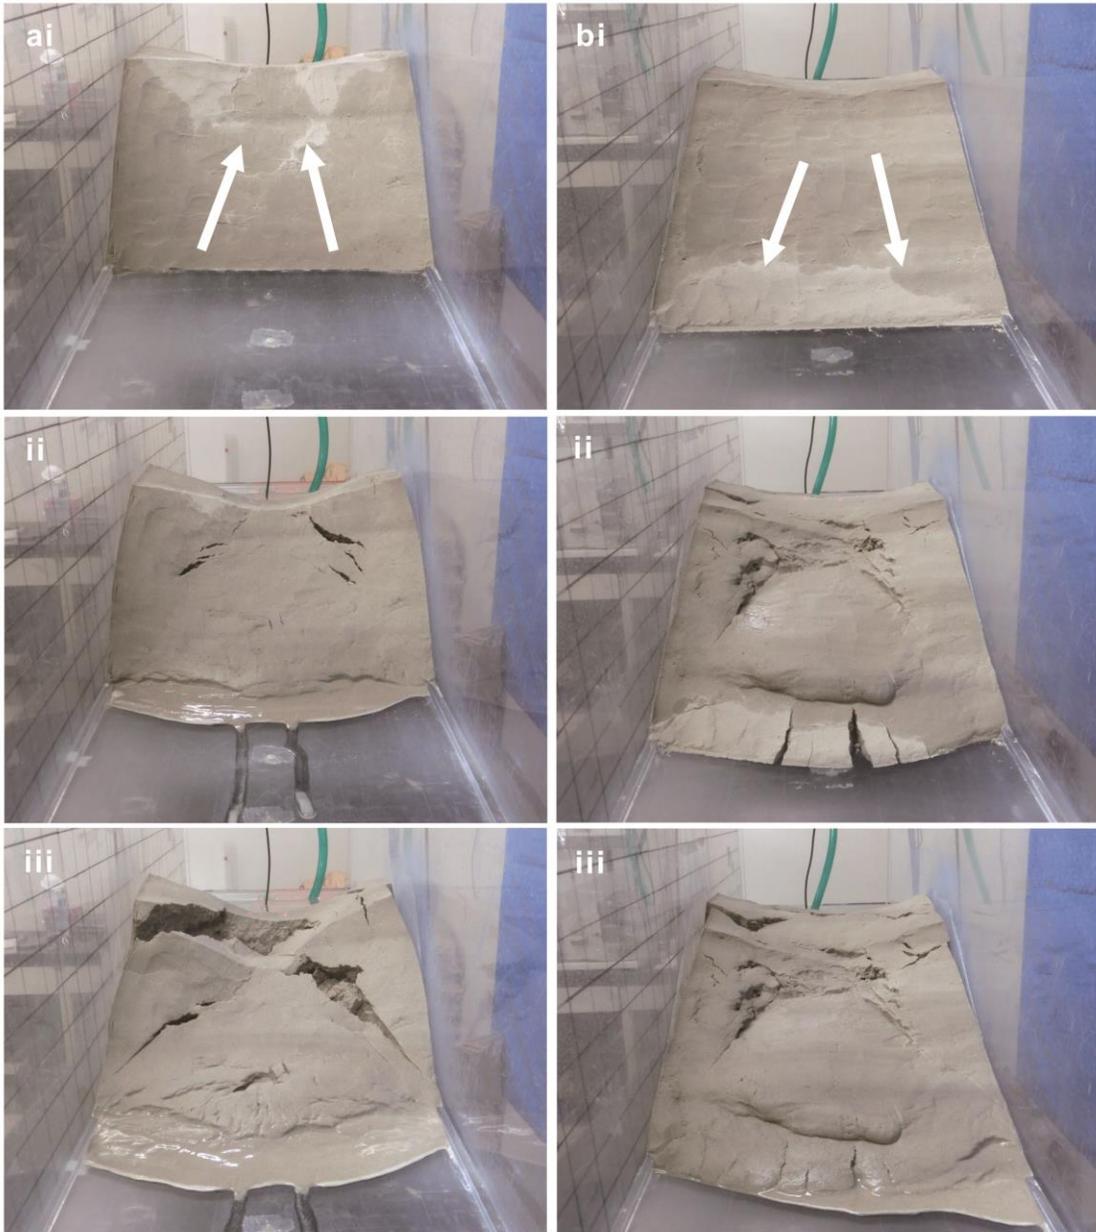
**Figure 6.1** Typical failure mechanisms of the dams showing (a) *Type I* - Upslope propagation of wetting front, exfiltration, sapping and sloughing of the fluidized soil mass (b) *Type II* - Downslope propagation of wetting front, bifurcation, and undermining of the slope toe.
