# **Internal erosion and piping failure of landslide dams**

**OKEKE, Chukwueloka Austin Udechukwu**

**Department of Geoscience  
Interdisciplinary Graduate School of Science and  
Engineering  
Shimane University, Japan**

**September, 2016**

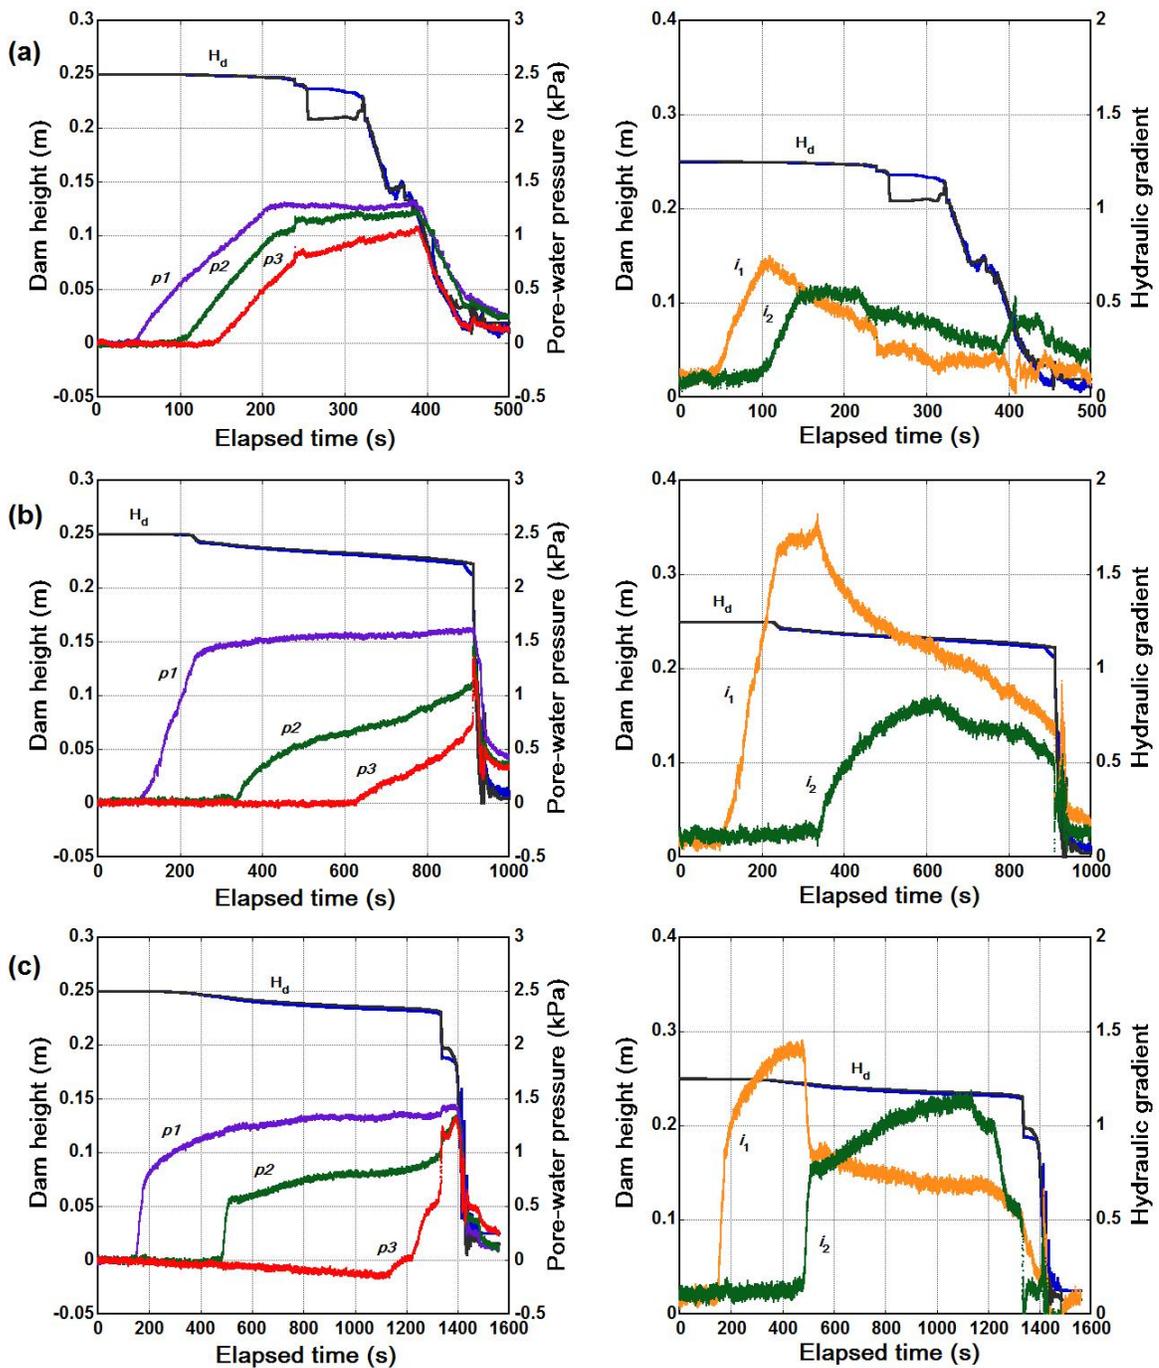
**Figure 6.2** Time-dependent transient changes in pore-water pressures and trends of hydraulic gradients in dams built with (a) *Sandfill dam* (b) *Gravelly dam I* and (c) *Gravelly dam II*.

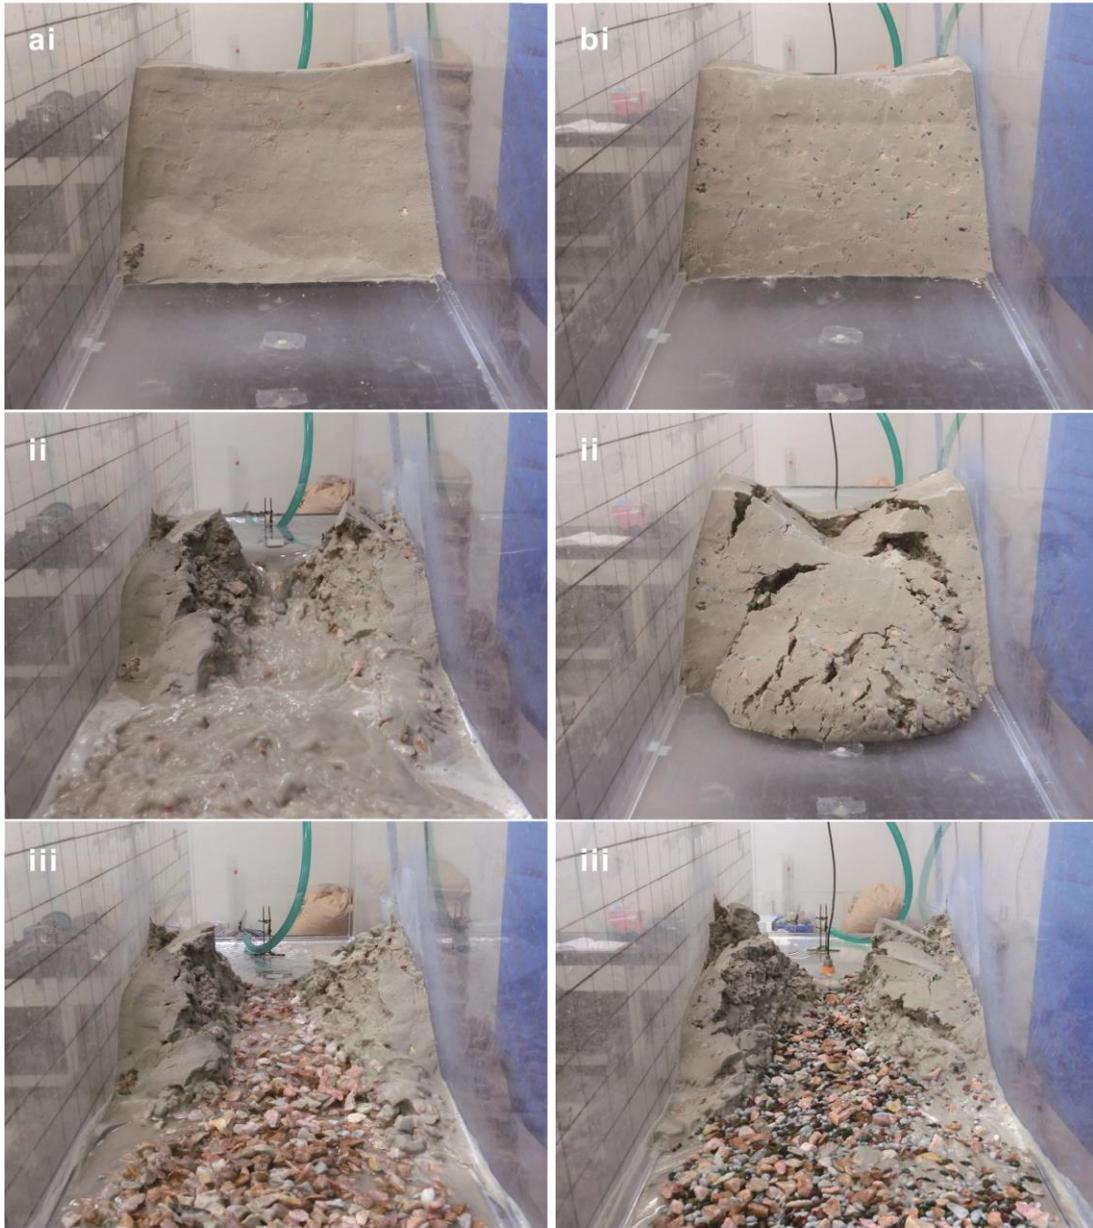
**Figure 6.3** Photographic sequence of seepage-induced failure of dams built with (a) *Gravelly dam I* and (b) *Gravelly dam II*.

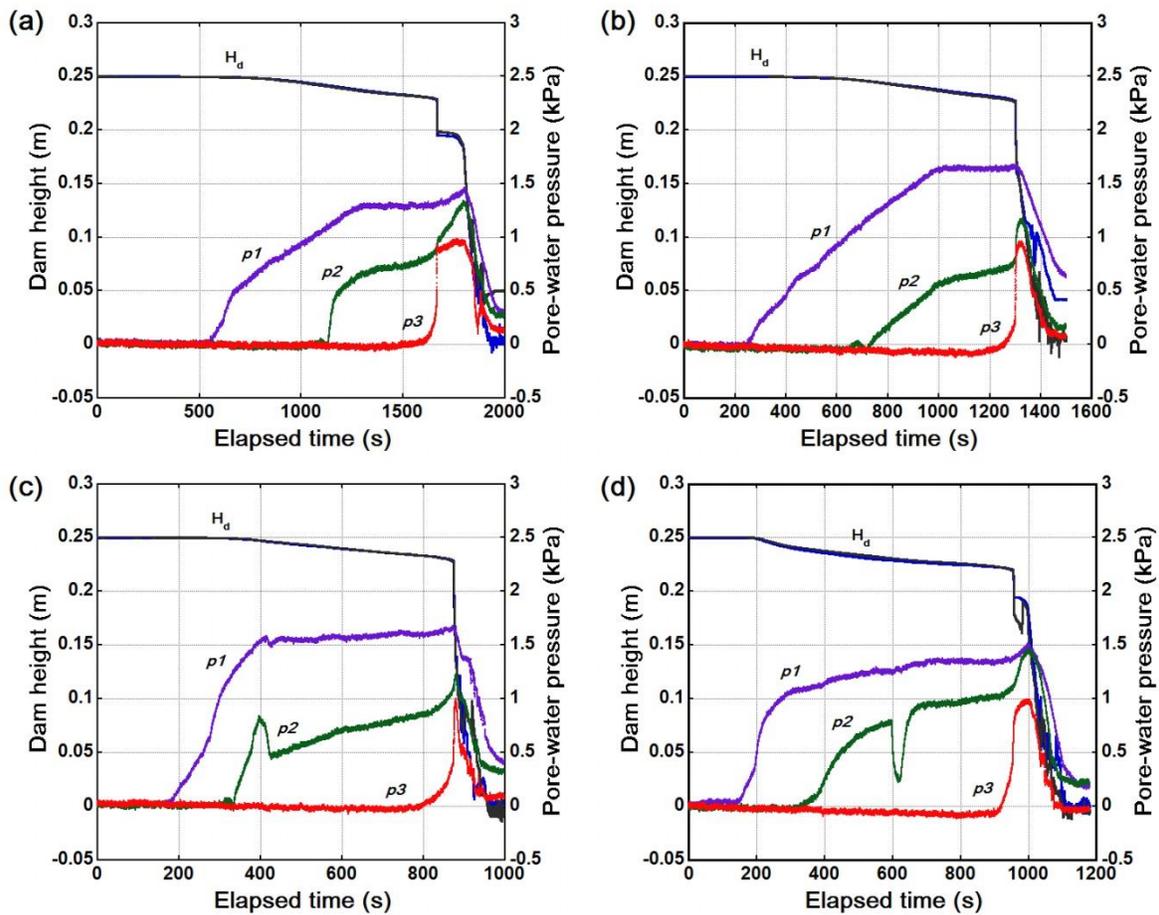
**Figure 6.4** Transient variations in pore-water pressures in experiments conducted with upstream inflow rates of (a)  $1.67 \times 10^{-5} \text{ m}^3/\text{s}$  (b)  $5 \times 10^{-5} \text{ m}^3/\text{s}$  (c)  $1 \times 10^{-4} \text{ m}^3/\text{s}$  (d)  $1.67 \times 10^{-4} \text{ m}^3/\text{s}$ .

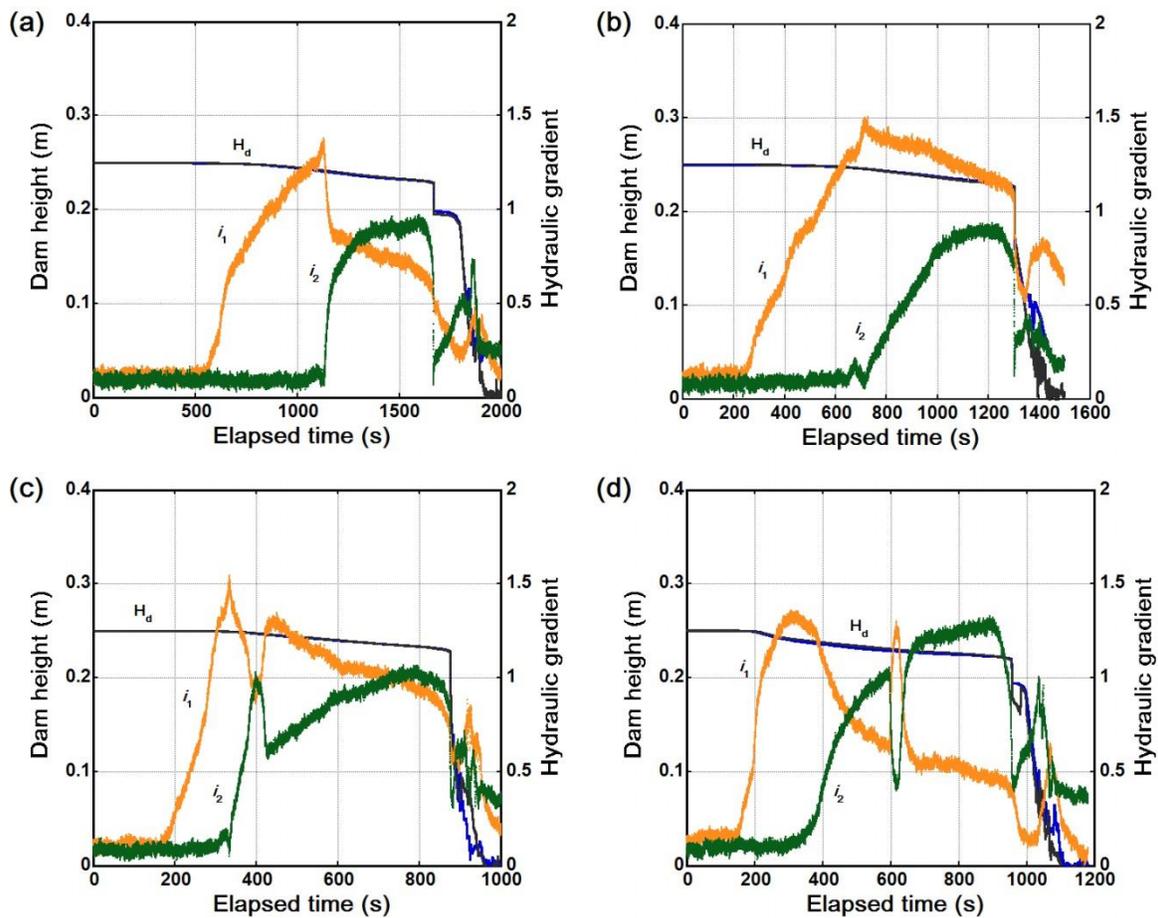
**Figure 6.5** Transient changes in hydraulic gradients in experiments conducted with upstream inflow rates of (a)  $1.67 \times 10^{-5} \text{ m}^3/\text{s}$  (b)  $5 \times 10^{-5} \text{ m}^3/\text{s}$  (c)  $1 \times 10^{-4} \text{ m}^3/\text{s}$  (d)  $1.67 \times 10^{-4} \text{ m}^3/\text{s}$ .

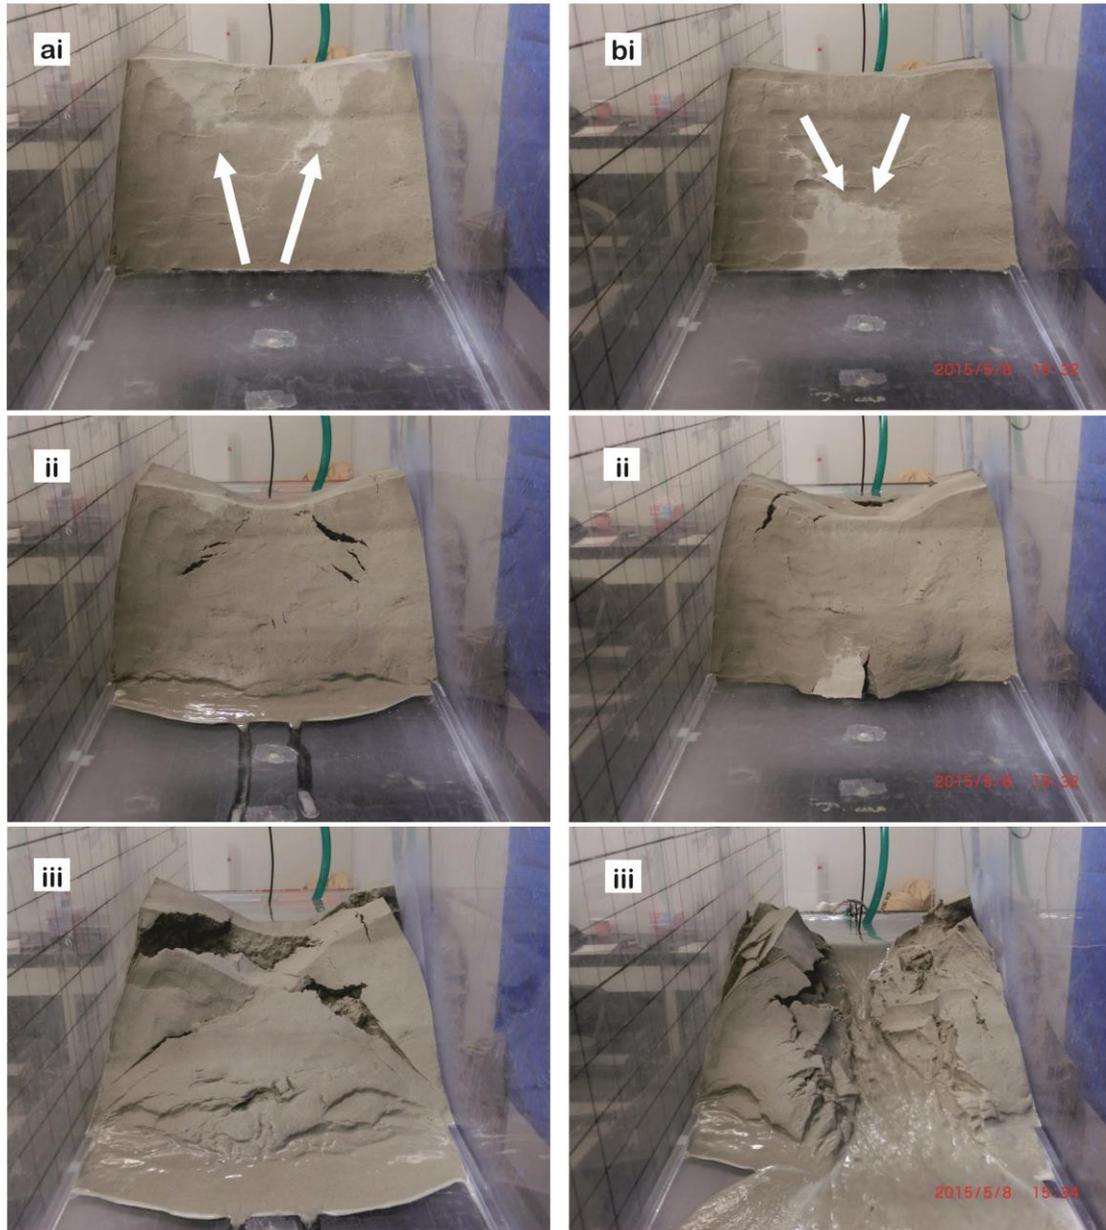
**Figure 6.6** Photographic sequence of the typical failure mechanism of experiments conducted with upstream inflow rates of **(a)**  $1.67 \times 10^{-5} \text{ m}^3/\text{s}$  and **(b)**  $1.67 \times 10^{-4} \text{ m}^3/\text{s}$ .

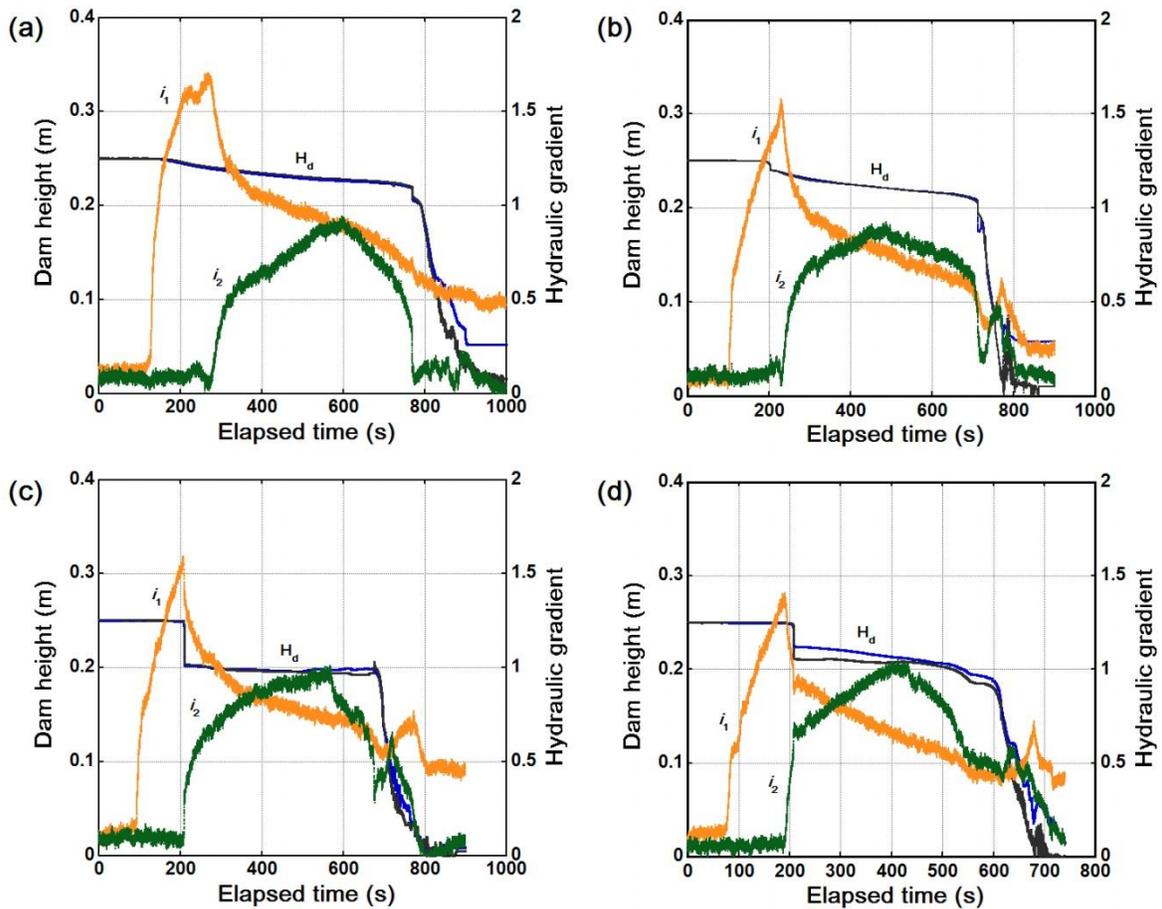
**Figure 6.7** Trends of hydraulic gradients in dams built with an  $e_o$  of 1.76 and antecedent moisture contents of (a) 5% (b) 10% (c) 15% (d) 20%.

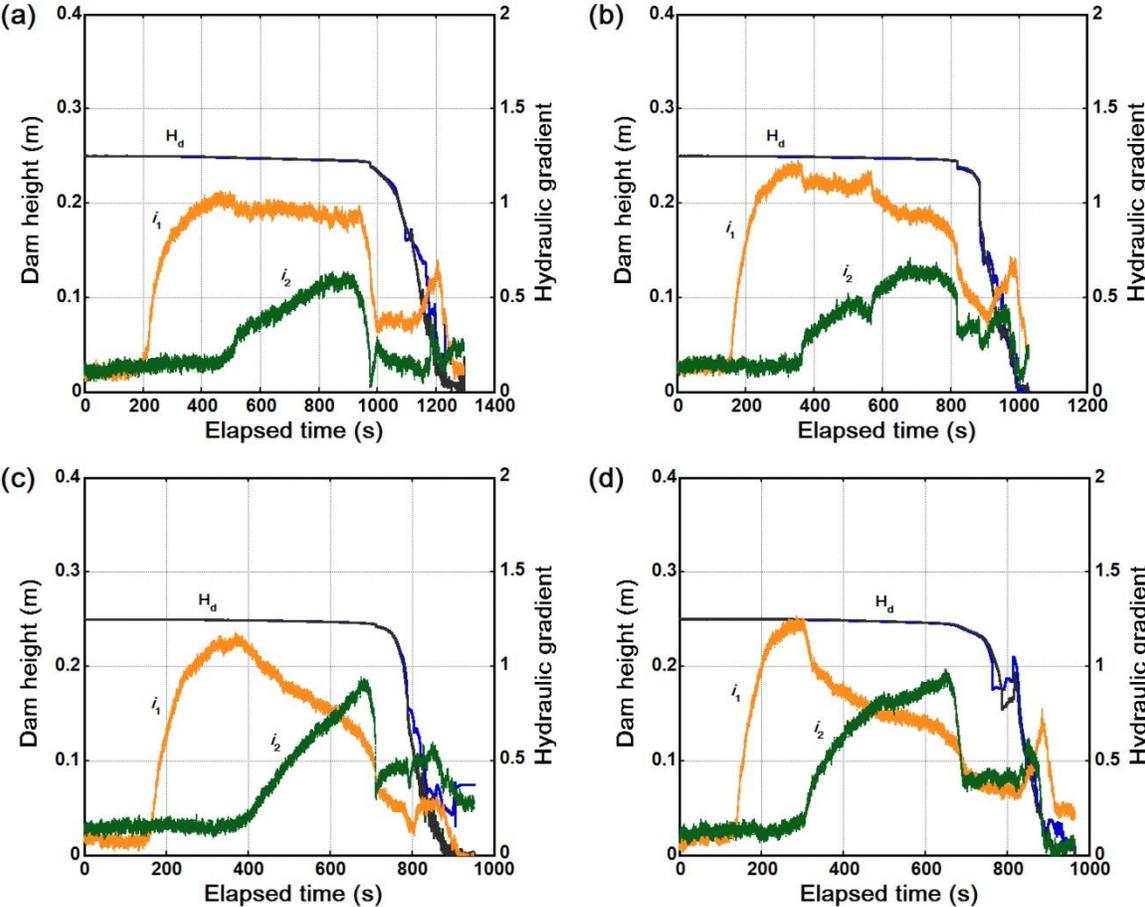
**Figure 6.8** Trends of hydraulic gradients in dams built with an  $e_o$  of 1.21 and antecedent moisture contents of (a) 5% (b) 10% (c) 15% (d) 20%.

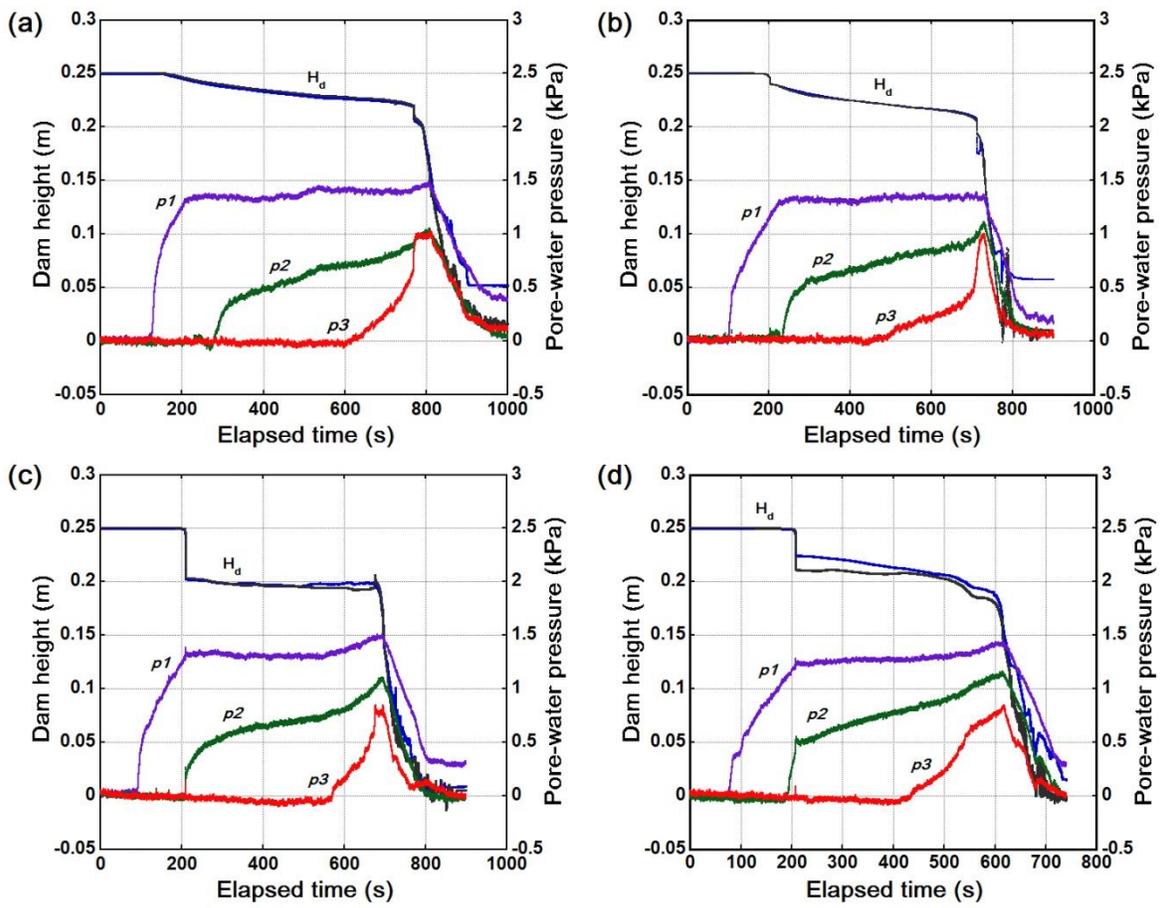
**Figure 6.9** Evolution of pore-water pressures in dams built with an  $e_o$  of 1.76 and antecedent moisture contents of (a) 5% (b) 10% (c) 15% (d) 20%.

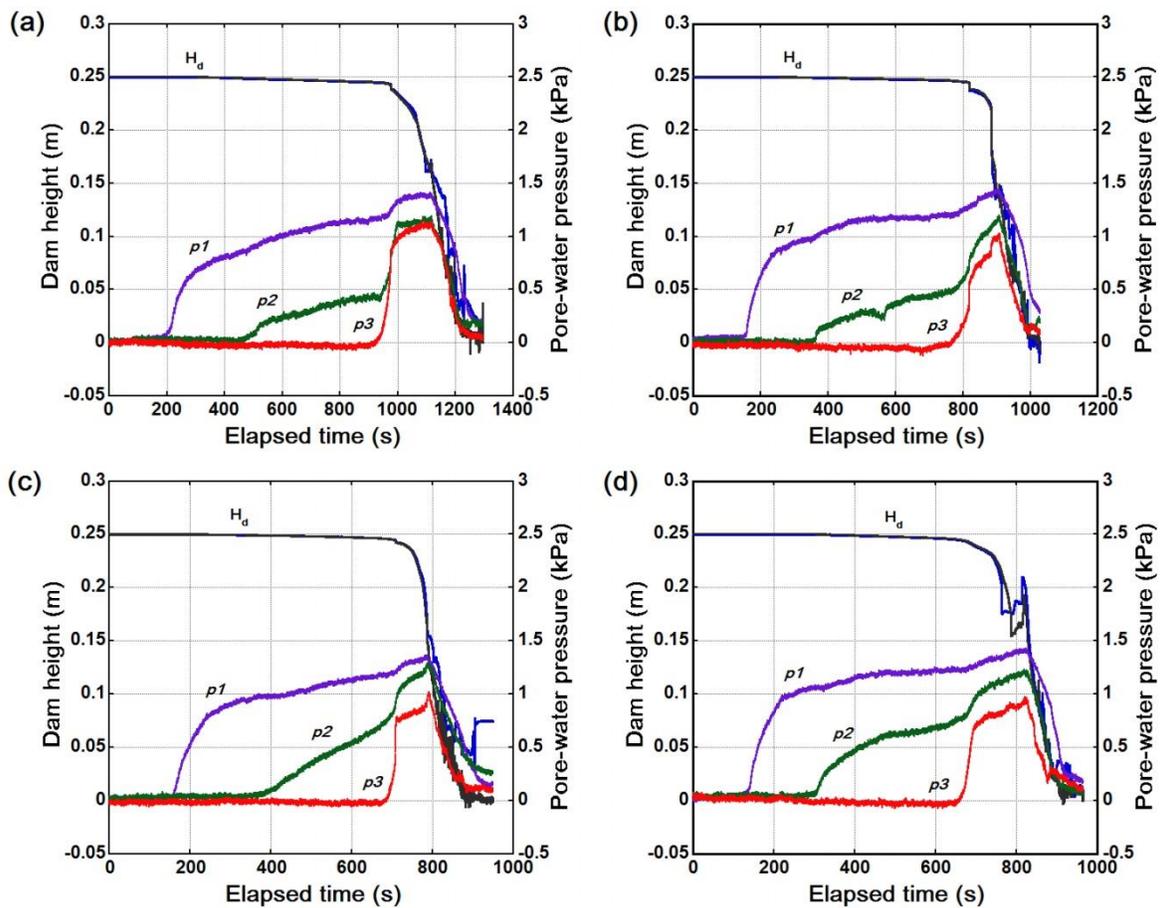
**Figure 6.10** Evolution of pore-water pressures in dams built with an  $e_o$  of 1.21 and antecedent moisture contents of (a) 5% (b) 10% (c) 15% (d) 20%.

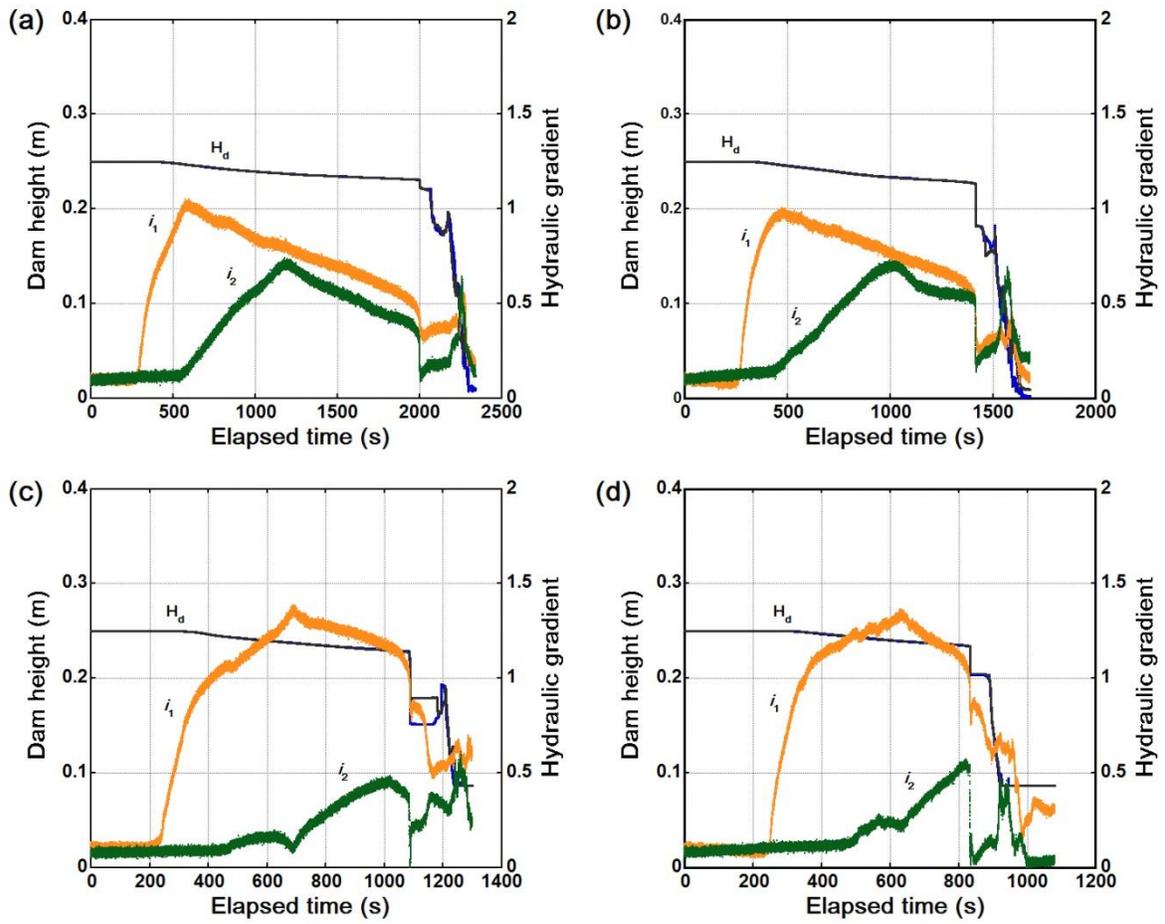
**Figure 6.11** Trends of hydraulic gradients in dams built with downstream slope angles of (a) 30° (b) 40° (c) 50° (d) 60°.

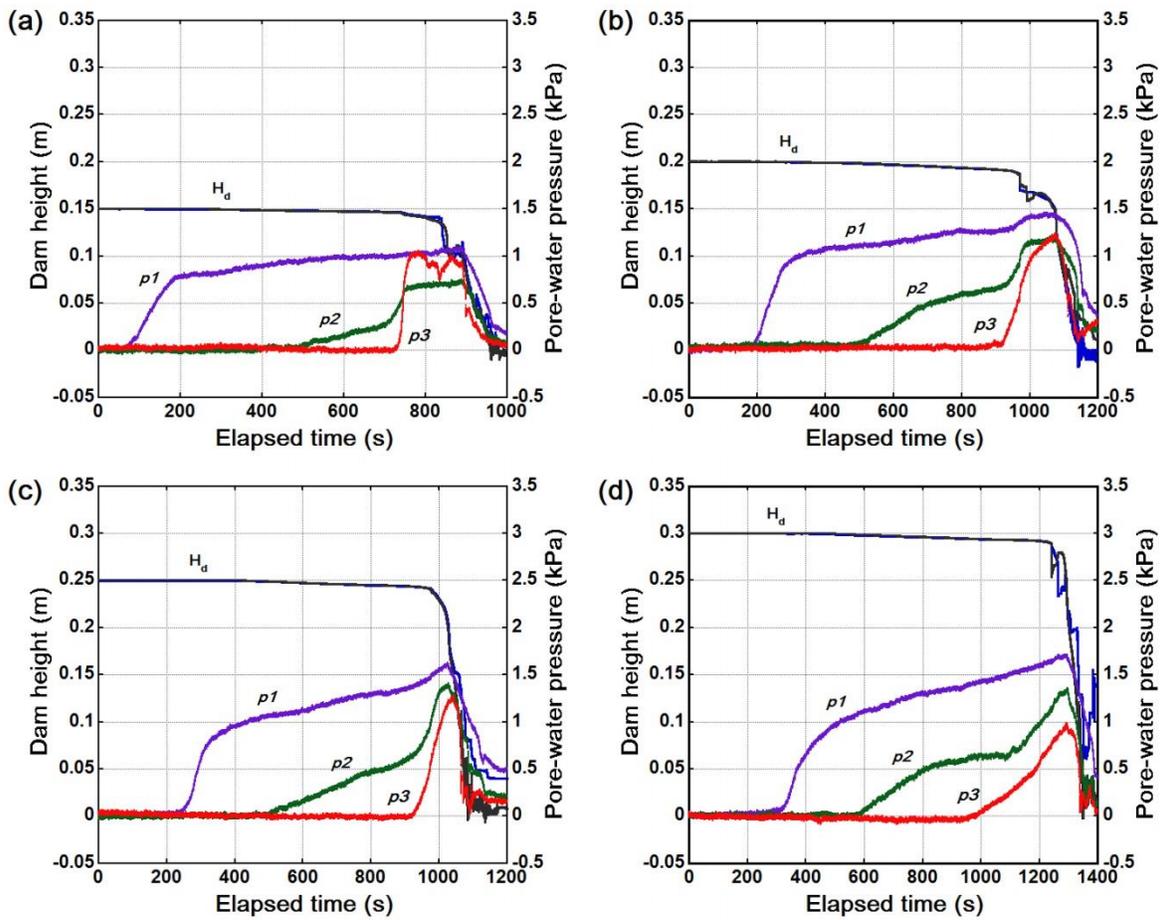
**Figure 6.14** Transient changes in pore-water pressures in dams built with dam heights of (a) 0.15 m (b) 0.20 m (c) 0.25 m (d) 0.30 m.

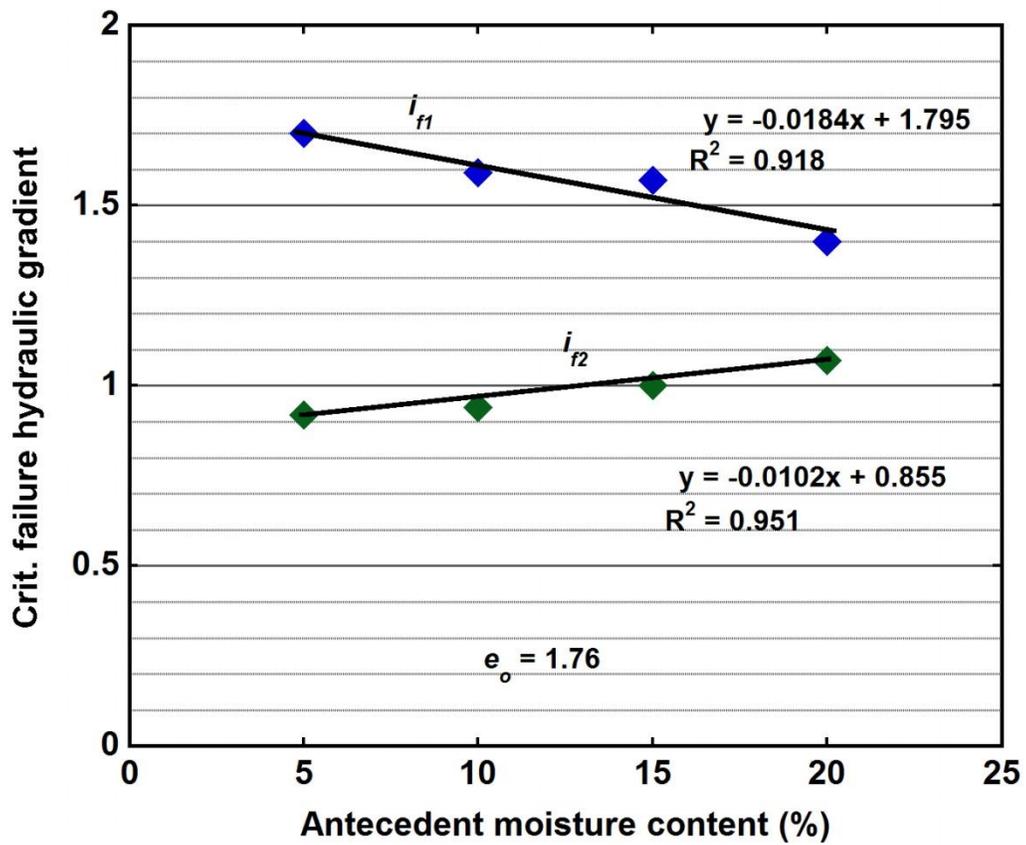
**Figure 6.18** Relationship between critical hydraulic gradients for collapse of the dam crest and antecedent moisture content for  $e_o = 1.76$

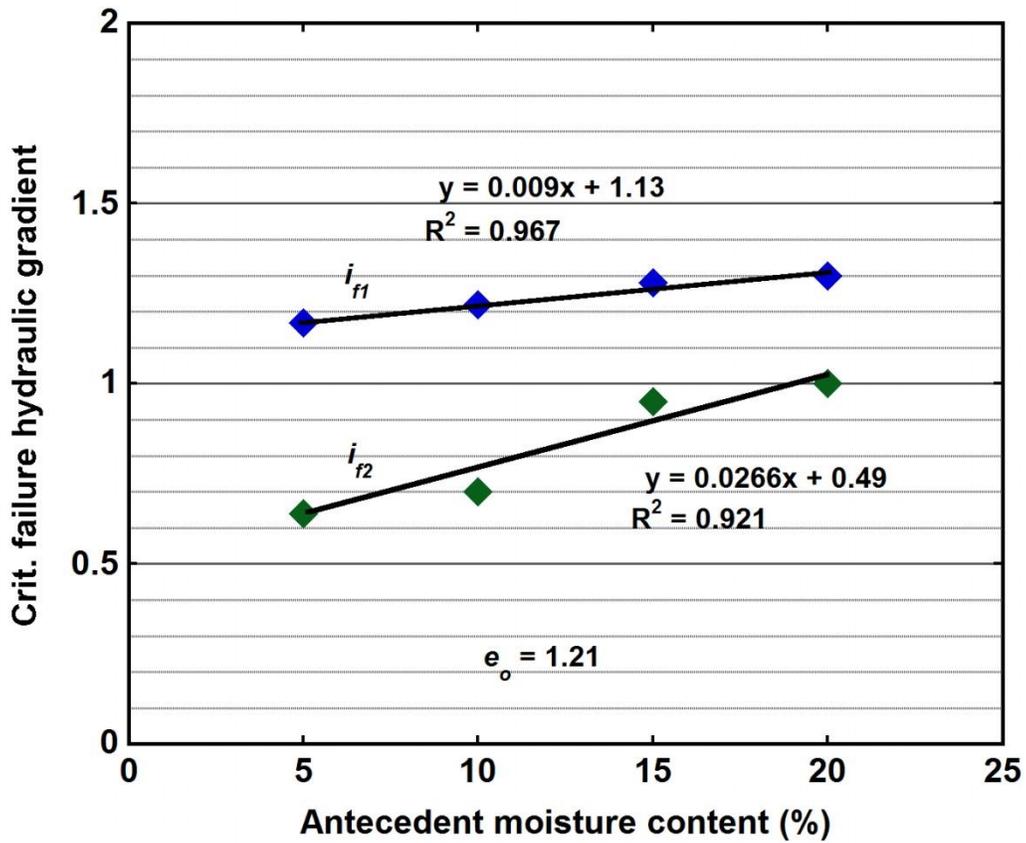
**Figure 6.19** Relationship between critical hydraulic gradients for collapse of the dam crest and antecedent moisture content for  $e_o = 1.21$

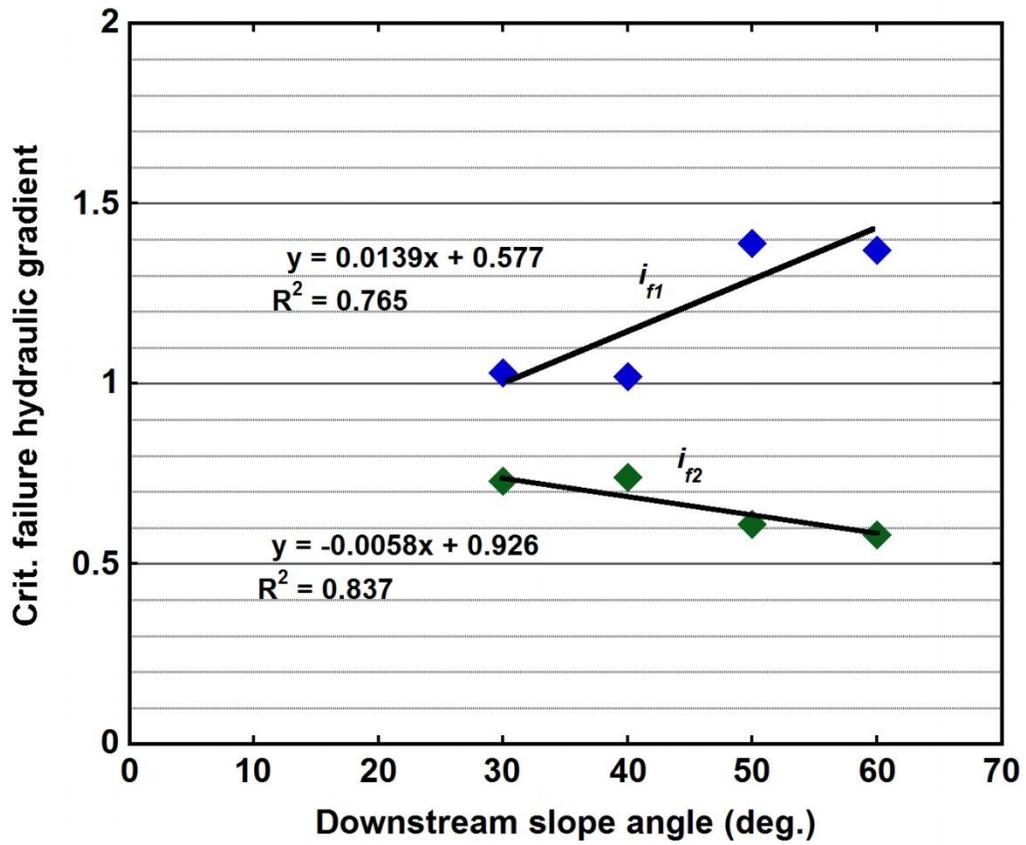
**Figure 6.20** Relationship between critical hydraulic gradients for collapse of the dam crest and the downstream slope angle

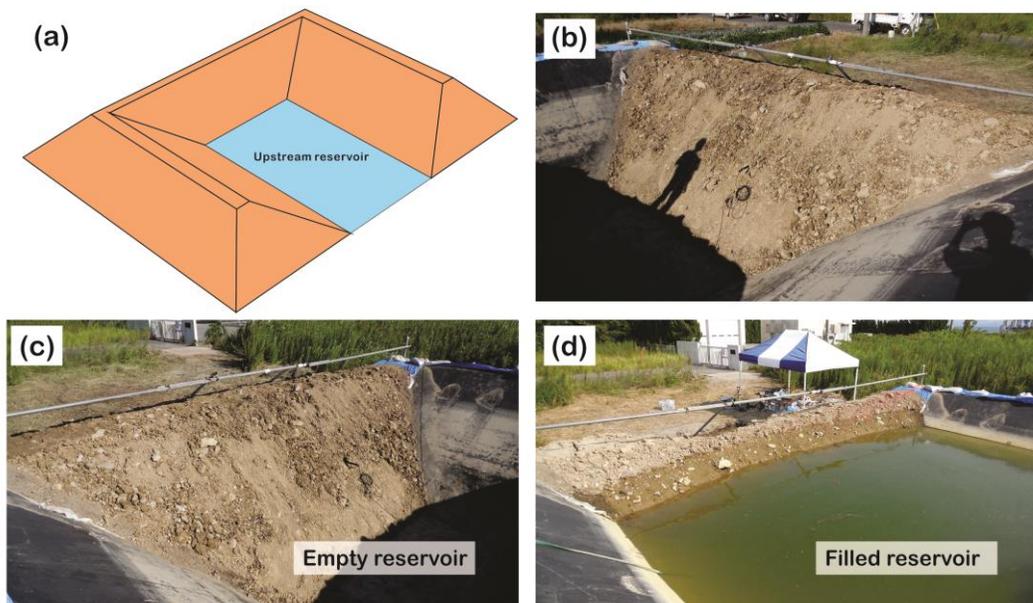
**Figure 7.2** The experimental facility. (a) A schematic diagram of the reservoir (b~c) Upstream side of the dam before the commencement of an experiment (d) The reservoir level at full capacity.

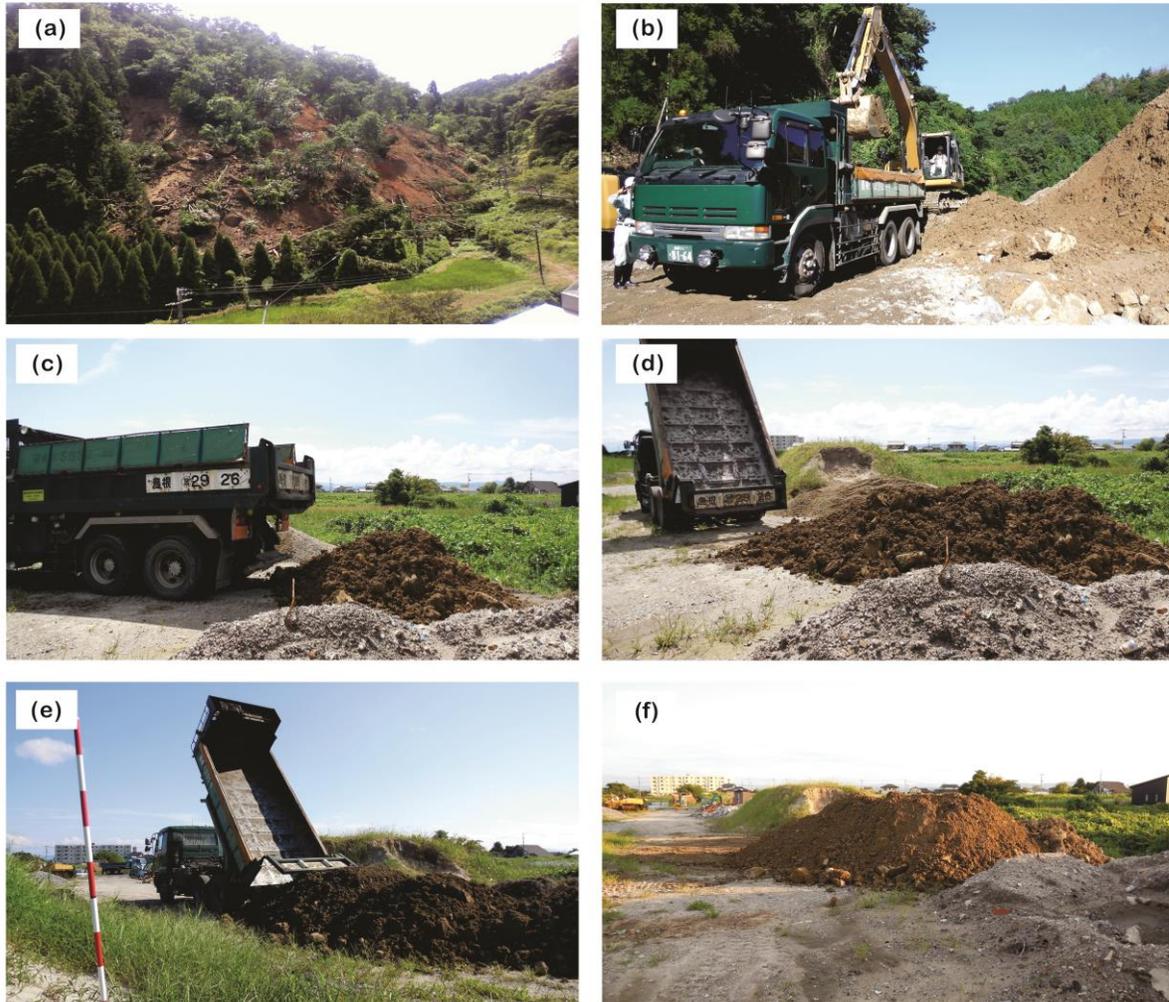
**Figure 7.3** Early stages of construction of the dam models showing: (a) The landslide at Mihata district, near Izumo, Japan (b) Toe part of landslide from where the landslide materials were sourced (c~f) Offloading of the landslide materials at the experimental site in Eshima Island.

The materials used in building the dam models were sourced from a landslide (hereinafter referred to as the Mihata landslide) which occurred on 6 August 2012, in Mihata district, near Izumo city, Shimane Prefecture, Japan (Figure 7.3). The materials consist of highly weathered igneous and sedimentary rocks including andesite, rhyolite, ferruginized sandstone, and mudstone. Table 7.1 shows the physical properties of the materials. The soil consists of 35.5% gravel, 37.5% sand, 20.9% silt and 6.1% clay size particles. The grain size distribution curves of the materials are shown in Figure 7.4. The average coefficient of curvature, coefficient of uniformity and effective grain size of the soil were 0.686, 93.33 and 0.015 mm, respectively.

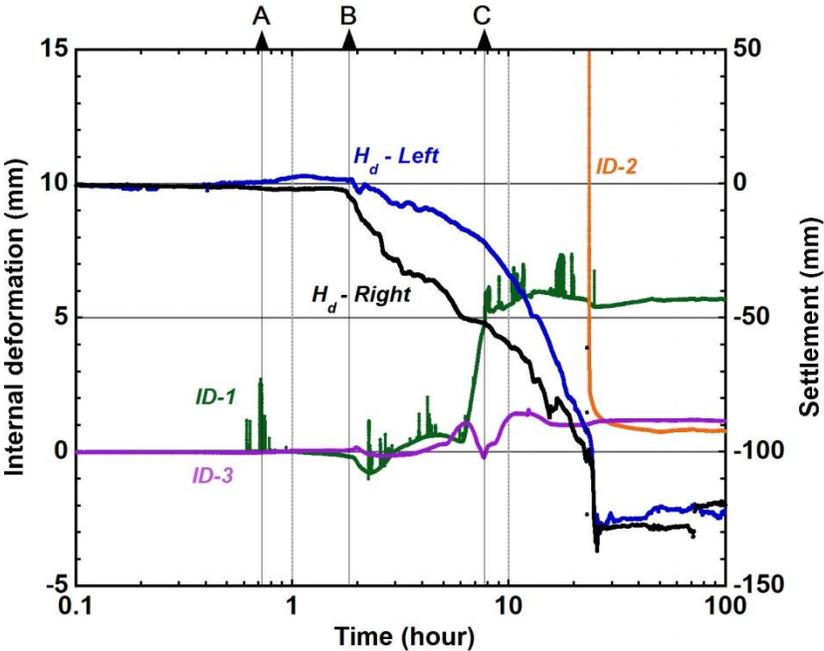
**Figure 7.7** Evolution of a poorly developed piping hole and the deformation mechanism of the dam during experiment 1.

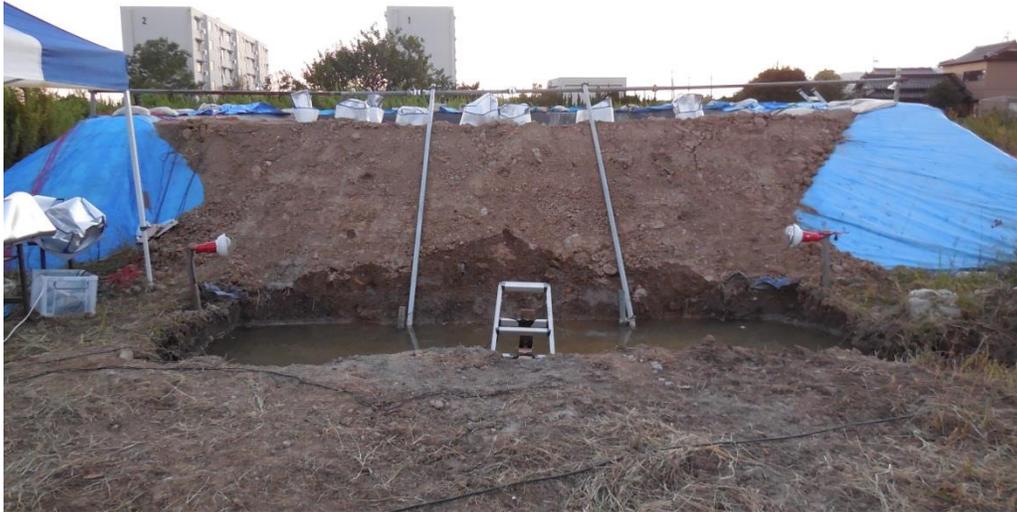
**Figure 7.8** Gradual unraveling of the downstream toe under steady-state saturation.

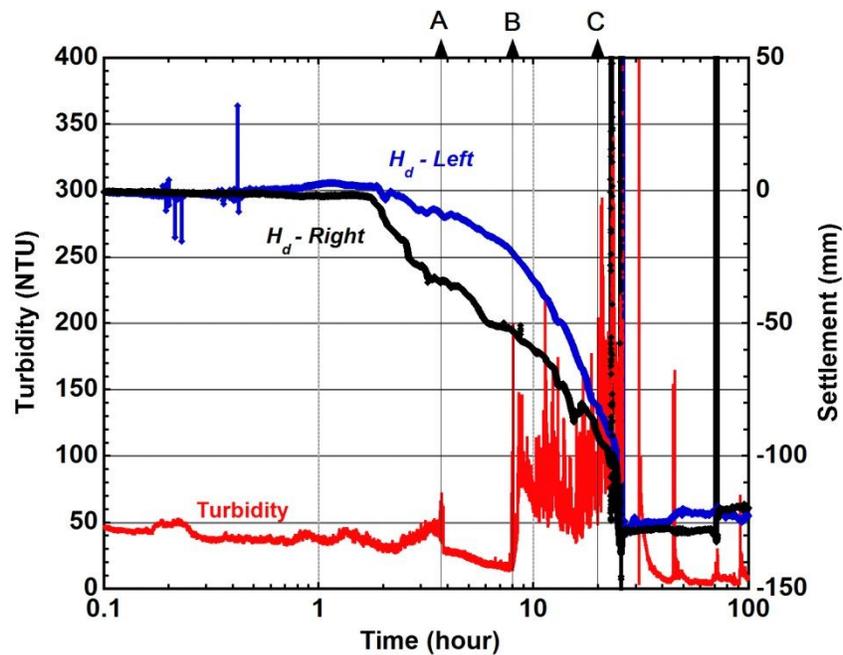
**Figure 7.9** Stage hydrograph and variation of turbidity of the hyperconcentrated flow in *Experiment 1*

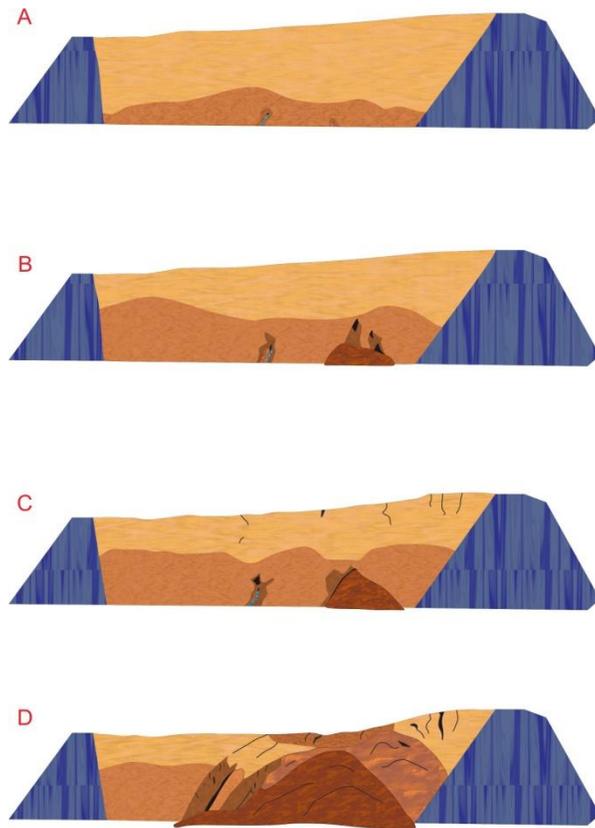
**Figure 7.11** Schematic diagram of the failure sequence of the dam in *Experiment 1*.

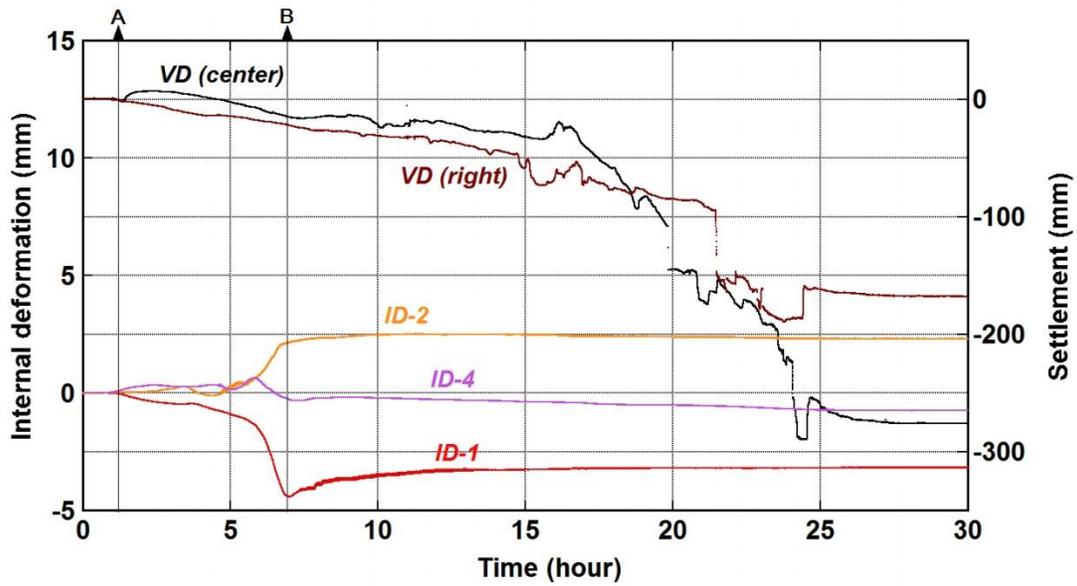
Figure 7.12 Deformation behaviour of the dam under steady-state seepage conditions

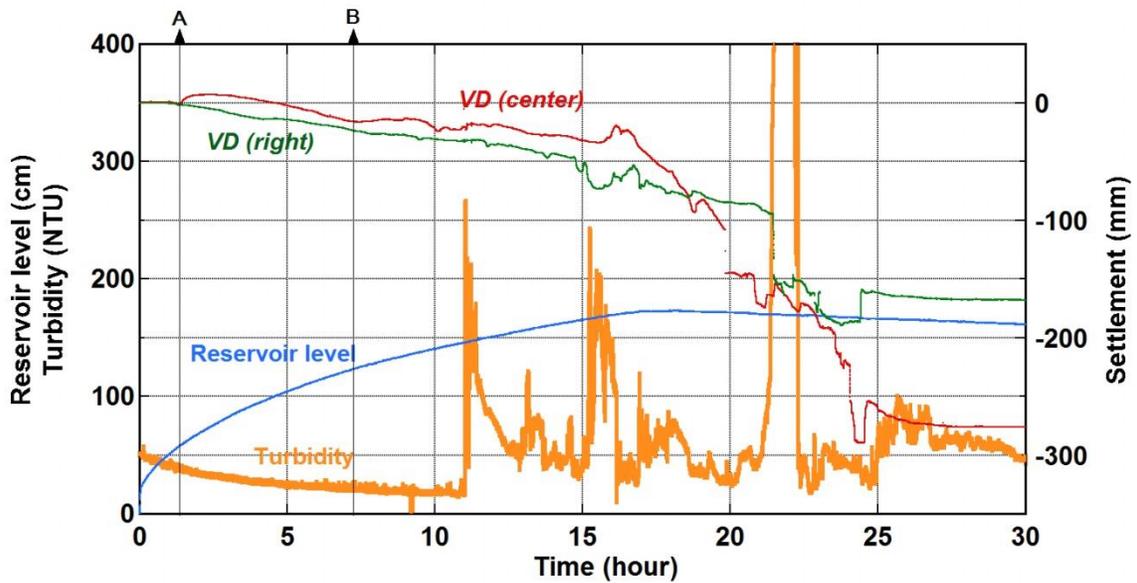
Figure 7.13 Stage hydrograph and variation in turbidity of the seepage water during Experiment 2

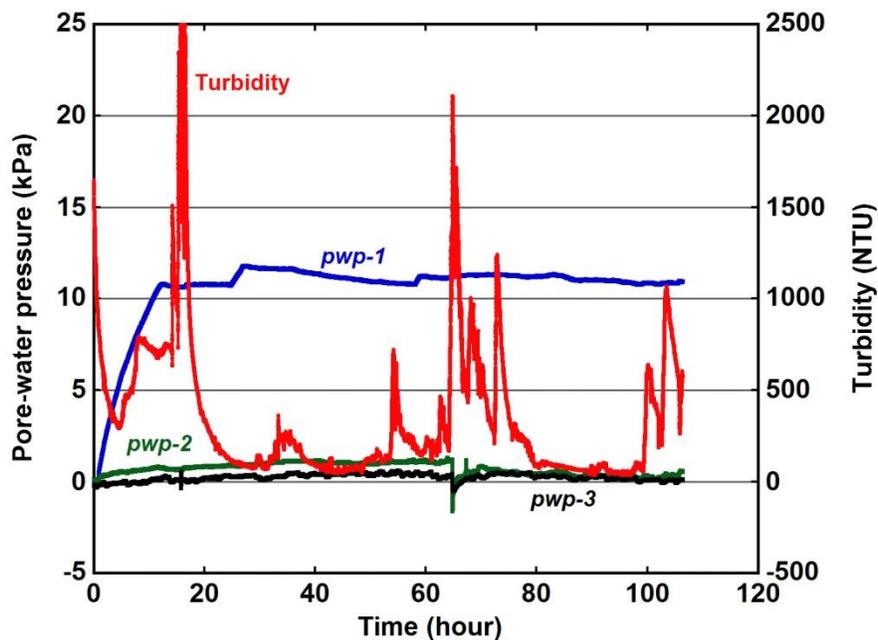
**Figure 7.14** Trends of pore-water pressures and variation in turbidity of the seepage water in *Experiment 3*.

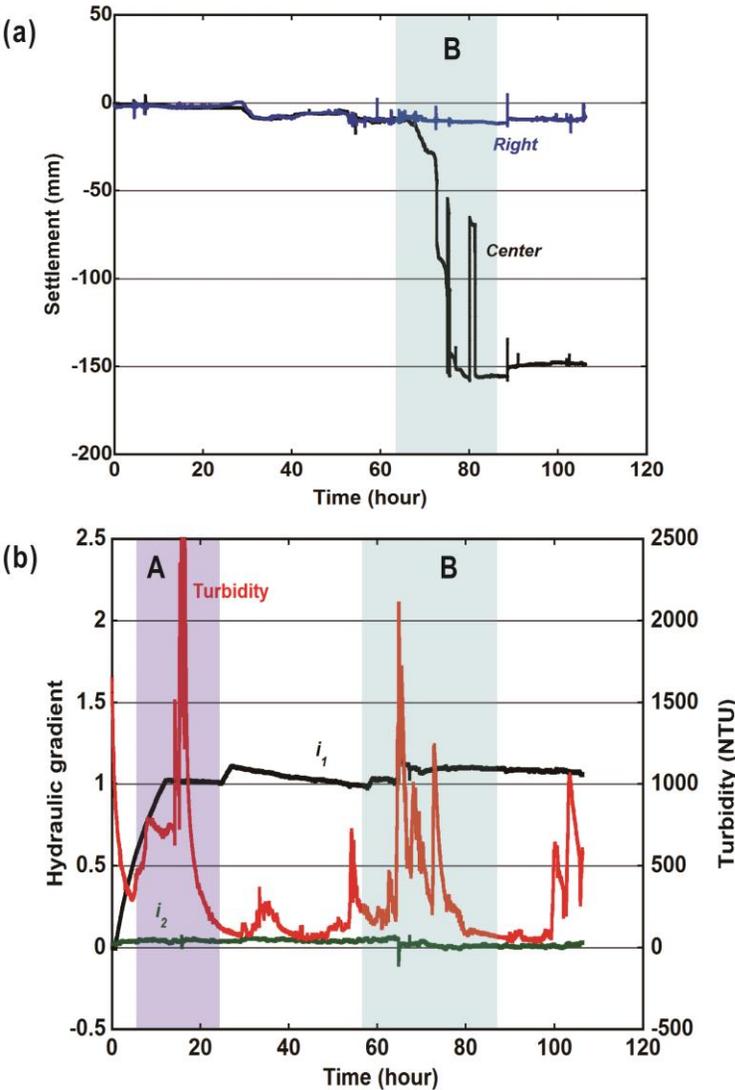
**Figure 7.15** Stage hydrograph and deformation mechanism of the dam model used in *Experiment 3* under steady-state flow conditions.
