# **Internal erosion and piping failure of landslide dams**

**OKEKE, Chukwueloka Austin Udechukwu**

**Department of Geoscience  
Interdisciplinary Graduate School of Science and  
Engineering  
Shimane University, Japan**

**September, 2016**

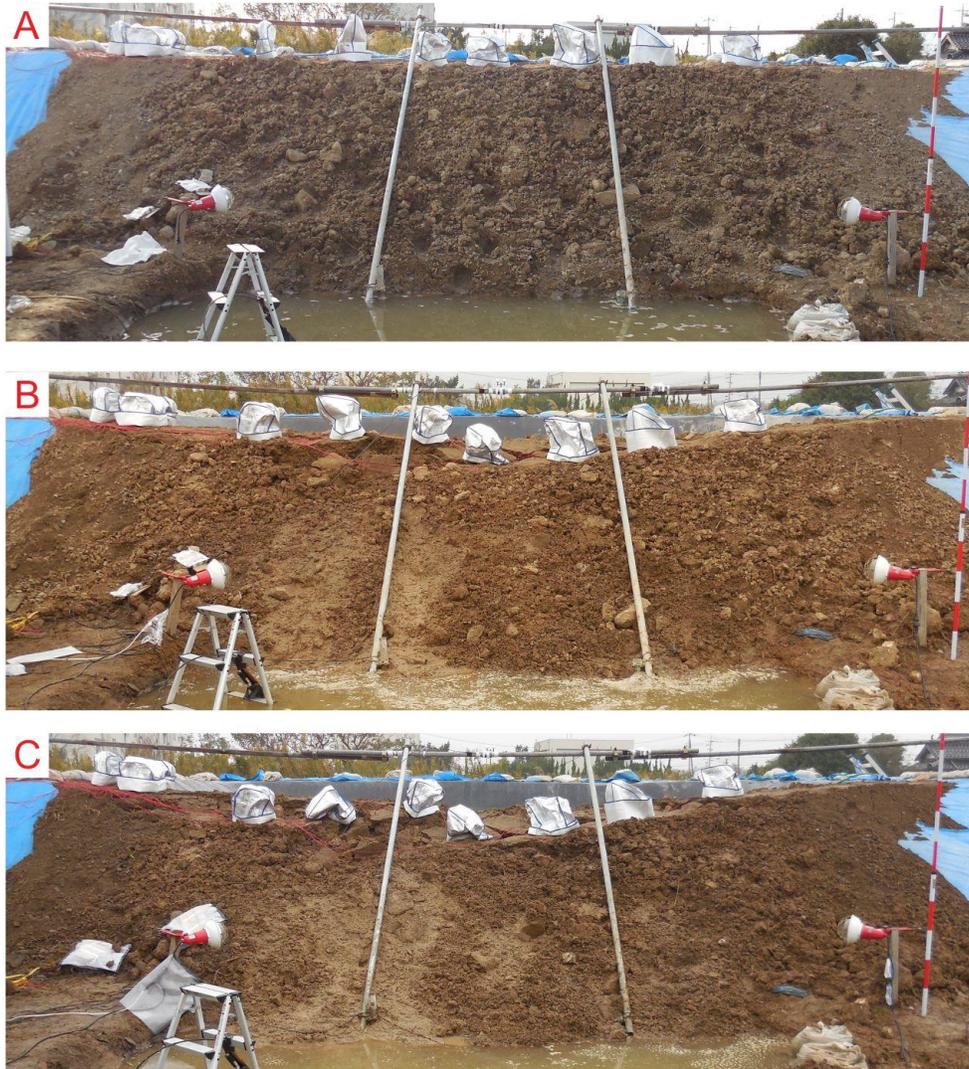
**Figure 7.16** Time-dependent deformation behaviour of the dam model used in *Experiment 3* under steady-state flow conditions.

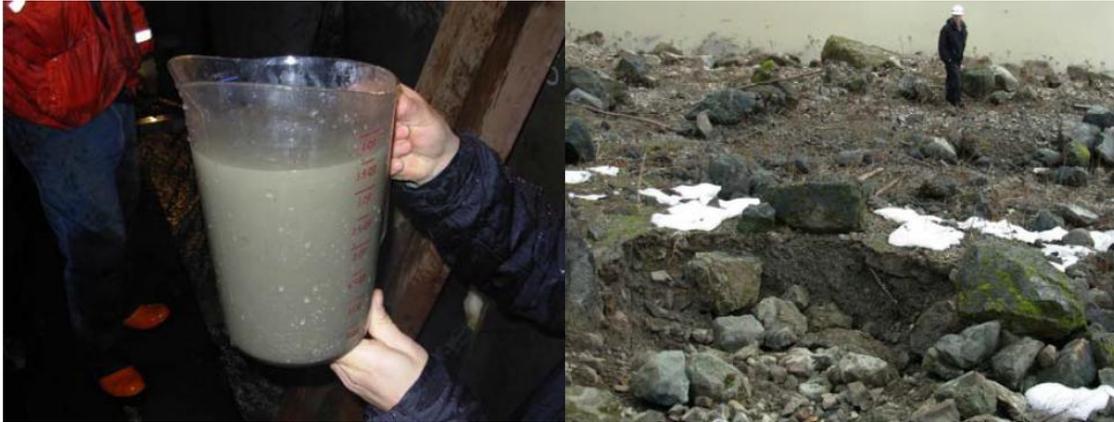
**Figure 7.17** Investigation of seepage in Howard Hanson Dam, USA. (a) Turbid water collected from a vertical drain at the right abutment, (b) Occurrence of a large depression at the upstream slope of the right abutment.

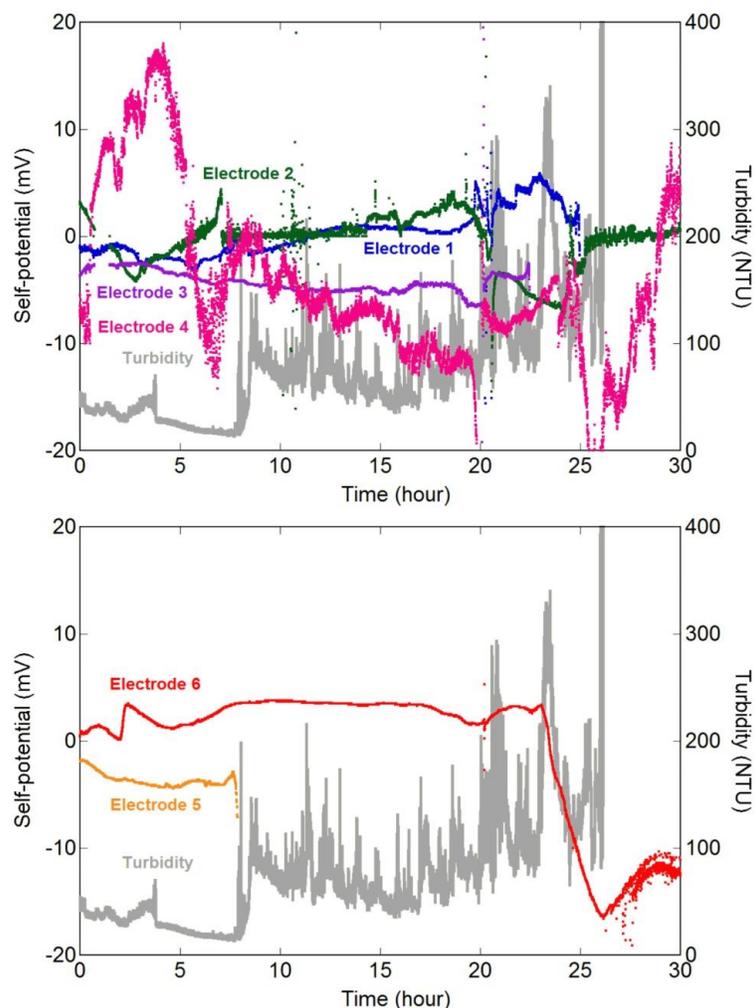
**Figure 7.18** Variations in turbidity and self-potential during internal erosion and piping in *Experiment 1*.
