# **Hydro-mechanical constraints and premonitory factors of landslide dam failure caused by seepage**

**Feb. 2020**

A dissertation submitted in fulfillment of the requirements for the degree of  
Doctor of Philosophy

Shimane University, Japan

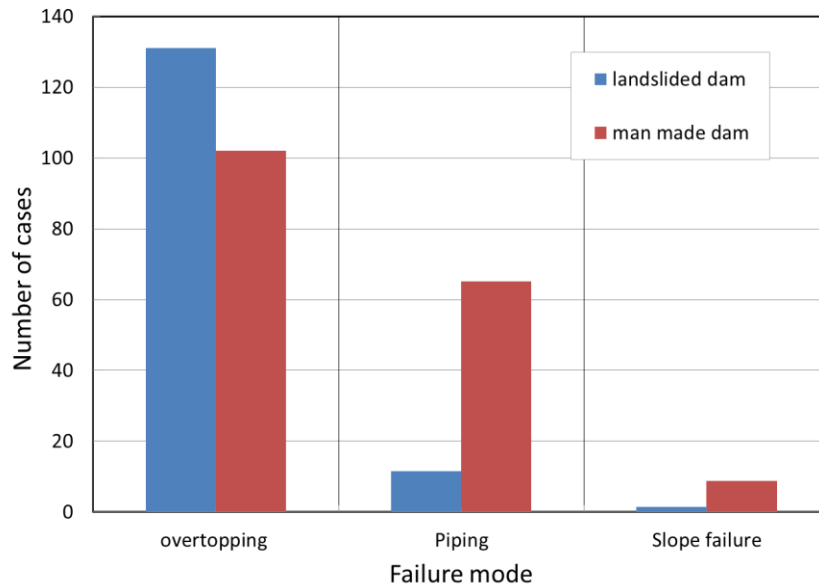
**Figure 2.1** Comparison of failure modes of landslide dams (144 cases) and man-made earth and rock-fill dams (176 cases) based on historical cases inventoried by Peng and Zhang (2012)

The failure mode of landslide dam is very similar to that observed for artificial earthen dams, generally occurring by overtopping, and infrequently by piping or slope failure or internal erosion (Costa and Schuster, 1988). Peng and Zhang (2012) made a comparison of failure modes of landslide dams, earth and rock fill dams using the datasets of 144 landslide dam failures, and 176 earth and rock fill dam failures. The result of their analysis indicated that 37% of piping cases were recorded in fabricated earth and rock fill dams while 8% were recorded in landslide dams (Figure 2.1).

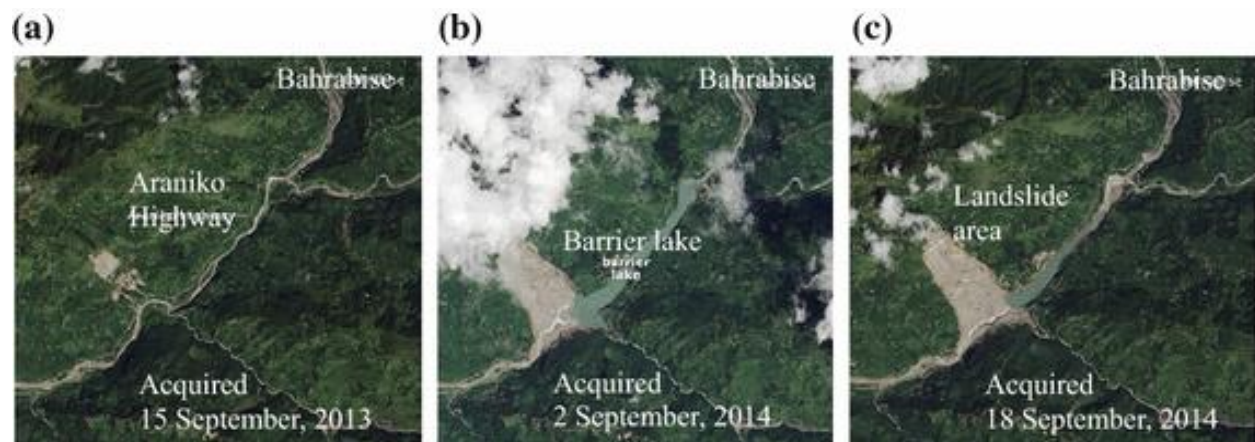
**Fig. 2.3** Landsat 8 satellite images a) before landslide; b) after landslide and before landslide dam breach; and c) after landslide dam breach (Shrestha and Nakagawa, 2016).

A massive landslide occurred at Jure village of Nepal on August 2, 2014. The landslide mass blocked the Sunkoshi River and created a landslide dam. Thirty-seven days after the formation, the Sunkoshi landslide dam breached on September 7, 2014. The peak flow discharge of the Sunkoshi landslide dam outburst at the dam outlet was found to be  $6436 \text{ m}^3/\text{s}$ , and the estimated time of the dam breach was found to be about 26 min (Shrestha and Nakagawa, 2016) (Fig. 2.3).

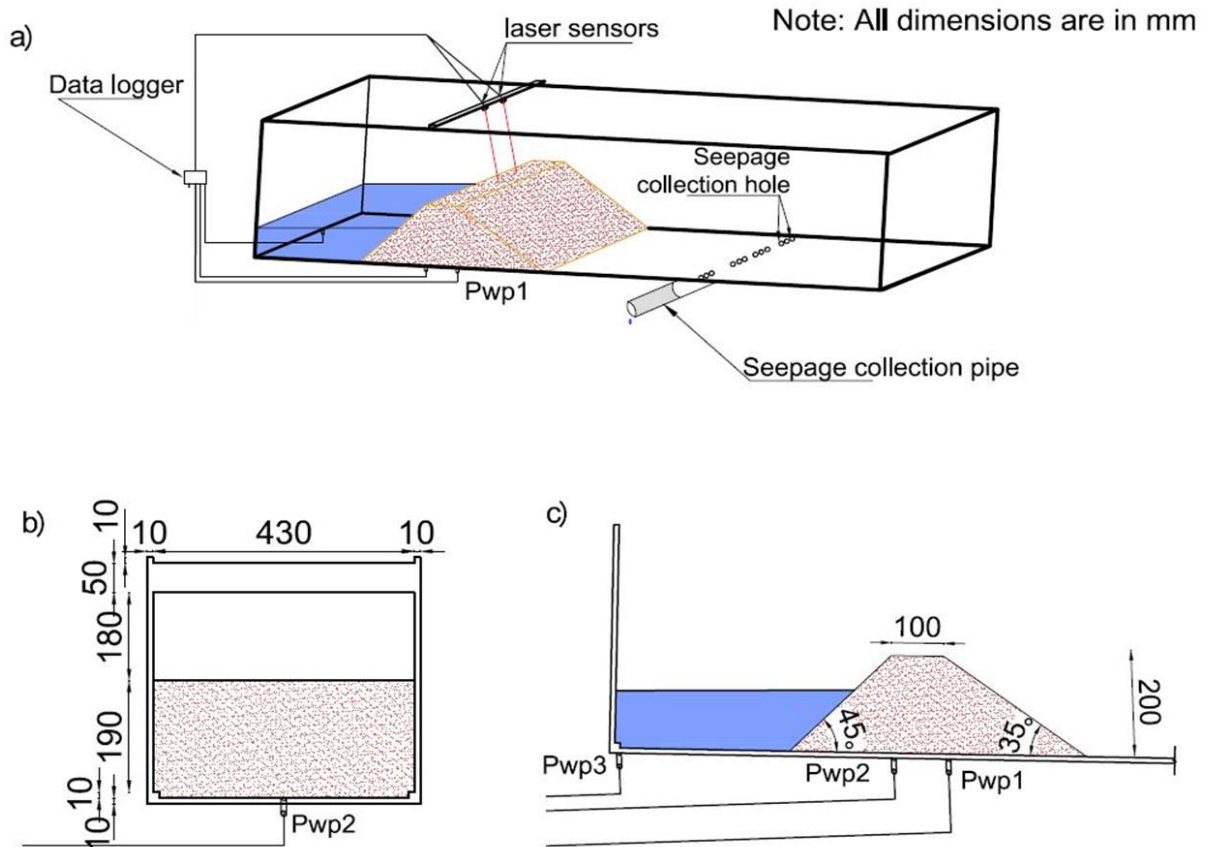
**Fig. 3.1** Experimental setup of the flume tank for samples of Group A. a) 3D view; b) cross-section and; c) longitudinal section.

maintain the roughness between the dam material and flume tank floor. The flume tank was built using Plexiglas, permitting visibility into the flume. The flume bed slope was maintained constant at 1:40 during all experiments. Four pore-water pressure sensors, with a rated capacity of 50 kPa, were used—hereafter referred to as Pwp1, Pwp2, Pwp3, and Pwp4—for the downstream and upstream sides of the dam body and at the reservoir and seepage water collection tank, respectively. Sensors Pwp1, Pwp2, and Pwp3 were connected to the flume tank from the base of the flume tank facing upwards. The filter material to control the flow of sand over it covered Pwp1 and Pwp2. The Pwp4 sensor was connected to the tank base, where seepage water was collected. Multi-function analog laser sensors (CMOS) were used to measure the vertical displacement from the top of the flume tank using a wooden frame—hereafter known as Vdr and Vdl, for the right and left sides, respectively. The vertical displacement of the dam crest was continuously monitored at two fixed points by laser sensors. A half-cut polyvinyl chloride (PVC) pipe was fixed below the holes with a gentle slope to collect seepage water. The Pwp4 sensor monitored the collected seepage water volume.

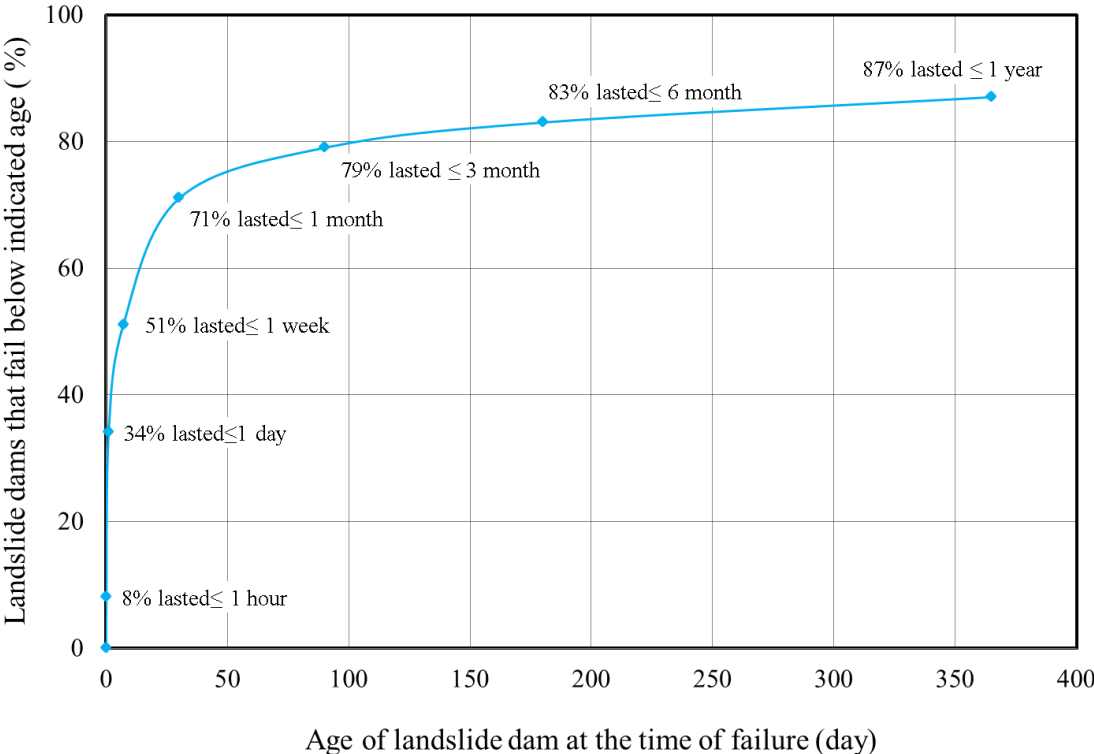
**Fig. 4.1** Age of landslide dam at the time of failure (240 cases) (Peng et al. 2012)

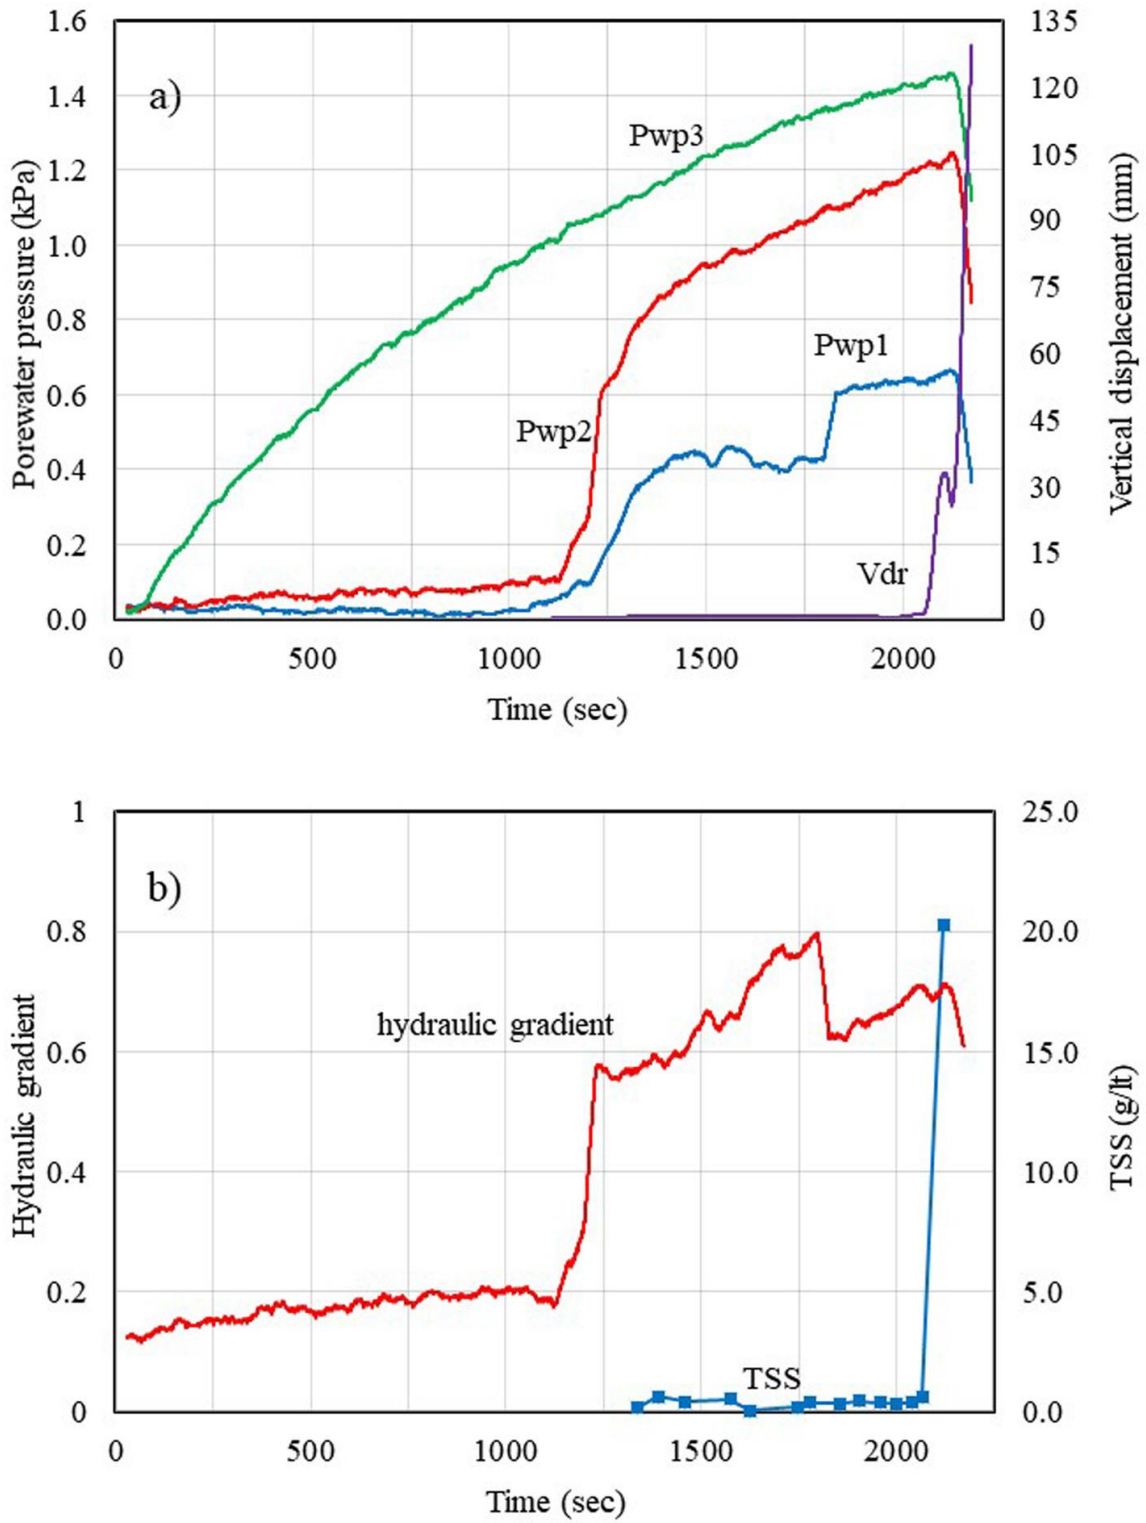
**Fig. 4.3** Experiment results of experiment No. EXP 4F of GII sample. a) Pore water pressure and vertical displacement; b) Hydraulic gradient and TSS

Experiment No. EXP 4F was conducted for the GII sample. The wetting front was rapidly increased just after the beginning of the reservoir fill up. The pore water pressure was increased at Pwp3 as the reservoir started filling up and Pwp2 also began to increase after Pwp3 started. Pwp1 began at nearly the same time as Pwp2. The pore water pressure at Pwp2 is increased very quickly and, as a result, the hydraulic gradient also increased very quickly, from about 0.2 to 0.6. Due to a sudden failure of a small soil mass block from the upper part of the slope of the dam's downstream side, the seepage water flow is stopped and the water pressure at Pwp1 is increased, which also affected the hydraulic gradient. Figure 4.3 shows the details of the experiment results. Initially, the hydraulic gradient reached the peak value but it does not decrease again to the minimum value, unlike in the other experiments in this study, and again started to increase instead. The hydraulic gradient was unsteady. Reasons for the fluctuation of the hydraulic gradient are: 1) the release of water from the downstream into different pocket areas of the downstream slope and 2) the failure of the downward slope and the decreased position of the flow line. The vertical displacement was nearly constant at the initial stage and, as the hydraulic gradient is increased, the vertical displacement also increased. Due to the appearance and disappearance of minor cracks in the dam crest, the vertical displacement is increased and later decreased. The vertical displacement is about 0.85 mm prior to the failure of the dam crest. Figure 4b shows that seepage began when the hydraulic gradient reached the initial peak value. Considering the time gap, due to the position of the seepage collection point, the vertical displacement began to increase when TSS is measured. With the changes in the hydraulic gradient and the increasing TSS, the dam became unstable and, finally, failed.

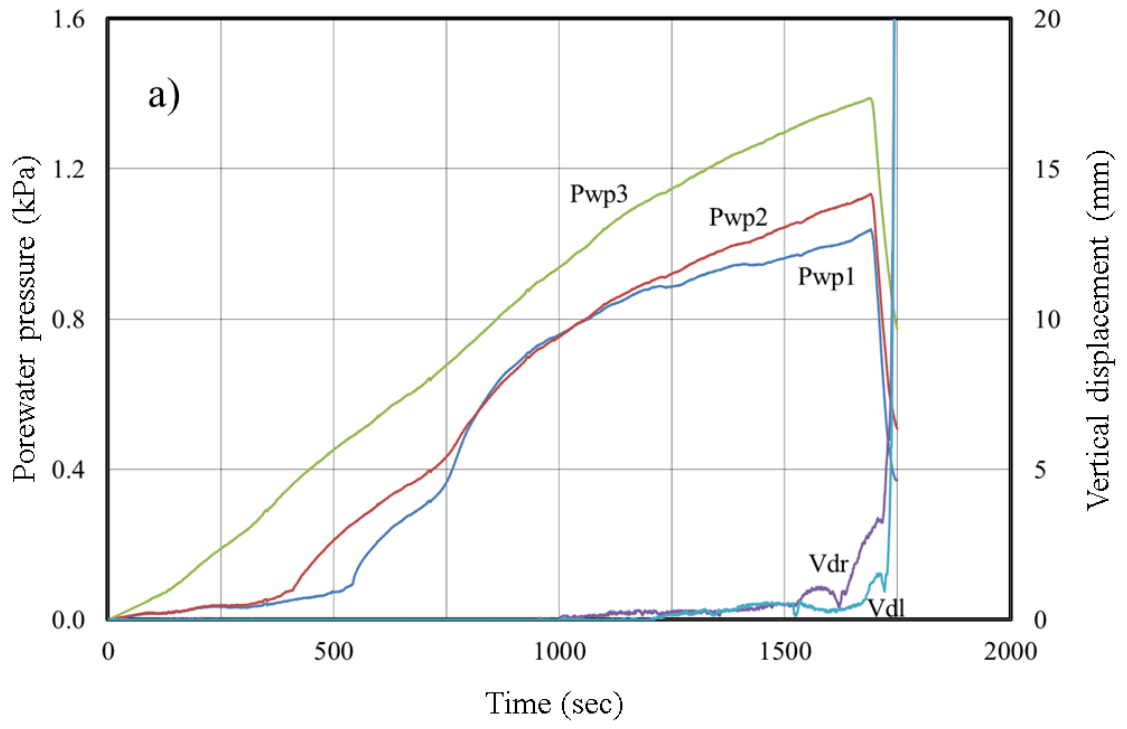
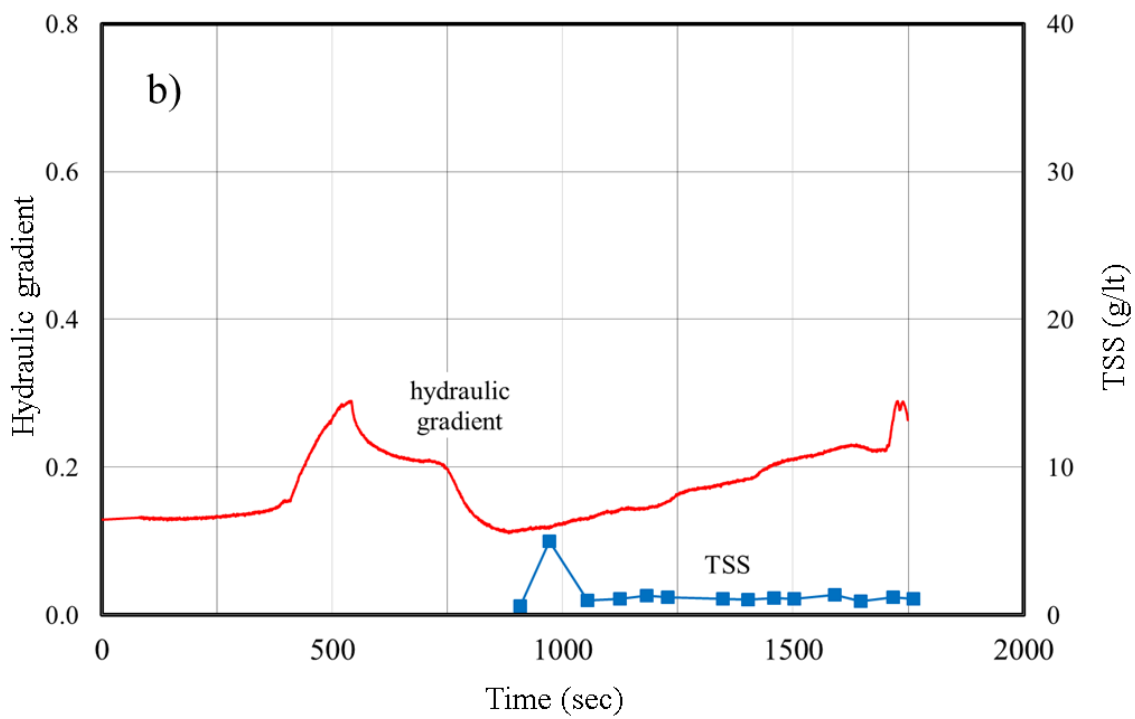
**Fig. 4.4** Experiment results of experiment No. EXP 6F of GIII sample. a) Pore water pressure and vertical displacement; b) Hydraulic gradient and TSS

Experiment No. EXP 6F was conducted for the GIII sample. Here, the seepage water has a great effect on the erosion and stability of the dam body. The coarser soil had a higher hydraulic conductivity and a higher chance of erosion of the fine particles. The pore water pressures at Pwp2 and Pwp1 began to increase very quickly in comparison to the GI and GII samples. The pore water pressure at Pwp2 increased rather quickly and, after approximately 250 s, the pore pressure at Pwp2 and Pwp1 become equal. The water level increased in the downstream side of the dam, as a result of which the slope failed. As the slope failed, the position of the flow line changed and the pore pressure at Pwp1 increased with its decreasing rate. The results are presented in Fig. 4.4. The vertical displacement started to increase as the hydraulic gradient increased. This could be the effect of changes in the water content of the dam body. The up and down movement of the vertical displacement is the result of the sudden presence and absence of minor cracks at the dam crest. The hydraulic gradient reached the peak value and started to decrease as the pore pressure increased in Pwp1. After reaching the low value of the hydraulic gradient, it slowly increased as the water level increased in the reservoir and slope edge failed of the downstream slope. The hydraulic gradient changed with the change in the topography of the downward slope. As the pore water pressure reached approximately 1.4 kPa at Pwp3, the vertical displacement increased rapidly and the dam crest failed. The seepage water began to come out at about 500 s of the peak hydraulic gradient. The GIII sample has big voids, due to which the fine soil particles, which were in-between the coarse particles, came out with the seepage water—resulting in higher turbidity. The TSS value is approximately 1.2 g/lt, which was higher in comparison to that of the GII and GI samples without kaolinite.

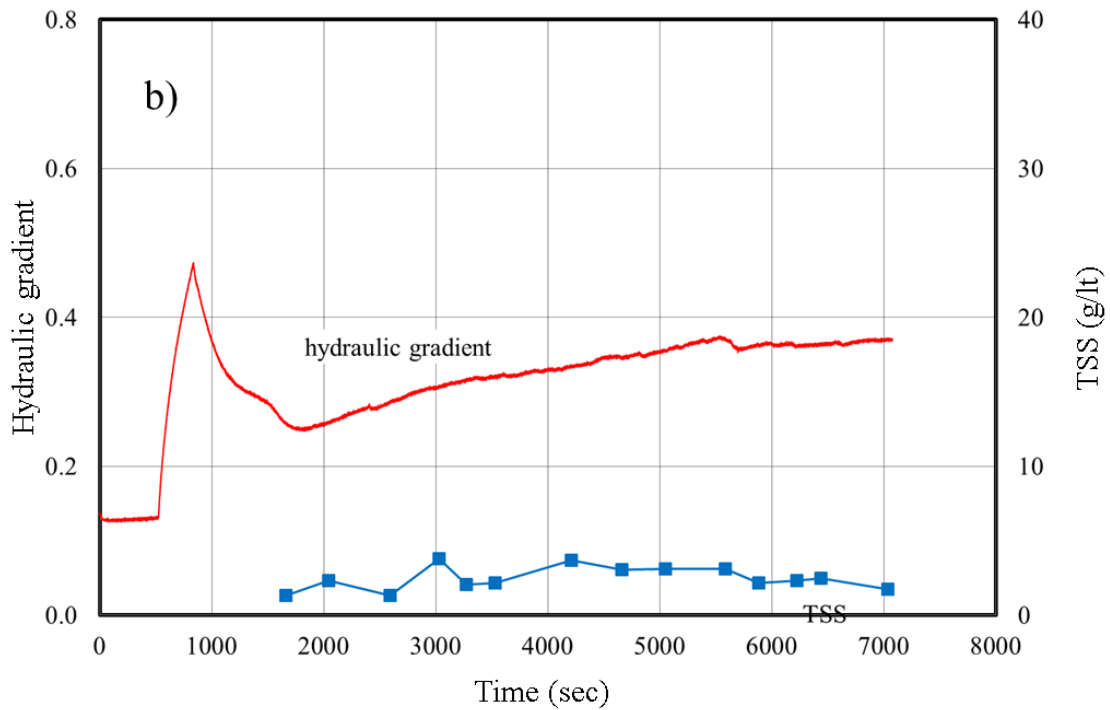
**Fig. 4.5** Experiment results of experiment No. EXP 1NF of GI sample (with kaolinite). a) Pore water pressure and vertical displacement; b) Hydraulic gradient and TSS

in these experiments. Here, the constant hydraulic gradient and decreasing TSS are the causes of the dam crest not-failure.

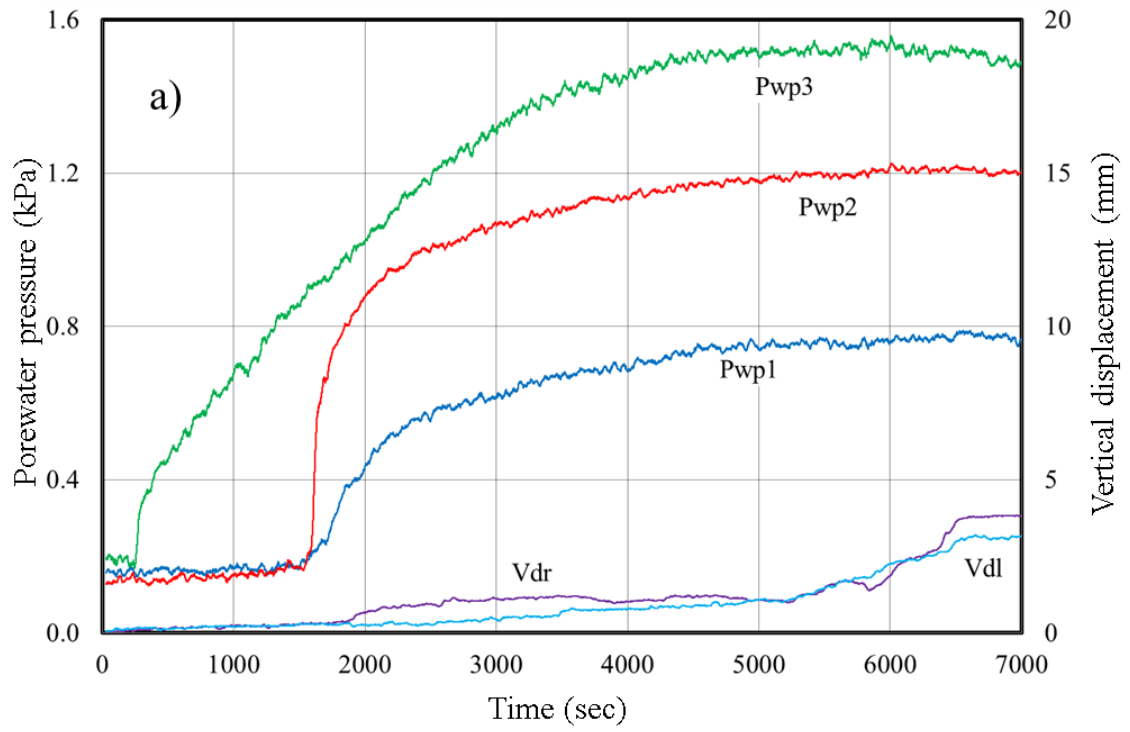
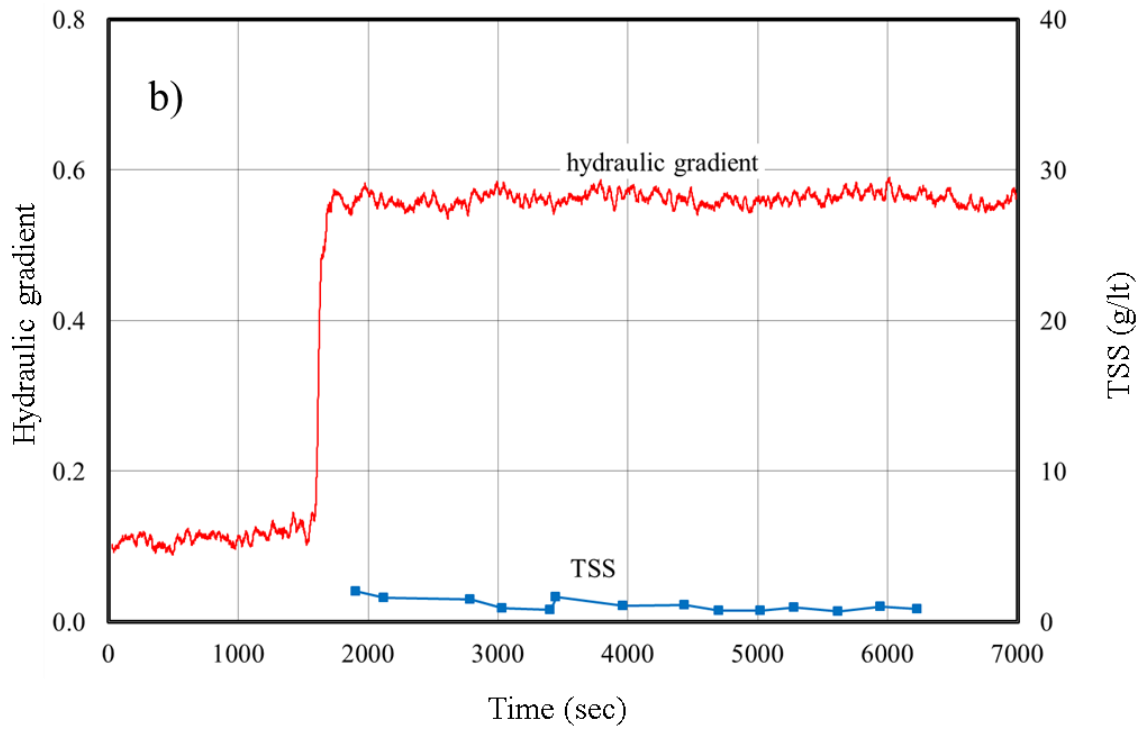
**Fig. 4.7** Experiment results of experiment No. EXP 3NF of GIII sample. a) Pore water pressure and vertical displacement; b) Hydraulic gradient and TSS

Experiment no. EXP 3NF was conducted for the non-failure case of the GIII sample. The hydraulic gradient result obtained in this experiment is typical in this study, where the hydraulic gradient reached the peak value and become constant. The pore water pressure at Pwp2 and Pwp1 increased at the same time as in the failure case experiment. The rate of increase for Pwp2 and Pwp1 differed from that in the failure case for the same sample. The vertical displacement increased from when the hydraulic gradient began to increase—i.e. when the water level started to increase in the dam body. The vertical displacement increased very slowly, up to about 3.0 and 4.0 for Vdl and Vdr, respectively. Finally, the vertical displacement became constant and the pore water pressure in the reservoir started to decrease, which may be due to the higher rate of seepage water than of inflow into the reservoir. Figure 4.7 shows the experiment results. The maximum hydraulic gradient of this experiment is approximately 0.67, which is higher than in the failure case for a coarse sample. The seepage water came out after 1850 s—i.e. just after the hydraulic gradient reached the peak value. The vertical displacement increased simultaneously with seepage water. After reaching 1.5 mm, the vertical displacement increased rapidly until 3.7 mm and became constant. This experiment shows that the presence of TSS and the increment of the vertical displacement are not the only satisfactory conditions for failure but that the role of the hydraulic gradient also needs to be considered. The hydraulic gradient should reach the peak value, then decrease to the minimum value and once again start to increase as in the failure case presented in this report. In this experiment, the hydraulic gradient is the main cause behind the dam crest not-failure.

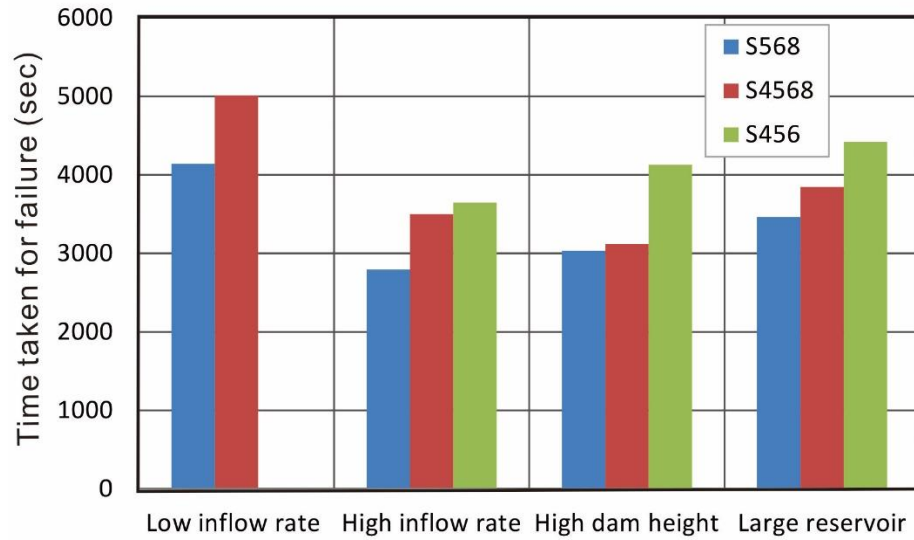
**Fig. 6.1** Time taken for failure of dam crest for different conditions

- Experiments conducted on three samples prepared by mixing the silica sand revealed that the time of failure of experiments increases depending on the changes in the percentages of fine and coarser sand. Samples with finer particles exhibited a short dam life span (Fig 6.1).

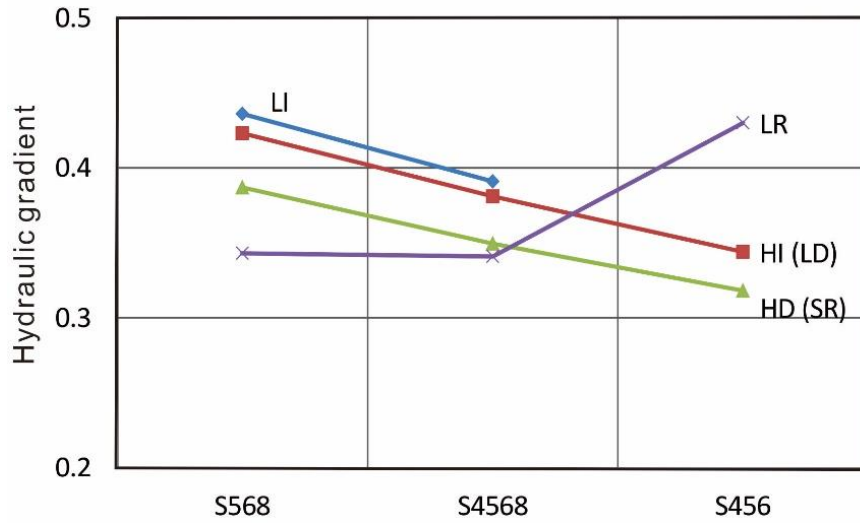
**Fig. 6.2** Maximum hydraulic gradient for low inflow rate (LI), high inflow rate (HI), low dam (LD), high dam (HD), small reservoir (SR) and large reservoir (LR) of three samples

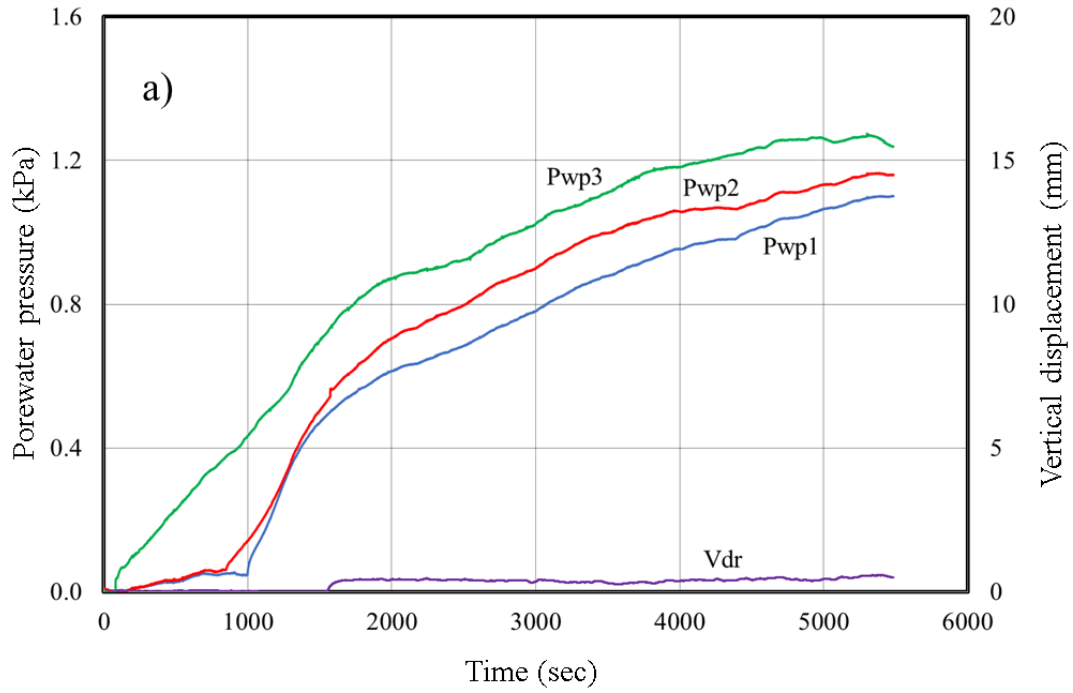
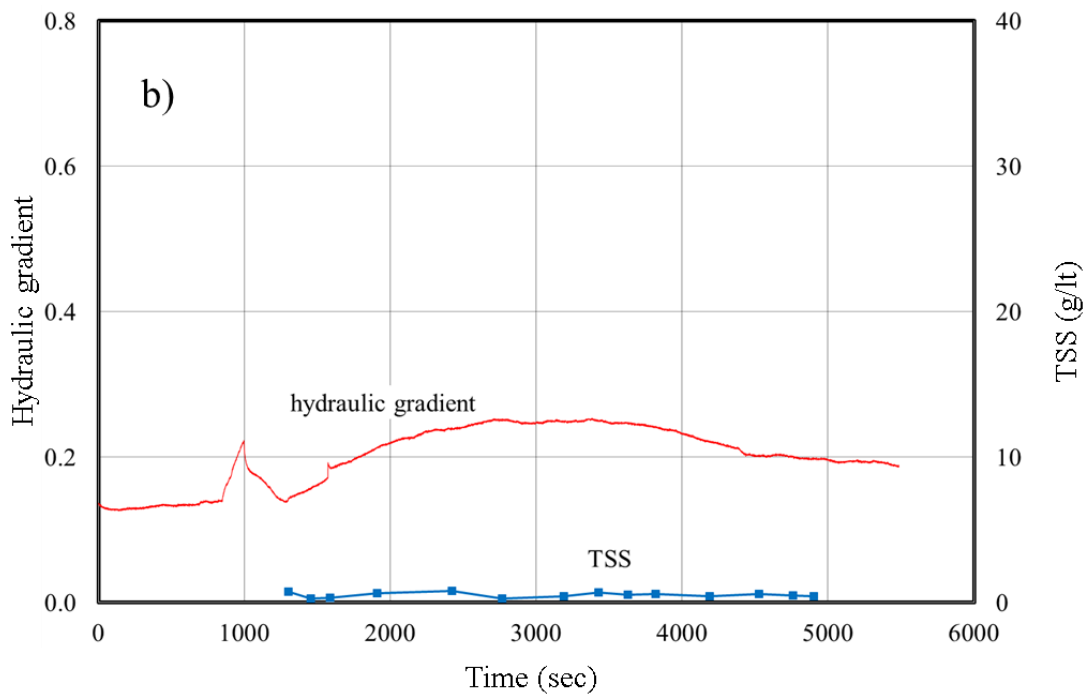
Fig 8.1 Experiment results of experiment No. EXP 6NF of GIII sample. a) Pore water pressure and vertical displacement curves; b) Hydraulic gradient and TSS

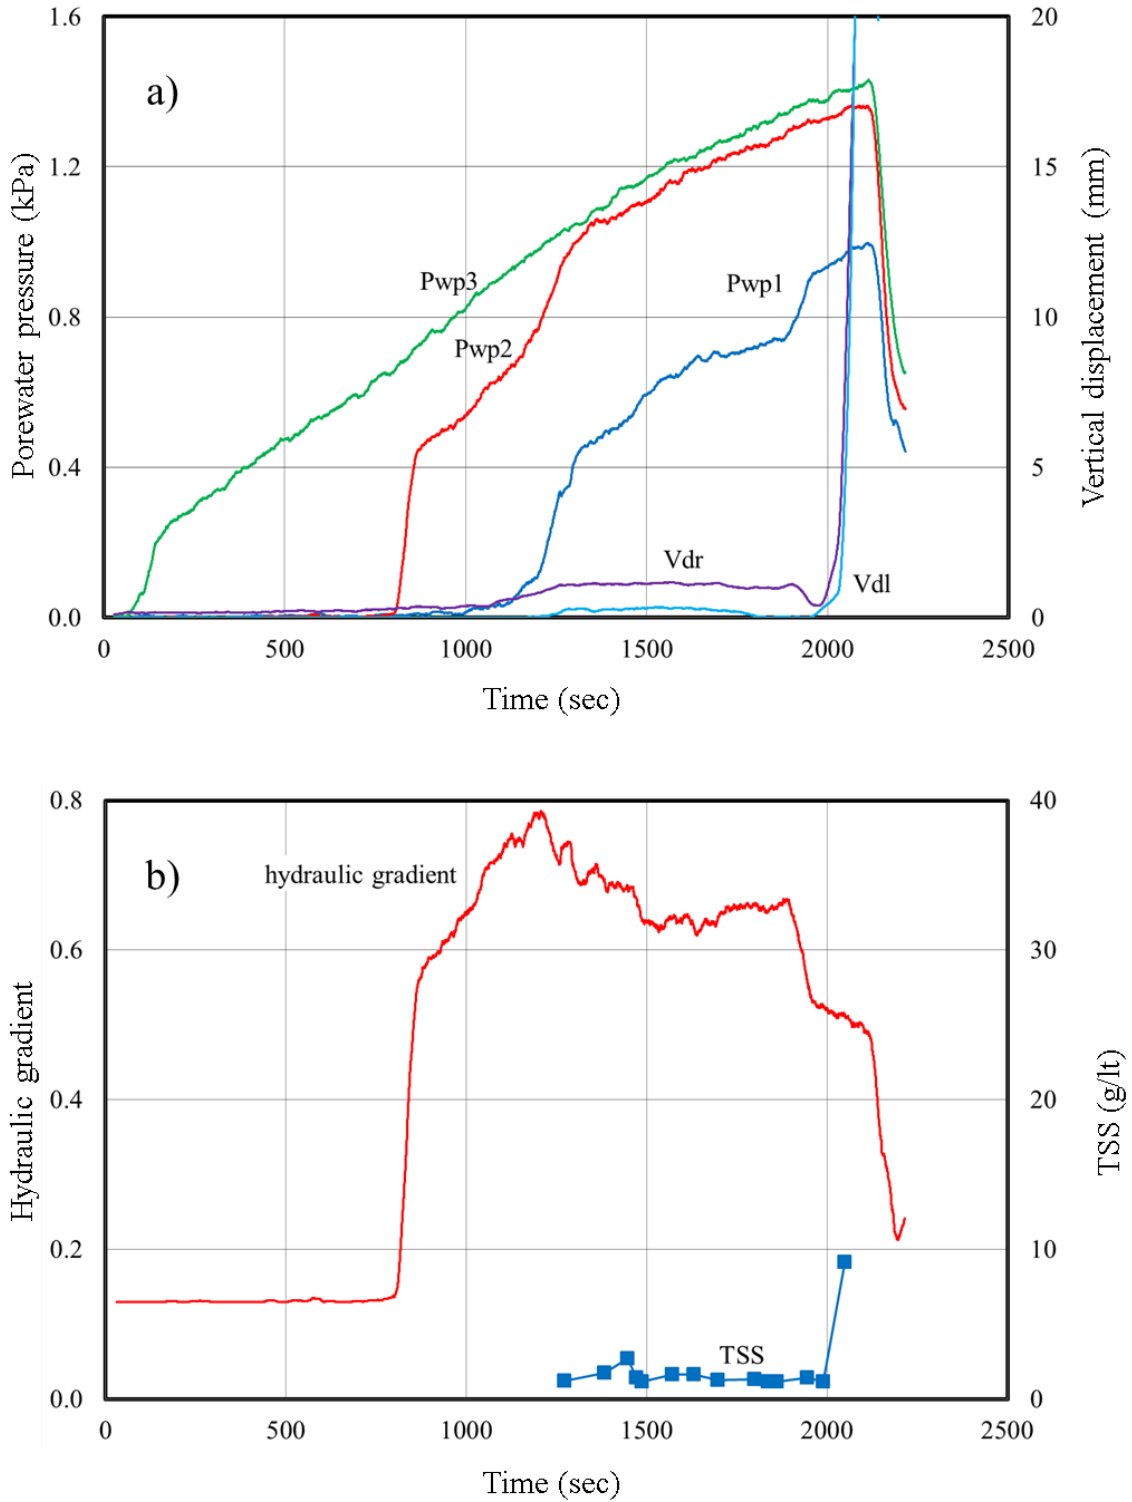
Fig. 8.2 Experiment results of experiment No. EXP 3F of GIII sample. a) Pore water pressure and vertical displacement curves; b) Hydraulic gradient and TSS

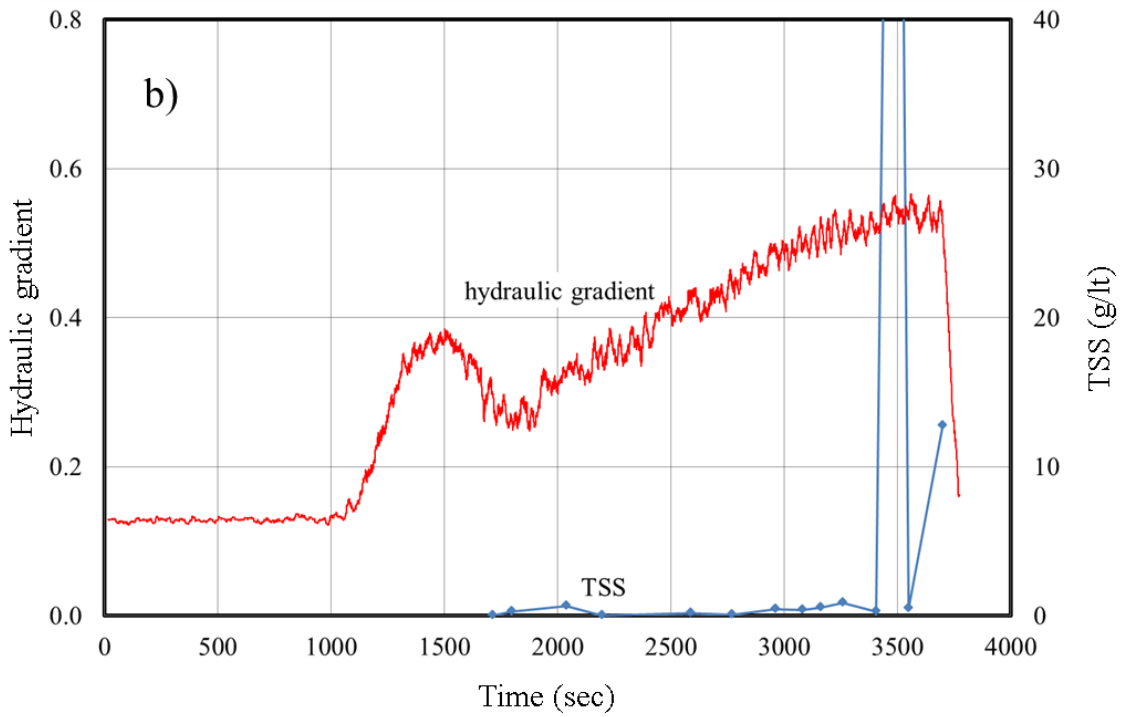
Fig. 8.3 Experiment results experiment No. EXP 5F2, of GIII sample. a) Pore water pressure and vertical displacement curves; b) Hydraulic gradient and TSS

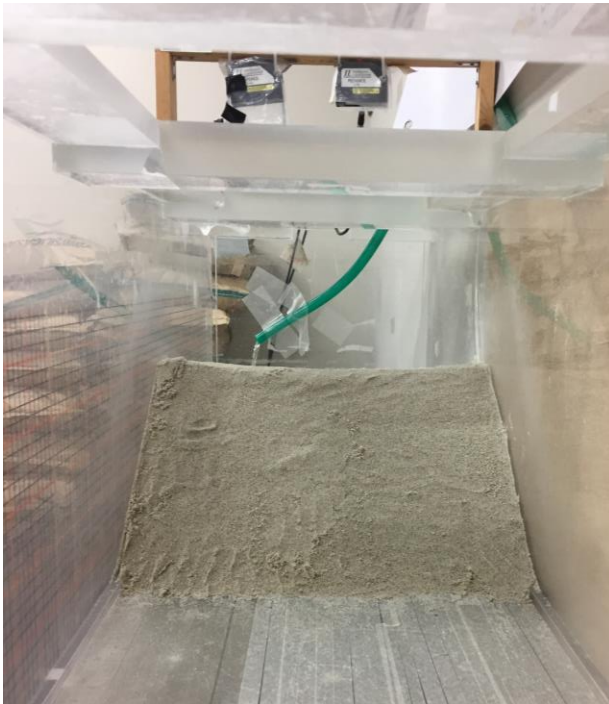
Fig. 8.4 Photographs of experimental setup. a) Side view of flume tank during experiment; b) Downstream slope of dam with laser sensor at the top of flume tank
