Rocky coastal cliffs reinforced by vegetation roots and potential collapse risk caused by sea-level rise

Tetsuya Kogure

Institute of Environmental Systems Science, Shimane University, 1060 Nishikawatsu-cho, Matsue, Shimane 690-8504, Japan

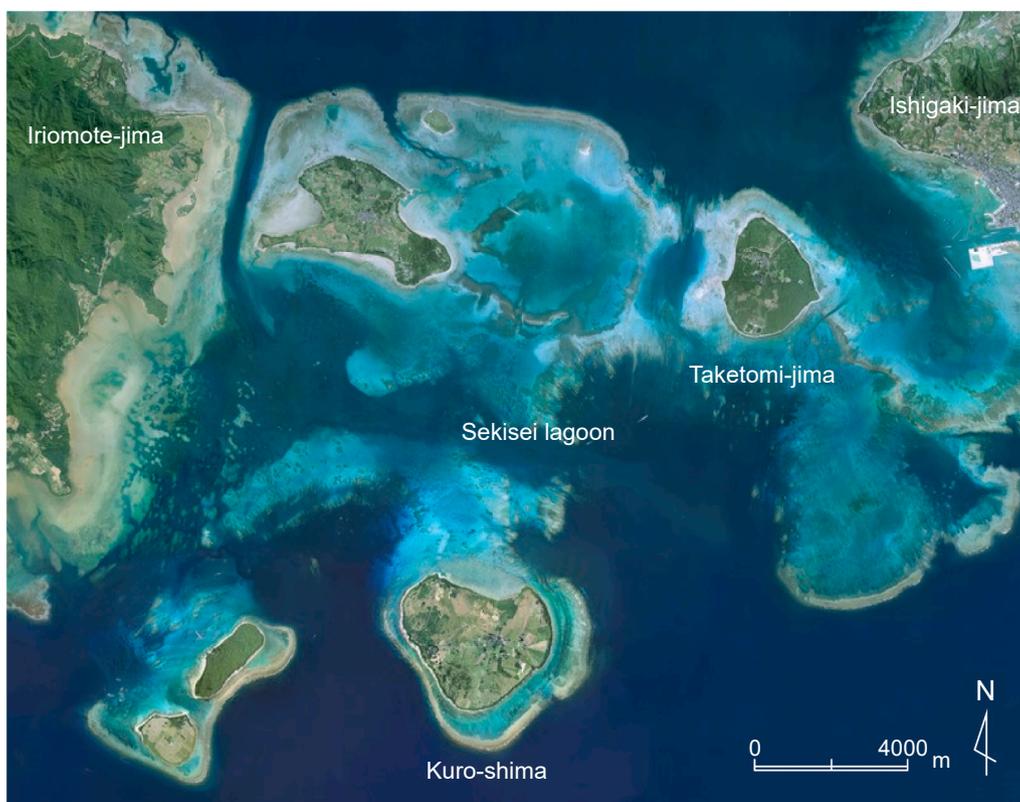
Fig. 2. Aerial photography of the study sites.

Taketomi-jima (Fig. 1b) and Kuro-shima (Fig. 1c) are low-lying islands comprising uplifted coral limestone surrounded by fringing reefs located in Sekisei Lagoon (Fig. 2). The Pleistocene coral limestone is referred to as Ryukyu limestone. The top surface of the cliffs on both islands is covered with vegetation, most of which includes *Pandanus odoratissimus* (PO, recently referred to as *Pandanus odorifer* (Callmänder et al., 2021)), a dominant coastal vegetation mainly from South Asia through Polynesia (Fig. 3).

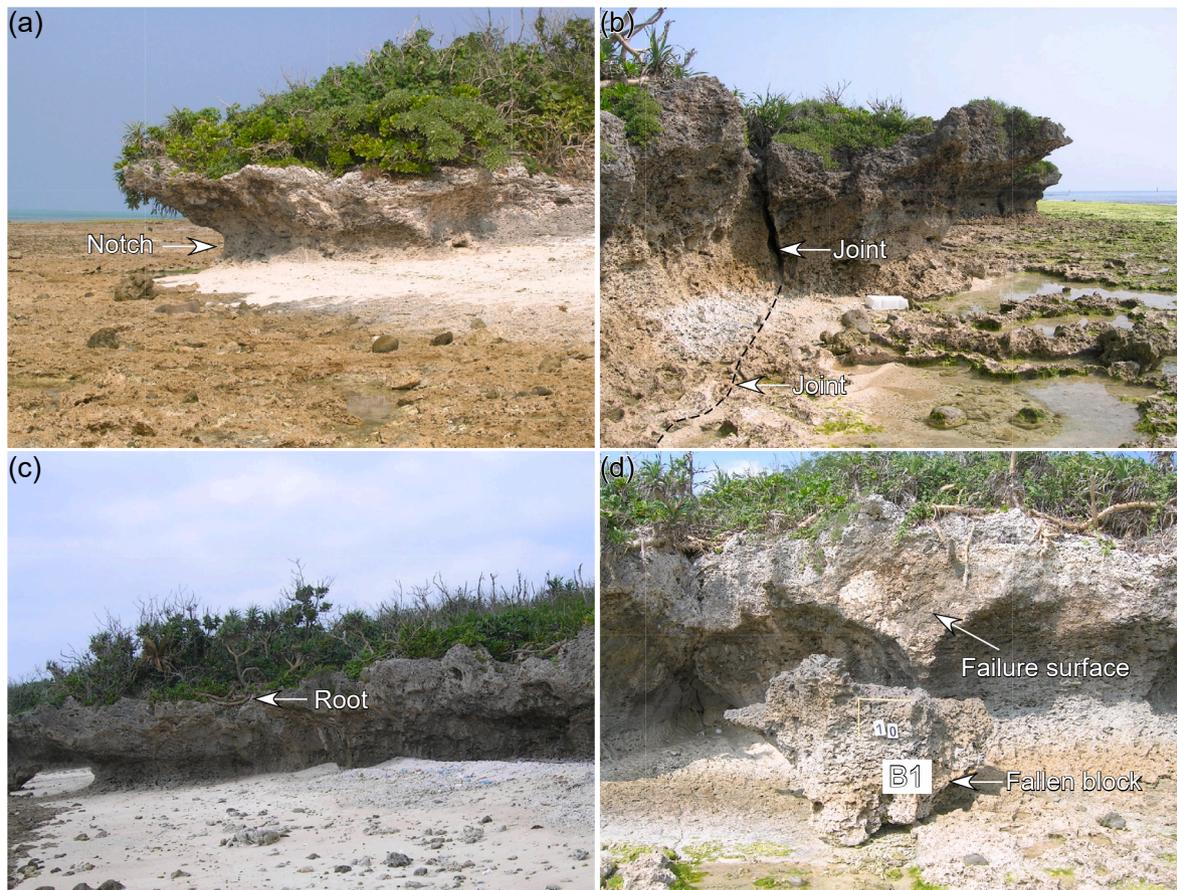
Fig. 4. Coastal cliffs and blocks in Taketomi-jima: (a) top surface of a cliff covered with vegetation; (b) a vertical joint visible on a cliff and reef flats; (c) roots on a cliff surface; (d) a vertical failure surface with roots.

Taketomi-jima is located 4 km away from the southwestern part of Ishigaki-jima (Fig. 1a), with a maximum elevation below 20 m and north-south and east-west widths of 3 and 2 km, respectively (Fig. 1b). The strike and dip of the fault running through the central part of Taketomi-jima is N70°E75°S. Coastal cliffs composed of Ryukyu limestone occur along the island coastline except for the northern part, where sandy beaches dominate. The cliffs exhibit a flat top surface and a particular notch at their base (Fig. 4a). Vertical joints fully transect the

cliff and reef flat in front of the cliff (Fig. 4b). The top surface is fully covered with PO (Fig. 4c). The aerial roots of PO with a diameter of ca. 5 cm extend even inside the cliff body to stabilize the top surface, while some roots likely induce cliff collapses by enlarging surface cracks (Fig. 4d).

In addition to Kuro-shima, blocks comprising Ryukyu limestone are found along the Taketomi-jima coastline (Fig. 4). Stability analysis of the blocks occurring in Kuro-shima revealed that many of these blocks were produced by gravity-induced collapses (Kogure and Matsukura, 2010a; Kogure and Matsukura, 2012) or wave-induced collapses of coastal cliffs (Kogure and Matsukura, 2010b; Kogure and Matsukura, 2012). This suggests that the blocks in Taketomi-jima were also likely produced by cliff collapses. Therefore, stability analysis should also be conducted in Taketomi-jima to determine the cliff collapse risk.

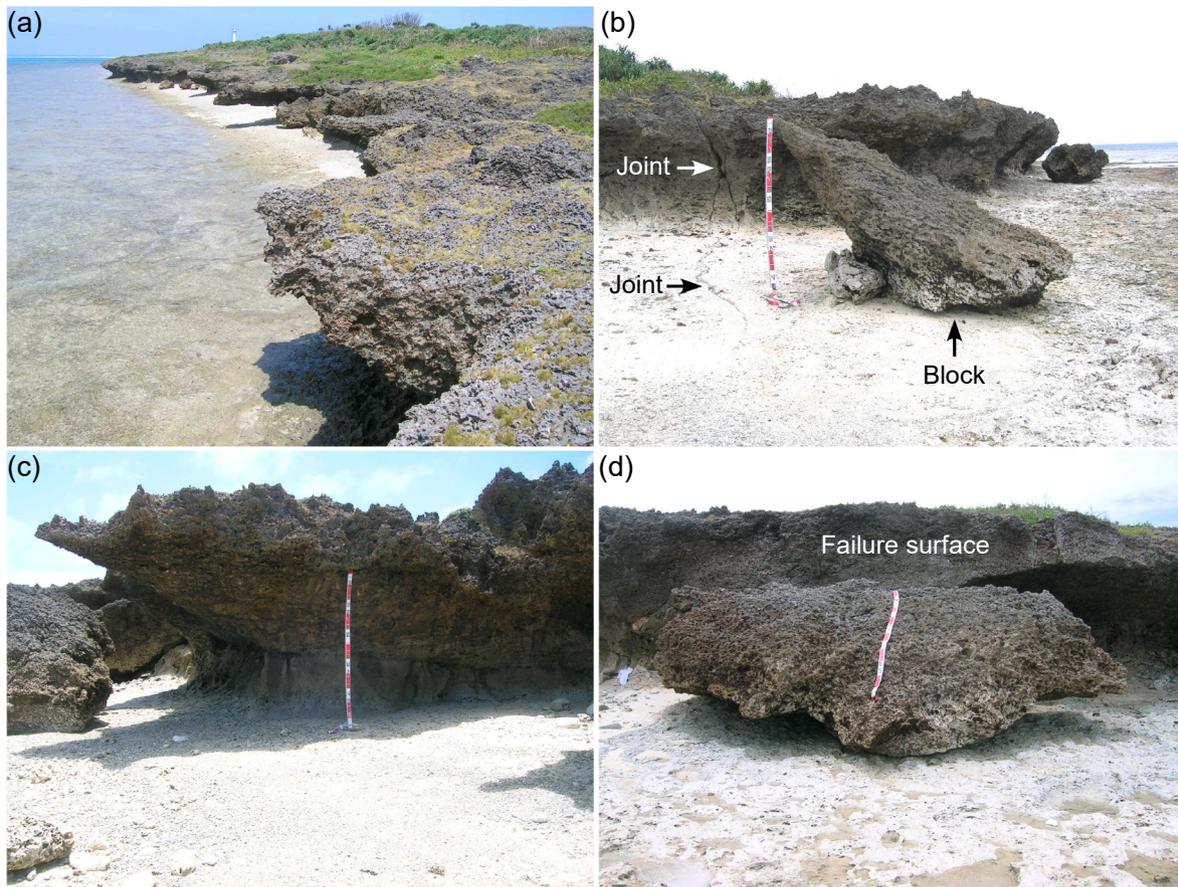
Fig. 5. Coastal cliffs and blocks in Kuro-shima: (a) top surfaces of cliffs covered with less vegetation; (b) vertical joint visible in coastal cliffs and reef flats (modified after Fig. 4a in Kogure and Matsukura (2010a)); (c) notched surface without roots; (d) vertical failure surface without roots.

maximum elevation below 15 m and north–south and east–west widths of 3.5 and 3 km, respectively (Fig. 1c). A low-lying notched cliff with a height ranging from 3 to 4 m occurs along the island coastline from the northeastern part through the south toward the northwestern part (Fig. 1c and 5a). Vertical joints with a crack width between ten and several tens of centimeters are present in coastal cliffs or reef flats

(Fig. 5b). These joints are systematically rather than randomly developed, so they likely originate from geological processes (Kogure and Matsukura, 2011). Vegetation partly covers the flat top surface (Fig. 5a), while no vegetation nor vegetation roots appear on other surfaces, such as notched and failure surfaces (Fig. 5c and 5d, respectively). In contrast to Taketomi-jima, PO does not cover the seaward edge of the top cliff surface in Kuro-shima. PO grows in more inland areas in Kuro-shima, e. g., ca. 50 m from the front face of cliffs (Fig. 6).

be attributed to reinforcement by PO roots. This situation is consistent with the fact that no horizontal tension cracks occur in the notched face of the cliffs in Kuro-shima where no PO grows on the top surface of the cliffs just above the notches (Fig. 5).

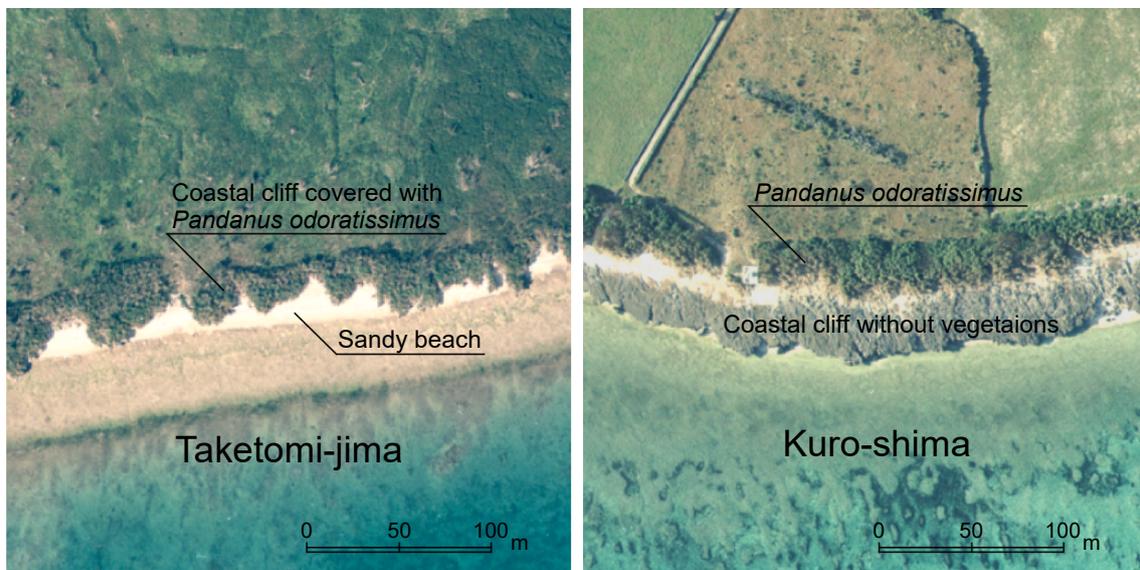
Fig. 6. Difference in vegetation on the top surface of coastal cliffs between Taketomi-jima and Kuro-shima.

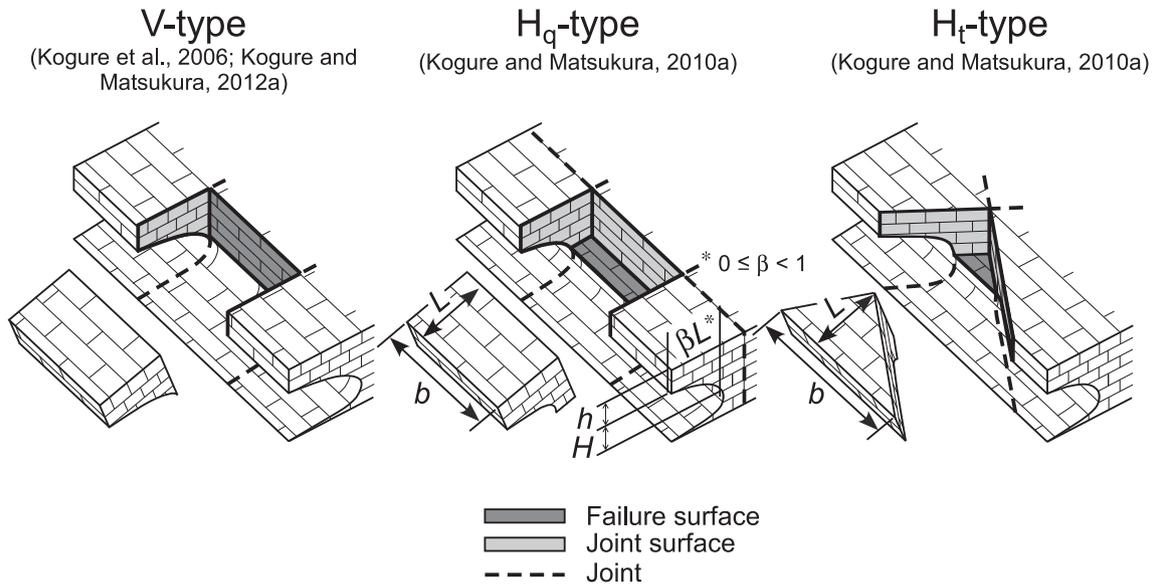
Fig. 7. Types of cliff collapses at the study sites.

Ryukyu limestone cliff collapses reveal a vertical failure surface (Kogure et al., 2006; Kogure and Matsukura, 2012) or a horizontal failure surface (Kogure and Matsukura, 2010a) (Fig. 7). Kogure et al. (2006) and Kogure and Matsukura (2012) theoretically demonstrated that collapses with a vertical failure surface are induced by the development of tension cracks in the cliff top surface resulting from destabilization by a deepened notch at the cliff base. Kogure and Matsukura (2010a) also theoretically explained the mechanisms of collapses with a horizontal failure surface. The failure body in these cliff collapses is bounded by vertical joints, and therefore, the collapsed cliff is separated from adjacent cliffs by vertical joints before the collapse (Fig. 7). Notch development destabilizes cliffs bounded by vertical joints and finally results in a collapse with a horizontal failure surface, where the failure body collapses into the sea (reef flats). Kogure and Matsukura (2010a) found that the shape of the horizontal failure surface is quadrangular or

triangular, which were denoted as H_q - or H_t -type collapses, respectively (Fig. 7). The shape of the horizontal failure surface changes with the number of vertical joints along coastlines and the intersectional angle between the coastlines and joints (Kogure and Matsukura, 2011). Collapses with a vertical failure surface are referred to as V-type collapses in the present study (Fig. 7).

where H and h denote the height of the notched roof (from the retreat point) and the vertical height of the cliff face, respectively, β is the ratio of the notch depth to the block length, L ($0 \leq \beta < 1$) (Fig. 7) and g is the

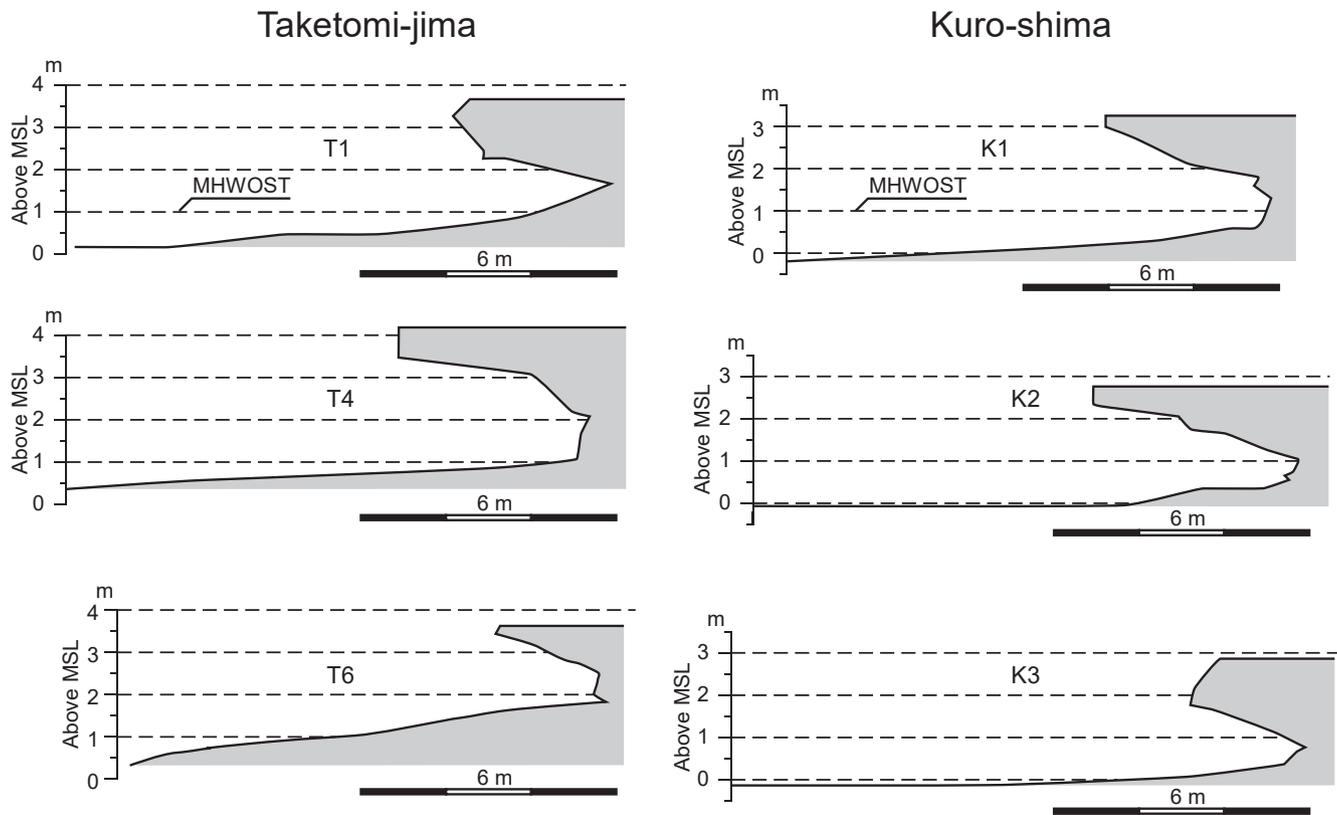
Fig. 8. Vertical profiles of the coastal cliffs in Taketomi-jima and Kuro-shima. MHWOST denotes the mean high water at ordinary spring tide.

Fig. 8 shows vertical profiles of the coastal cliffs on both islands (K2 and K3 were retrieved from Kogure and Matsukura (2012)). The cliff height corresponding to the height from the retreat point of a notch to the top surface, $H + h$, is similar on both islands. However, the elevation of the notch retreat point ranged from 1.87 to 2.53 m in Taketomi-jima and from 0.76 to 1.29 m in Kuro-shima. In addition, the elevation of the

top surface ranged from 3.63 to 4.18 m in Taketomi-jima and from 2.75 to 3.31 m in Kuro-shima. These data indicate that the coastal cliff elevation is approximately 1 m higher in Taketomi-jima than that in Kuro-shima.

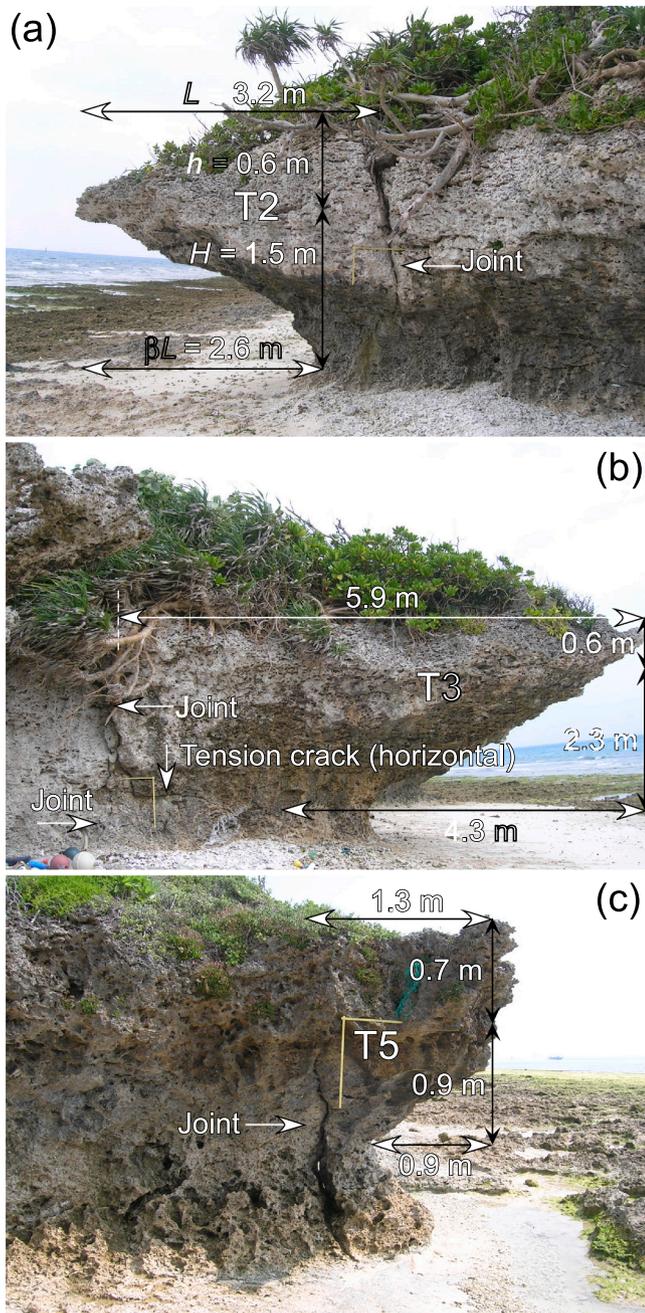
Fig. 9. Photos showing the dimensions of the coastal cliffs in Taketomi-jima considered in stability analysis: (a) T2; (b) T3; (c) T5.

likely destabilized by notch development and occurs at risk for collapse toward the sea. Therefore, the crack is likely a tension crack generated in the horizontal failure surface. Table 3 lists the results of the measurements at T2, T3 and T5 and B1–B2 in Taketomi-jima. The dimensions of T2, T3 and T5 are as follows: $L = 1.3\text{--}5.9$ m; $\beta L = 0.9\text{--}4.3$ m ($\beta = 0.72\text{--}0.81$); $b = 2.4\text{--}2.5$ m; $H = 0.9\text{--}2.3$ m; and $h = 0.6\text{--}0.7$ m. The length of the horizontal tension crack at T3 is 0.8 m, which corresponds to 50% of the length of the potential failure surface.

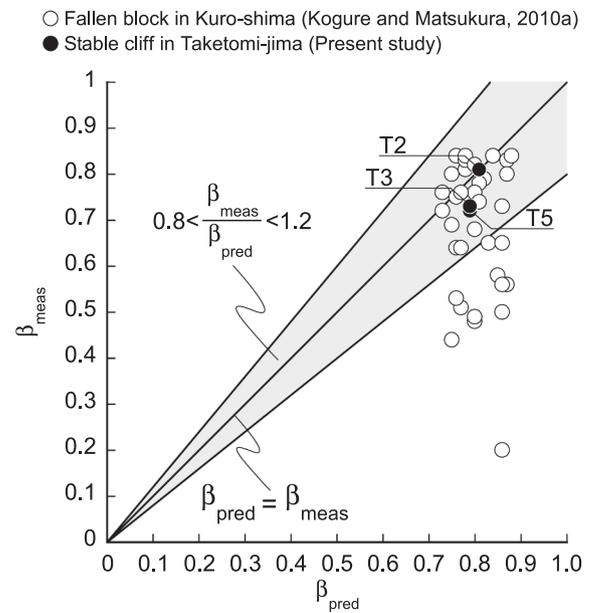
Fig. 10. Results of stability analysis. The open circles plotted outside of the shaded area indicate the cliffs collapsed by extreme waves such as tsunamis (Kogure and Matsukura, 2010b).

The β_{meas} and β_{pred} values at T2, T3 and T5 are shown in Fig. 10 together with data obtained from Kogure and Matsukura (2010a). All of the data pertaining to T2, T3 and T5 are close to $\beta_{\text{meas}} = \beta_{\text{pred}}$ line, suggesting that the cliffs are ready to collapse at any moment. Considering that T3 contains a horizontal tension crack with a length that is half of that of the potential failure surface, the cliff stability has likely been greatly reduced. Therefore, the appearance of a stable cliff, i.e., T3, may

The stability analysis results indicate that the PO root system likely reinforces T2, T3 and T5 because these cliffs are unstable in terms of their dimensions (Fig. 10). PO develops a complex aerial root structure that provides additional stiffness and increases the drag coefficient against tsunami flow (e.g. Tanaka et al., 2007). However, to the author's knowledge, no reports have demonstrated or examined the root tensile strength (RTS) of PO. RTS measurement of PO may be difficult because the maximum root diameter is too large to conduct mechanical tests: the maximum root diameter is larger than 35 mm in males and 45 mm in females (Adkar and Bhaskar, 2014). Therefore, no data or equations are currently available to calculate the RTS of PO.

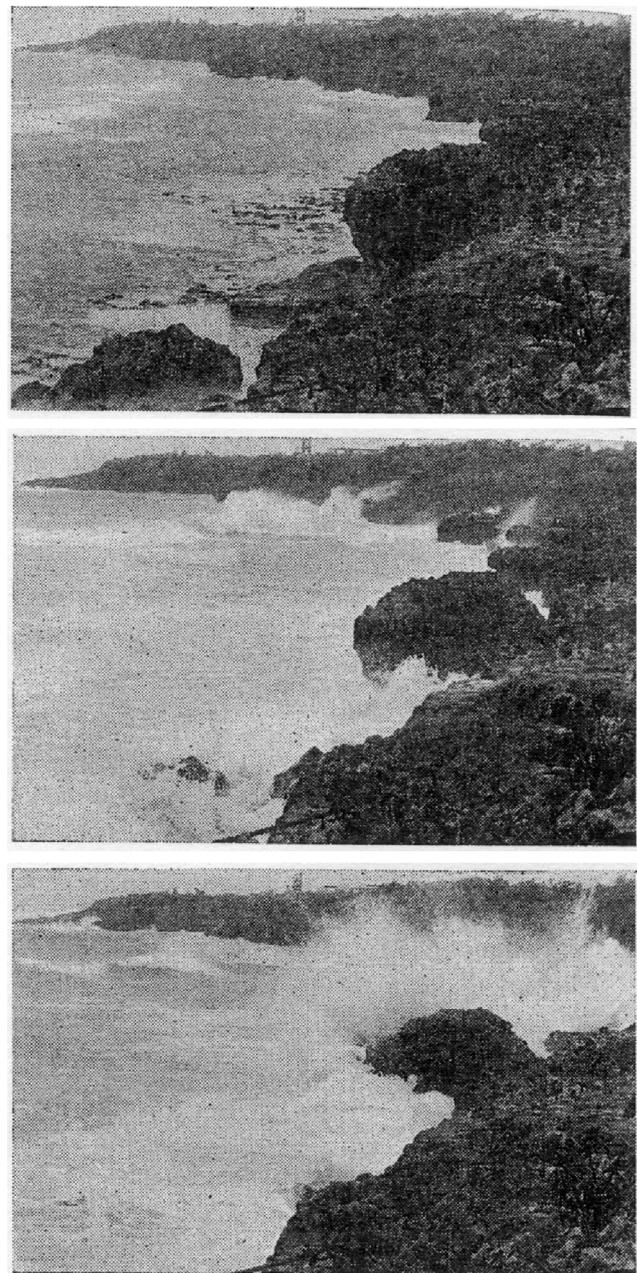
Fig. 11. Photographs of surging bores (Nakaza et al., 1988). Surging bores with a height ranging from 4 to 5 m and a period ranging from 10 to 15 min when a strong typhoon passes near the Ryukyu Islands.

Fig. 11 suggests that the relationship between the wave height and cliff height can control the spray amount, which transports salt to PO growing on the top surface of the cliffs. Therefore, the occurrence of PO on the coastal cliffs in Taketomi-jima and Kuro-shima may also be controlled by the difference in cliff elevation between these islands. Kawana (1987) reported that the sea level around both islands remained constant for ca. 3000 years from ca. 4000 to 1000 years ago and that the island elevation increased due to seismic activity over the last 1000 years. The occurrence of relative uplift is evidenced by the higher altitude of the retreat point of the notches on the islands than the mean sea level (Fig. 8) because the notch retreat point is usually formed at the mean sea level (Focke, 1978). Therefore, it is plausible that the difference in uplift amount between these islands, which is estimated as ca. 1 m (Fig. 8), has occurred over the last 1000 years, although the cause of the difference remains unclear.

A substantial amount of sea spray reaches the cliff top surface just above a given notch upon wave impact during a severe storm or typhoon (Fig. 11). This is more likely to occur in Kuro-shima, where the cliff top surface elevation is ca. 1 m lower (Fig. 8). Therefore, it is clear that wave impact-related sea spray occurs more abundantly on the cliff top surfaces in Kuro-shima than in Taketomi-jima, which can result in the disappearance of PO through the supply of salt.
