## Tandikek and Malalak flowslides triggered by 2009.9.30 M7.6 Sumatra earthquake during rainfall in Indonesia

### Abstract

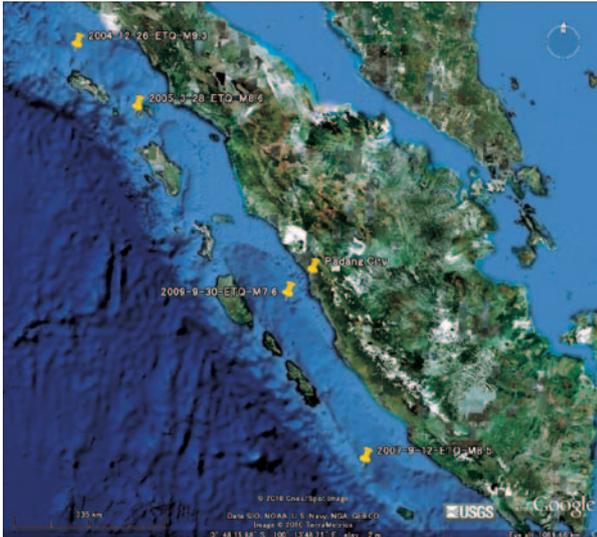
**Fig. 1.** Epicenter locations of four major earthquakes occurring around Sumatra between 2004 and 2009 (base figure from Google Map).

Earthquake activity is intense in southwestern Sumatra. As shown in Fig. 1, four major earthquakes occurred in the area between 2004 and 2009. The first and largest of these was the M9.3 earthquake that occurred on 26 December 2004. This earthquake caused a major tsunami disaster over a wide area, and 227,898 people lost their lives. A M8.6 earthquake occurred on 28 March 2005, followed by a M8.5 earthquake on 12 September 2007, and a M7.6 earthquake on 30 September 2009.

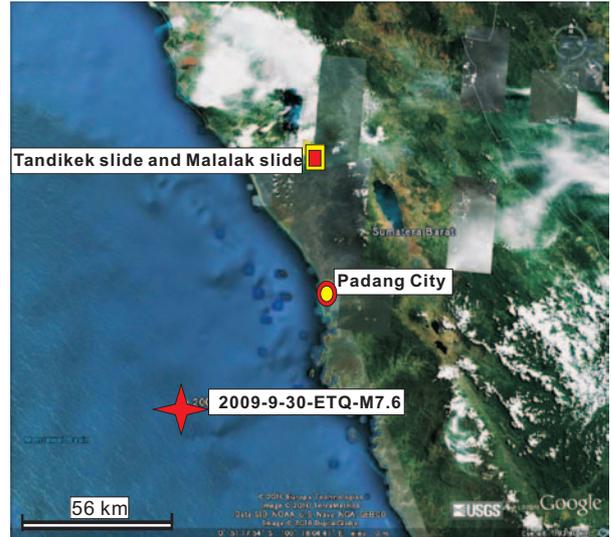
**Fig. 2.** Location map showing the epicenter of the 2009.9.30 M7.6 earthquake, Padang City, and the Tandikek and Malalak landslides.

Locations of the epicenter of this earthquake, Padang City, and the landslide area are shown in Fig. 2. We carried out field investigations in Padang City and the landslide area in March 2010. Building collapse was very severe in Padang City, and the collapse rate of buildings decreased with increasing distance from the epicenter. Almost no landslides occurred between the epicenter and Tandikek, including in Padang City, except for some small-scale rockfalls and soil slope collapses, even on steep mountainous slopes. How-

ever, extensive slides occurred in the Tandikek and Malalak districts (Fig. 2).

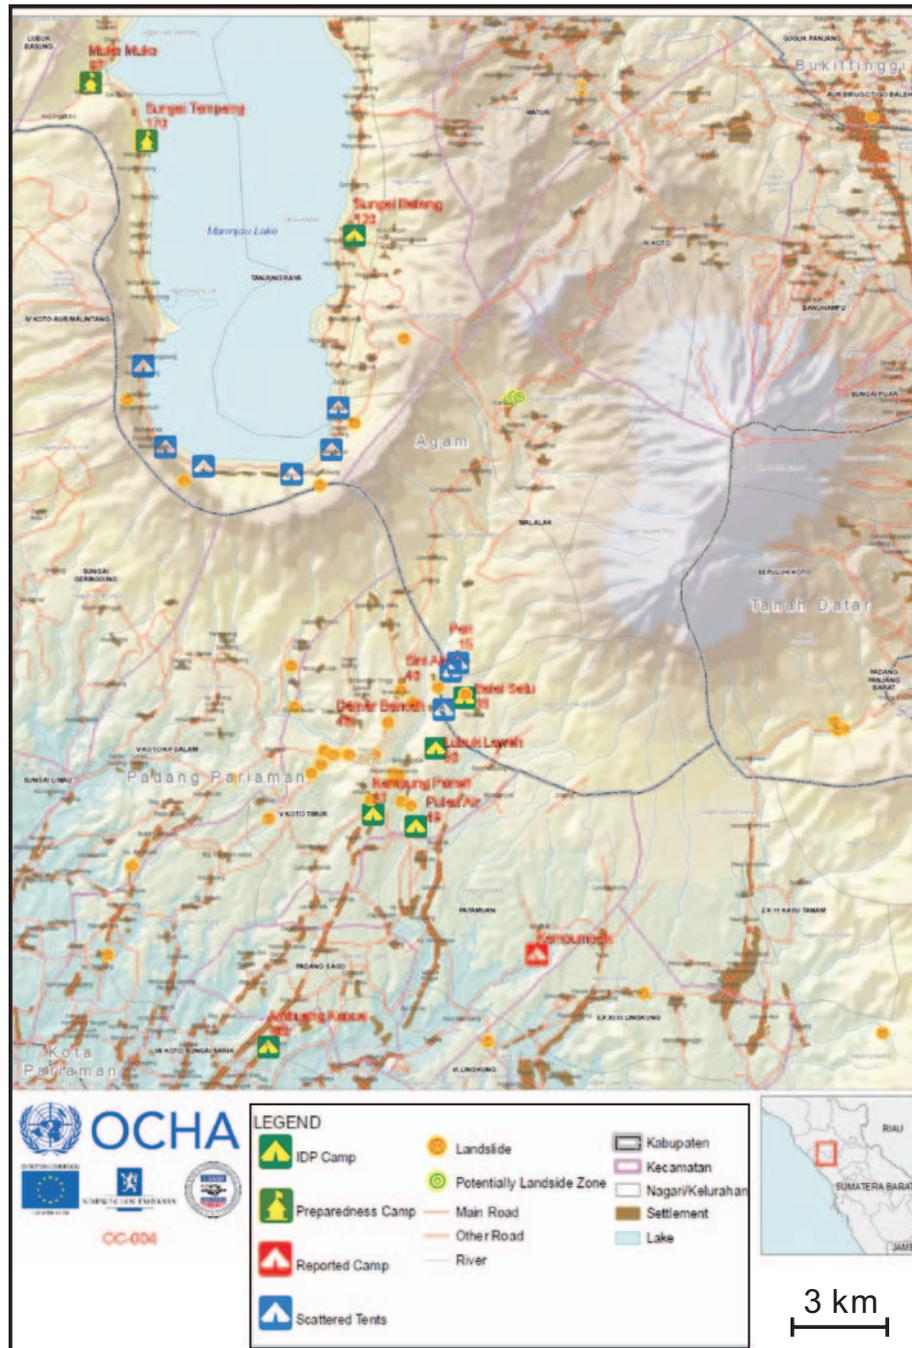
Fig. 3. Distribution of landslides triggered by the 2009.9.30 M7.6 Sumatra earthquake and IDP (internally displaced person) camp locations (from OCHA 2009).

Many landslides were triggered by the M7.6 2009.9.30 Sumatra earthquake. These moved for long distances at high speed, resulting in significant loss of life. Fig. 3 and Fig. 4 are maps showing the landslide distribution, as prepared by UN-OCHA (2009) and Badang Geological Agency, Indonesia. Thirty-three landslides were plotted in Fig. 3, whereas in Fig. 4 more than 60 landslides were plotted over a larger area. From Fig. 3, it can be seen that most of the landslides occurred at the mountain foot, at relatively low elevation.

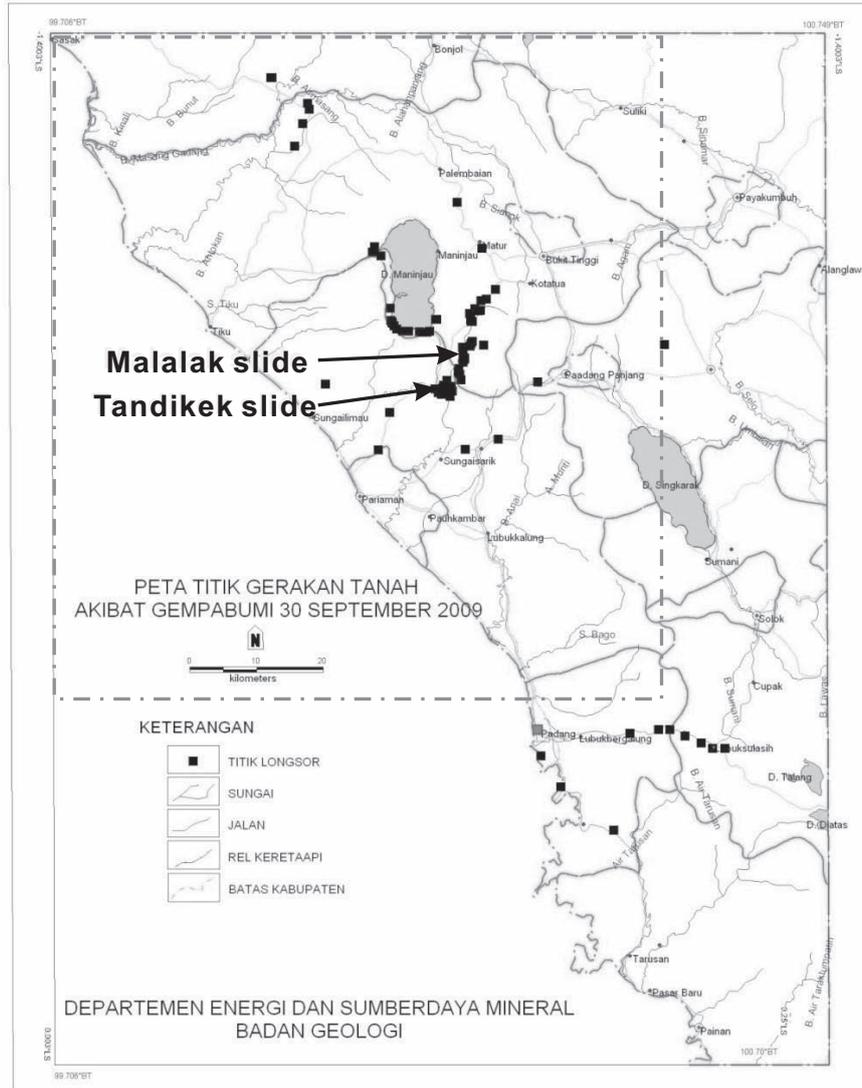
Fig. 4. Landslide distribution map made by the Badang Geological Agency, Indonesia. Dotted line rectangle is the area of the geological map shown in Fig. 5.

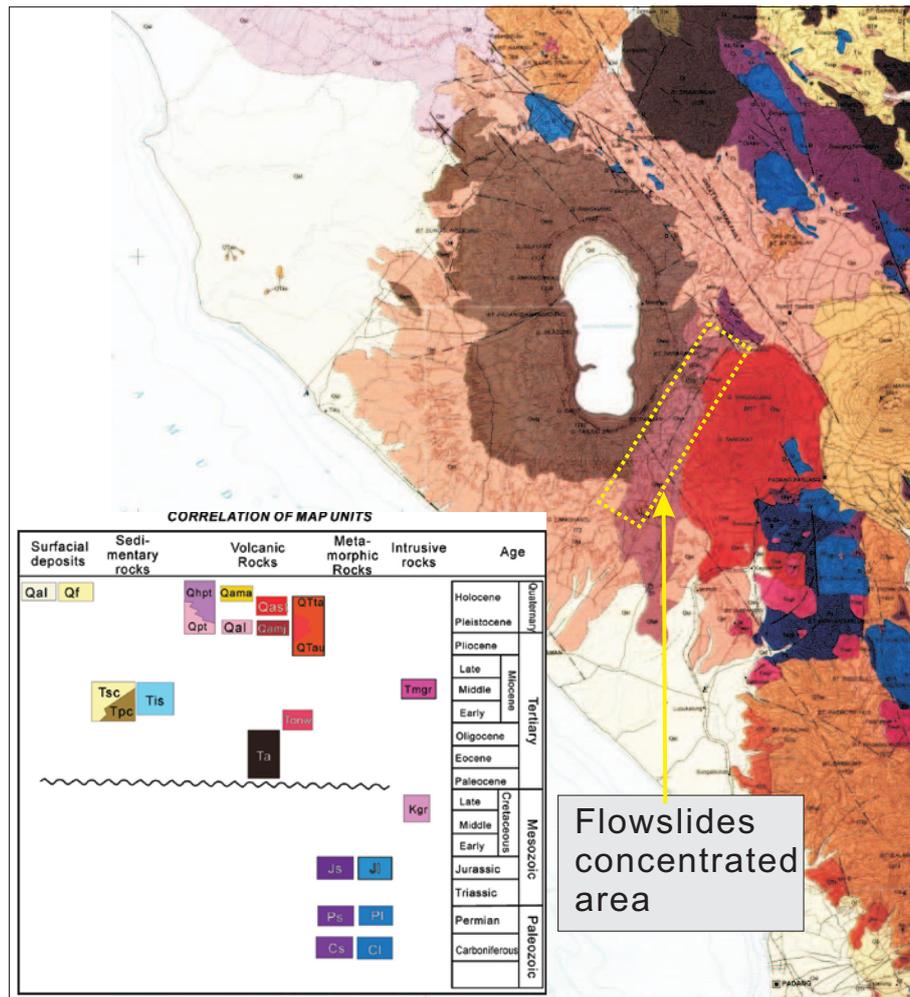
Fig. 5. Geological map of the landslide area and their surroundings.

A simplified geological map of the landslide area (Fig. 5) shows that lava and pyroclastic deposits are the main lithotypes present. In the area of concentrated flowslides, the bedrocks are Quaternary volcanic rocks (indicated as Qhpt and Qpt in the map). Previous work has found that the potential for flowslides to occur in pyroclastic strata is great, due to high grain crushing susceptibility (Wang & Sassa 2000). This is especially so in pumice layers.

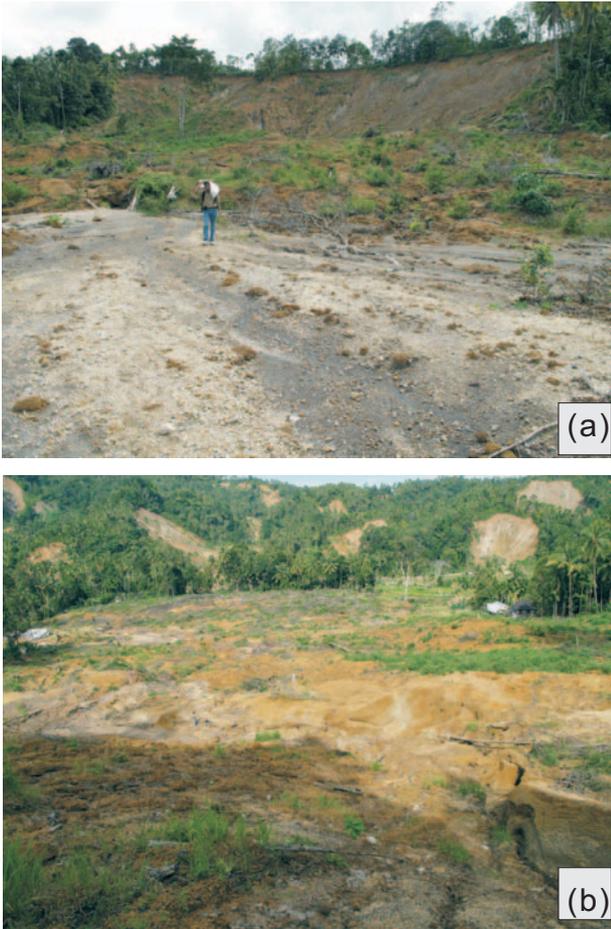
**Fig. 6.** Photos of the Tandikek flowslide. (a): The main scarp of the Tandikek flowslide. The slope angle was about 35 degrees; pumice layer distributed over stiff clay layer. (b): View from the source area of the Tandikek flowslide. The two remaining houses at the sides mark the boundaries of the flowslide.

The source and depositional areas of the Tandikek flowslide are shown in Fig. 6. The main scarp is steep, and the depositional area is very flat. The flowing process can be estimated from those photos. Fifty-seven houses were completely destroyed by the Tandikek flowslide, and no trace of them remains. The height of the main scarp was about 20 m, and the travel distance was about 220 m. From Fig. 6b, it is also evident that many other slope failures occurred on the steep slopes nearby.

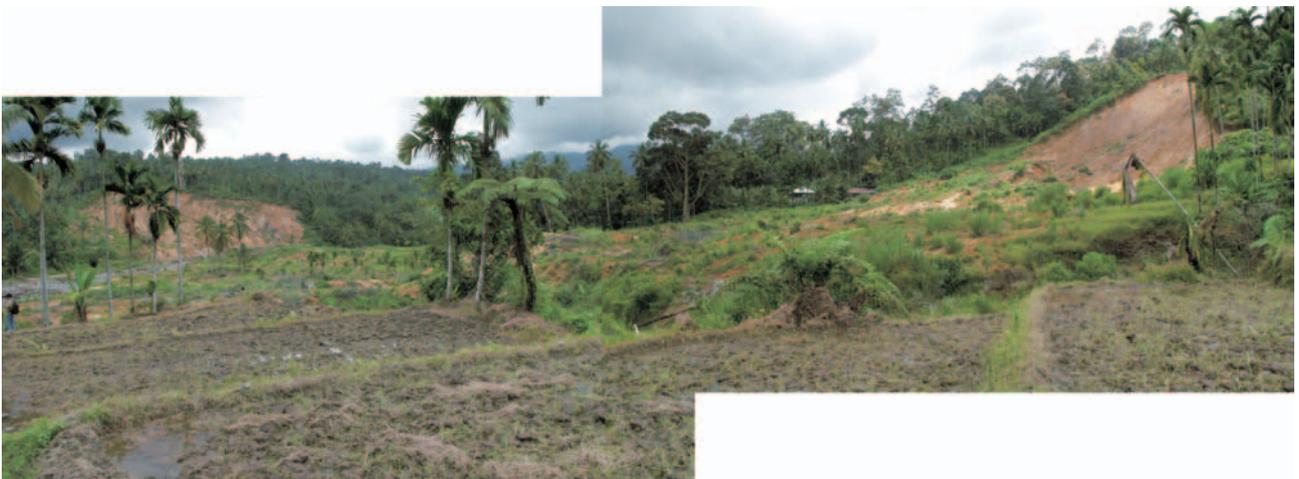
**Fig. 7.** Longitudinal section photograph of the Malalak flowslide showing the long travel distance of the flowslides. Almost no sliding mass was left in the source area, and all of the sliding mass was deposited on a gentle slope.

A longitudinal section photograph of the Malalak flowslide (Fig. 7) illustrates the flat deposition of the sliding mass of the flowslide. The sliding mass moved out of the slope in the source area, and covered the gentle slope uniformly, as there was no resistance to the sliding mass. As also can be seen from Fig. 8a, the slope covered by the sliding mass was also very gentle, a typical character of flowsliding. In the source area slope, the structure of the sliding surface is almost the same as that in the Malalak flowslide (see Fig. 8b), with a pumice layer overlying the stiff clay horizon.

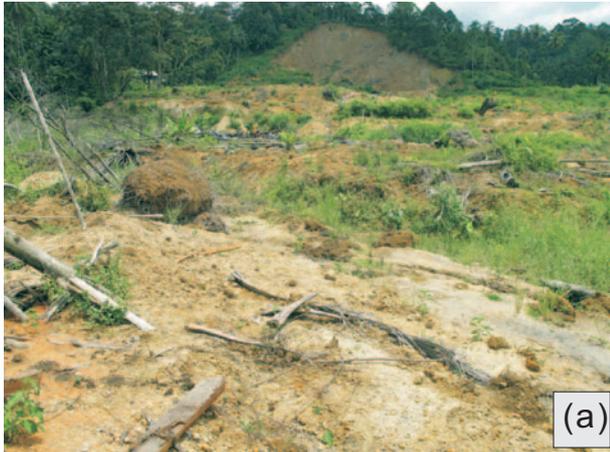
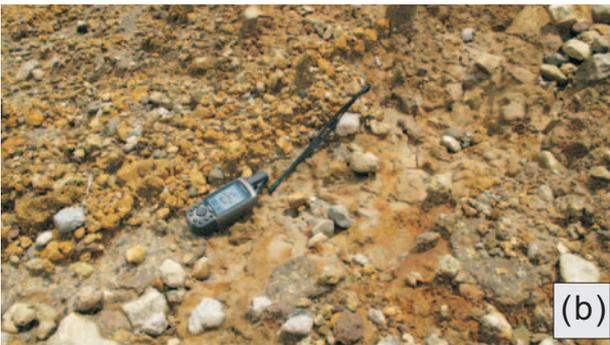
**Fig. 8.** (a): Photograph taken from the toe of the Malalak flowslide. The slope covered with the sliding mass is very gentle, showing a flowsliding character. (b) : Soil layer structure in the source area of the Malalak flowslide: Pumice layer overlying a stiff clay layer containing gravels.

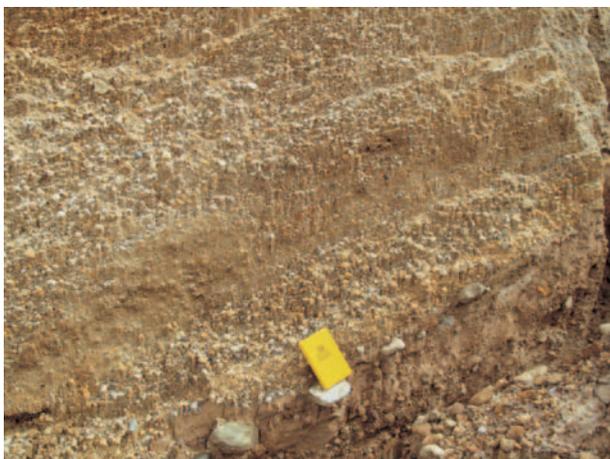
**Fig. 9.** Structure of the sliding surface in Tandikek flowslide: pumice layer overlying stiff clay layer with gravels.

The soil structure of the unwelded pumice layer overlying stiff clay can be seen clearly in Fig. 9, an example from the Tandikek flowslide. The thickness of the pumice layer

in both flowslides was about 1.5–2 m. The pumice layer easily collapses when cut by a shovel, showing a very loose structure. When eroded by rainfall, V-shape gullies form. Based on site observations, the pores are large and interconnected, and hence the permeability of the pumice layer is high. Water from rainfall can thus easily infiltrate the pumice layer.

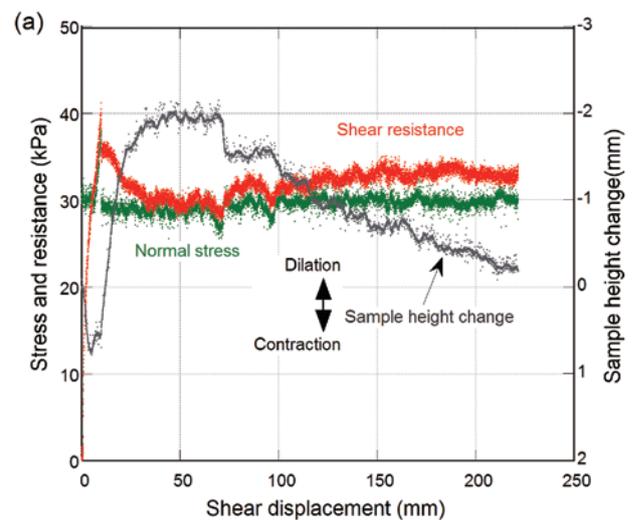
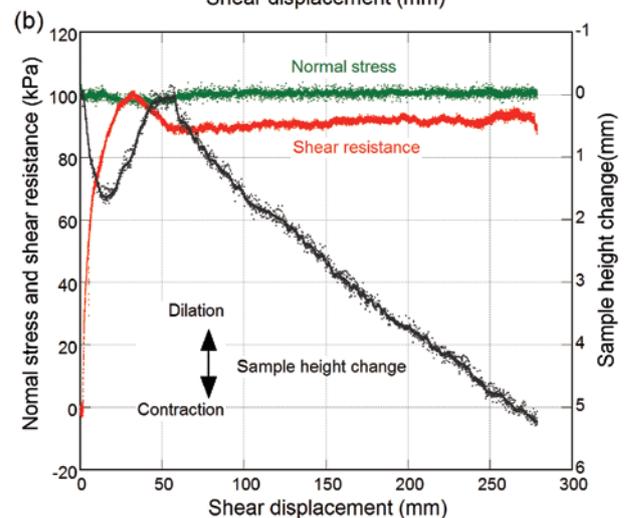
**Fig. 10.** Shear test results on a dry sample. (a) with a normal stress of 30 kPa; (b) with a normal stress of 100 kPa.

Fig. 10 shows the shear resistance and sample height change with shear displacement at the normal stress of 30 kPa and 100 kPa, respectively. As shown in Fig. 10a, the peak shear resistance reached 40 kPa, representing a friction angle of 53 degrees. Considering the natural slope

of 35 degrees, the factor of safety is 1.89, reflecting high stability in dry conditions. Dilation occurred when the shear displacement was from 10 mm to 70 mm, a very large range of shear displacement.

Under the normal stress of 100 kPa, the peak shear resistance reached 100 kPa (Fig. 10b), the same value of the normal stress, and the corresponding friction angle was 45 degrees. At a natural slope angle of 35 degrees, the factor of safety decreased to 1.43. This means that with increase in thickness of the pumice layer, the ability to resist earthquake decreases. For the sample height change, the dilation range of shear displacement became shorter, ranging from 20 mm to 55 mm. This contraction is much larger than that in the test with normal stress of 30 kPa, suggesting that additional grain crushing occurred during the shearing at higher normal stress.

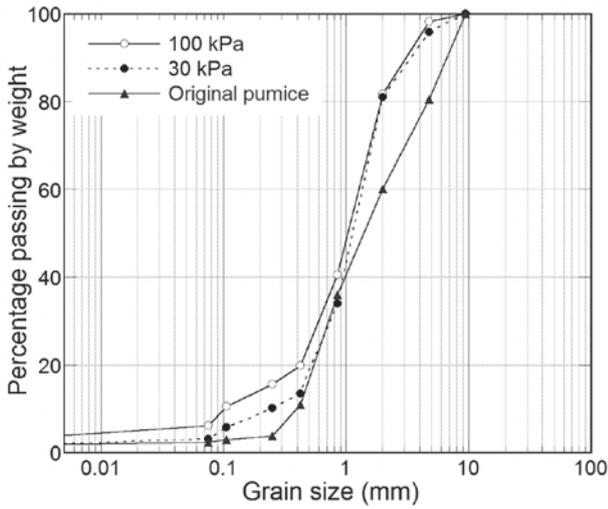
Fig. 11. Grain size distribution of the original pumice layer and sheared samples under normal stress of 30 kPa and 100 kPa, respectively.

Fig. 11 shows the grain size distributions of the original pumice layer and the shear zone samples under normal stress of 30 kPa and 100 kPa. Grain crushing clearly occurred during the shearing, and the extent of grain crushing is much larger with a higher normal stress.

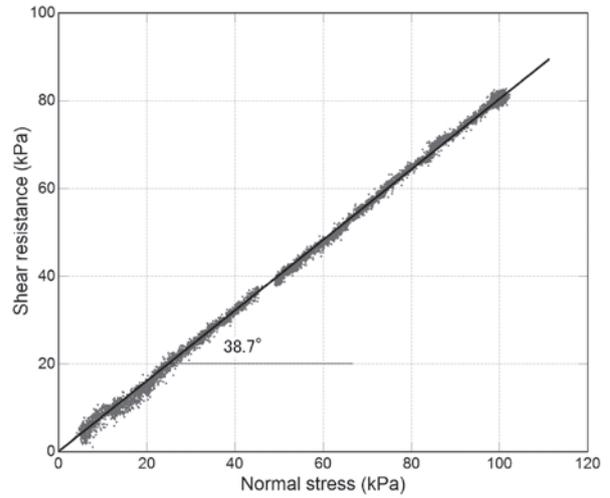
Fig. 12. Residual friction angle of the pumice layer.

With ring shear apparatus, the residual friction angle of the soil is easily determined. Fig. 12 is the result of residual friction angle analysis of the pumice layer. After shearing the sample to residual state under a normal stress of 100 kPa, the normal stress was decreased gradually, and the shear resistance then measured. The residual failure line is obtained when the normal stress decreased to 5 kPa, and the residual friction angle of 38.7 degrees is then derived. This value indicates that the pumice layer has high friction in the dry condition. If liquefaction does not occur in the soil, a flowslide cannot occur.

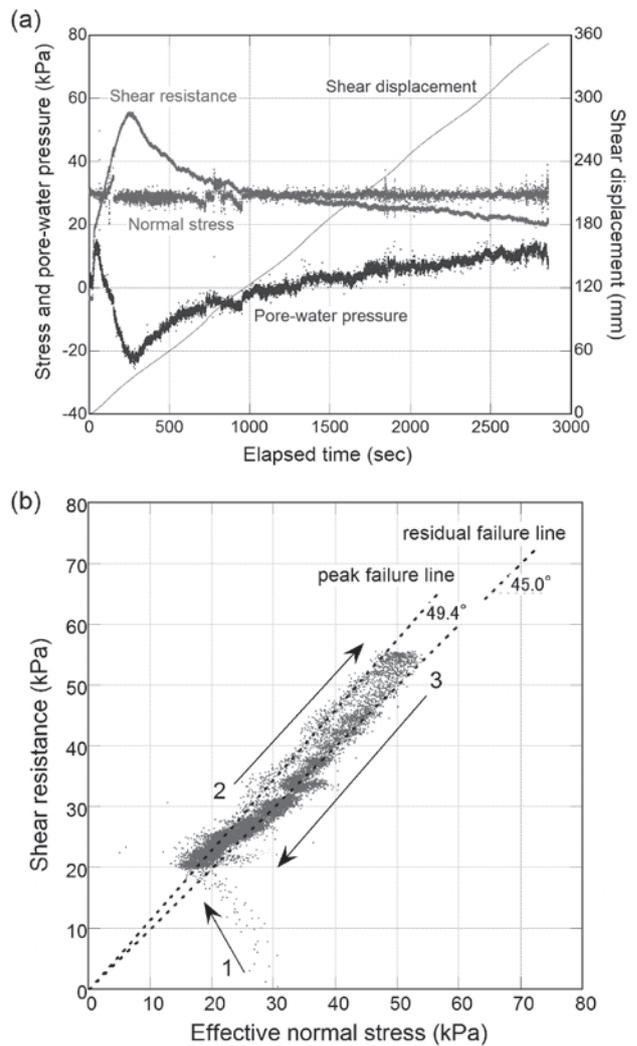
Fig. 13. Time series data (a) and stress path (b) of the undrained shearing test on a fully saturated pumice sample under normal stress of 30 kPa.

Test results for the normal stress of 30 kPa are shown in Fig. 13. Fig. 13a shows time series data, and Fig. 13b is the effective stress path. The negative pore pressure caused by dilation during shearing can be easily observed in both figures. The apparent friction angle of the pumice layer at the point when the peak strength (52 kPa) was reached is calculated as 60.0 degrees, much higher than that at the dry condition (53 degrees). After shearing for more than 300 mm, the generated pore pressure was almost one third of the normal stress. This result indicates that the pumice layer is very strong even in the saturated condition, and thus the slope can remain stable even during heavy rainfall.

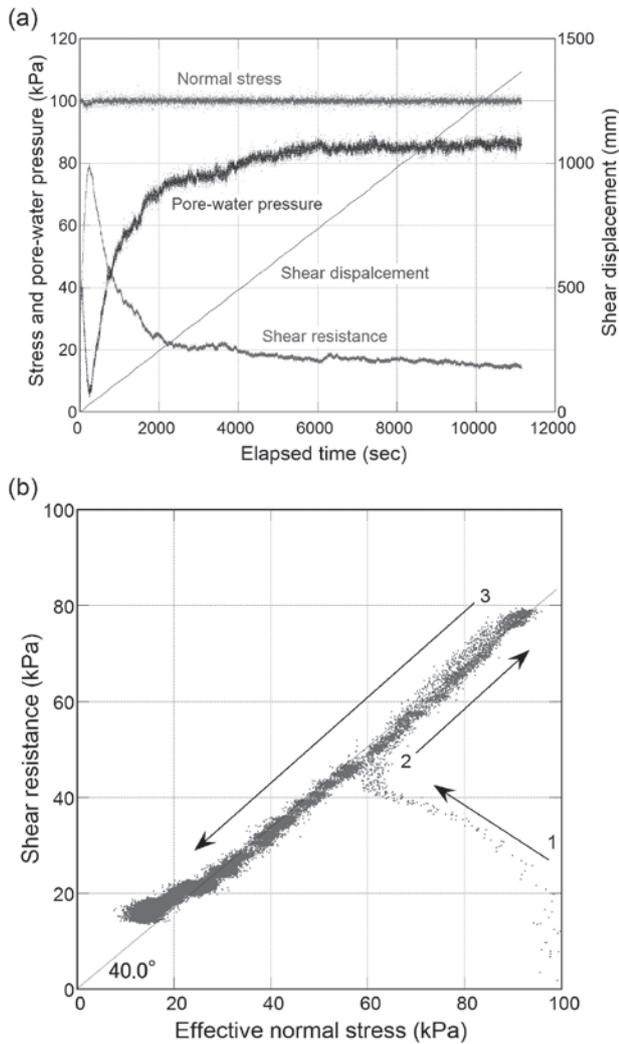
**Fig. 14.** Time series data (a) and stress path (b) of the undrained shearing test on a fully saturated pumice sample under normal stress of 100 kPa.

Fig. 14 shows equivalent results for the case where the fully saturated pumice layer was sheared under normal stress of 100 kPa in the undrained condition. High excess pore pressure was generated after shearing, and

relatively low shear resistance was reached. The test results show the effect of normal stress level on the mechanical behavior of soil. Although this case has no direct relationship to the 2009.9.30 flowslide disaster, the results hint that thick pumice slopes may be more dangerous than the thin pumice layer, if fully saturated.

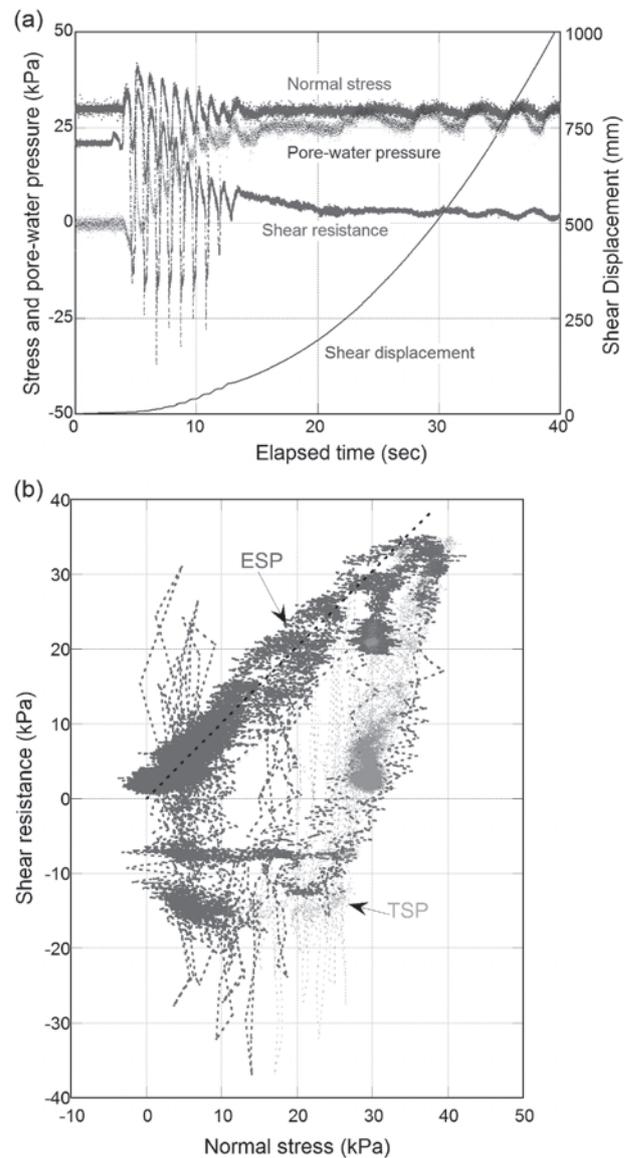
**Fig. 15.** Time series data (a) and the stress paths (effective stress path (ESP) and total stress path (TSP)) (b) of the undrained shearing test on a fully saturated pumice sample under cyclic shearing.

The test results are shown in Fig. 15. The results confirm that the shear resistance never exceeded the normal stress, and the shear resistance decreased cycle by cycle during the cyclic loading, while the pore-water pressure increased gradually, and reached the value of normal stress when the cyclic loading ended (Fig. 15a). Almost complete liquefaction occurred in the pumice sample after the cyclic loading.

Although the stress paths in Fig.15b are quite complex, the effective stress path finally reached the original point, meaning complete liquefaction occurred in the sliding zone of the flowslide, when the slope failed due to the triggering force of the earthquake.
