# **Internal erosion and piping failure of landslide dams**

**OKEKE, Chukwueloka Austin Udechukwu**

**Department of Geoscience  
Interdisciplinary Graduate School of Science and  
Engineering  
Shimane University, Japan**

**September, 2016**

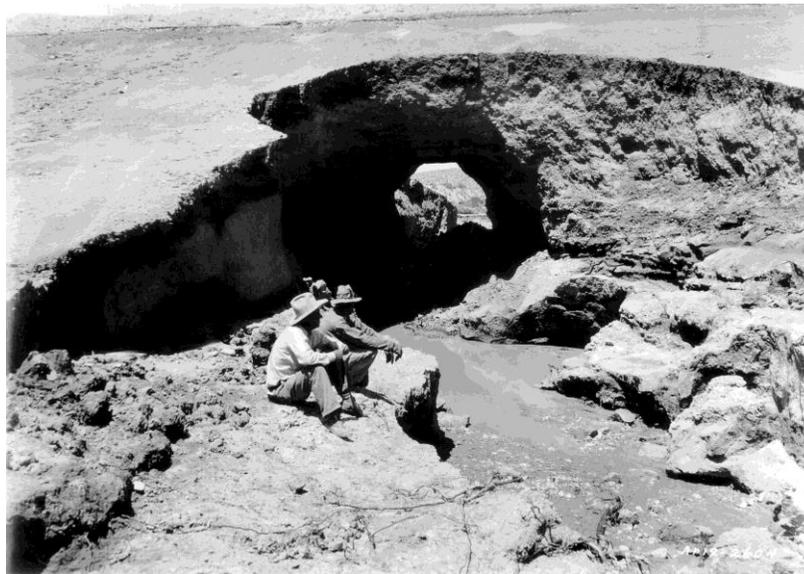
**Figure 1.15** The May 1937 piping failure of a dam in Arizona (USA) comprised of dispersive soil (Image source: USDA NEH 633.13)

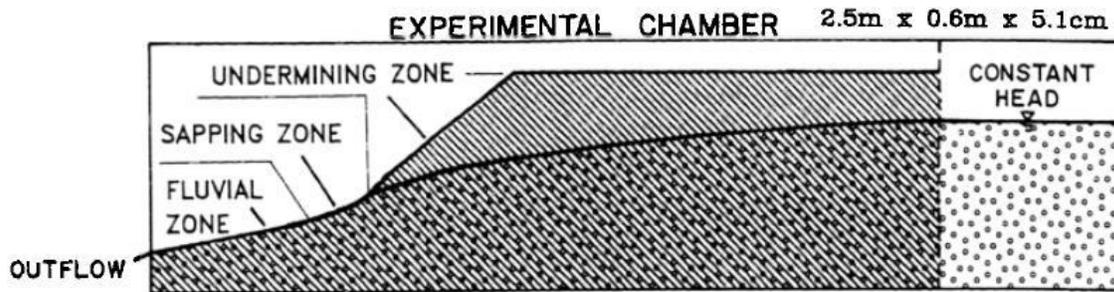
**Figure 2.4** Experimental groundwater sapping chamber, showing the three major sapping zones. Ruled areas are sand, circles represent saturated zone. Permeable screen (dashed line) permits water to flow from constant head reservoir into sand (Howard and McLane 1988).

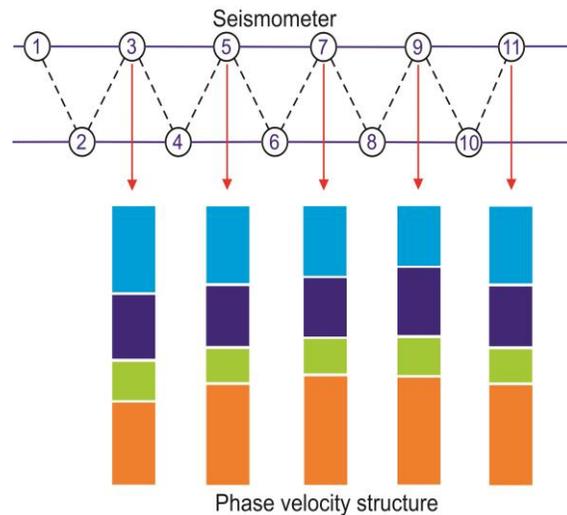
**Figure 3.4** Microtremor measurements using an array of nested triangles comprised of 12 geophones (Wang et al. 2015)

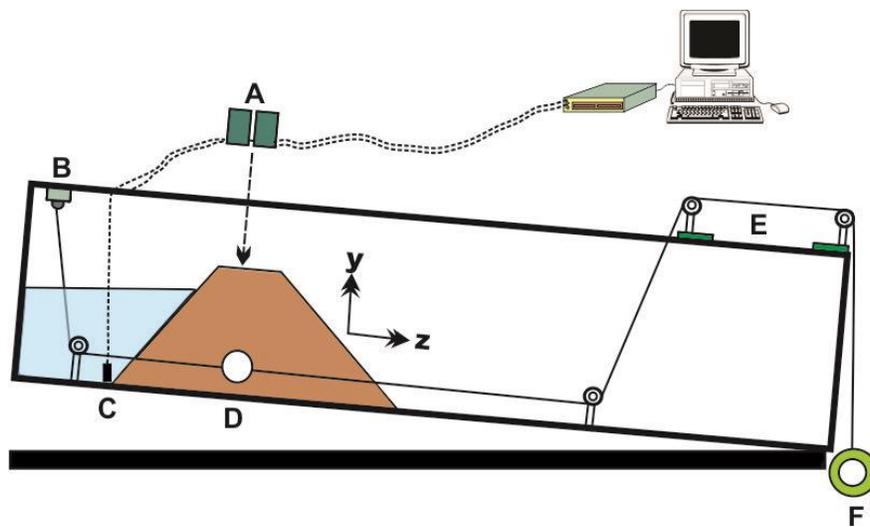
**Figure 4.2** Experimental setup with sensor positions. **A** Laser displacement sensors **B** Linear displacement transducer **C** Upstream lake level sensor **D** Ball target **E** Pulleys **F** Suspended weight of 2.21 N.

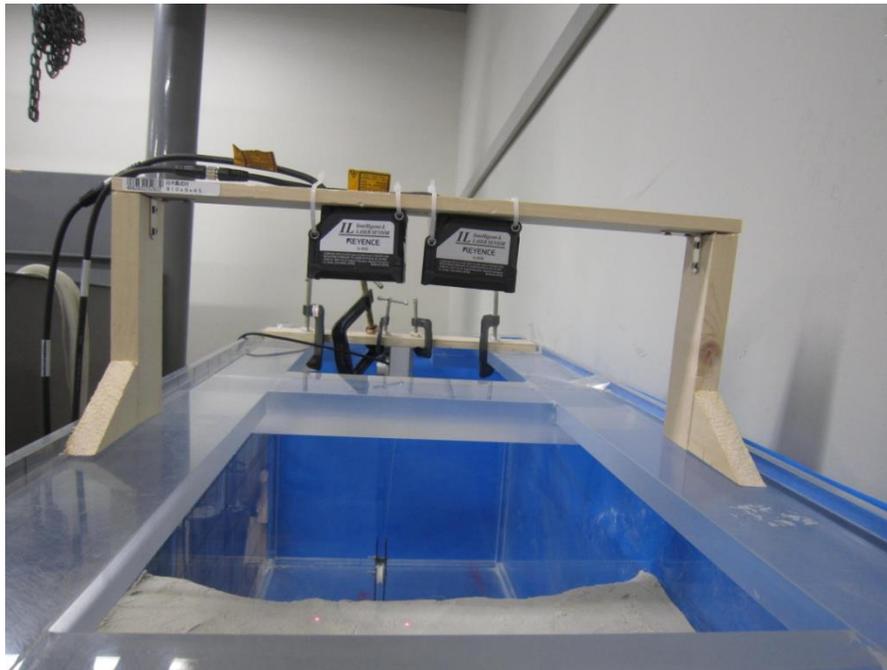
**Figure 4.3** Location of laser displacement sensors used in monitoring crest settlement and the dynamic changes in the dam height as a result of internal erosion and piping.

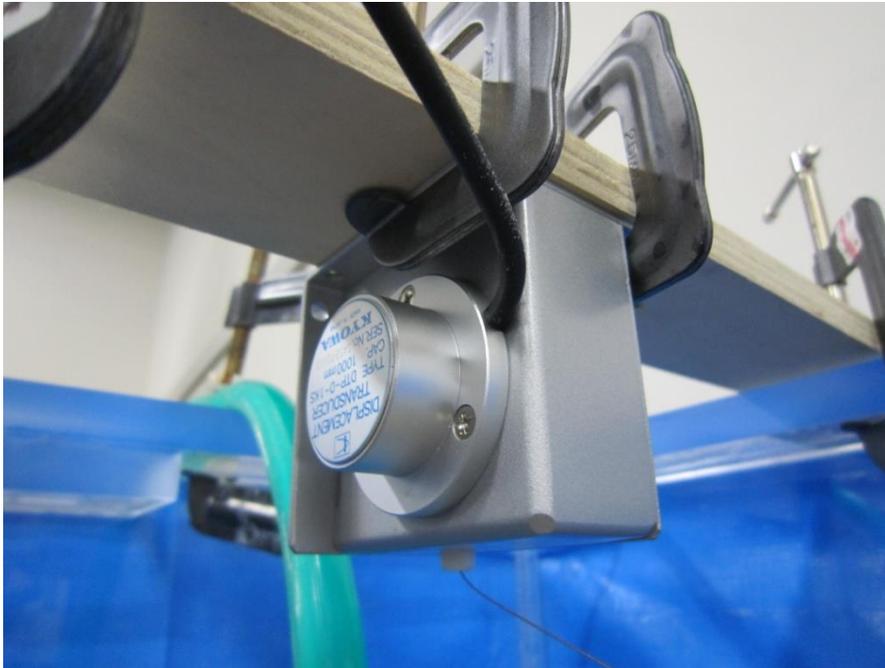
**Figure 4.4** Location of the linear displacement transducer inside the flume tank.

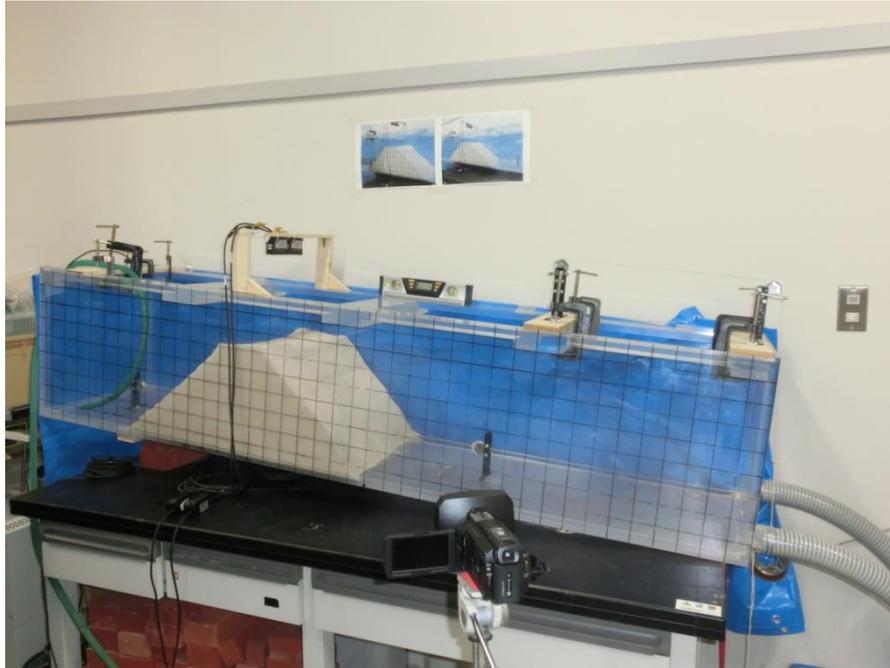
**Figure 4.5** Setup of the laboratory experiment showing the location of monitoring sensors and the rubber hose used for filling of the upstream lake.

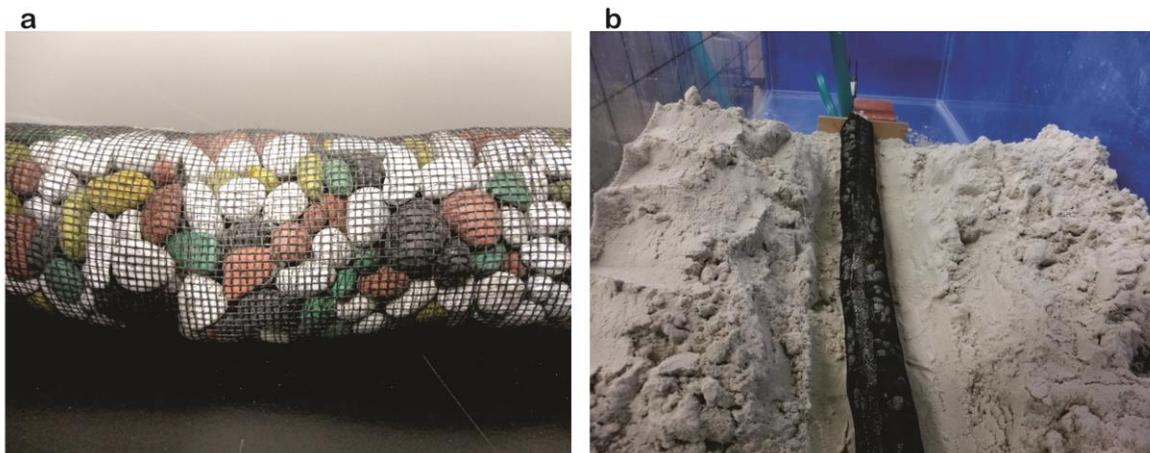
**Figure 4.6** **a** The encased pebbles used to initiate internal erosion. **b** Laying of the encased pebbles during the construction of the dam model

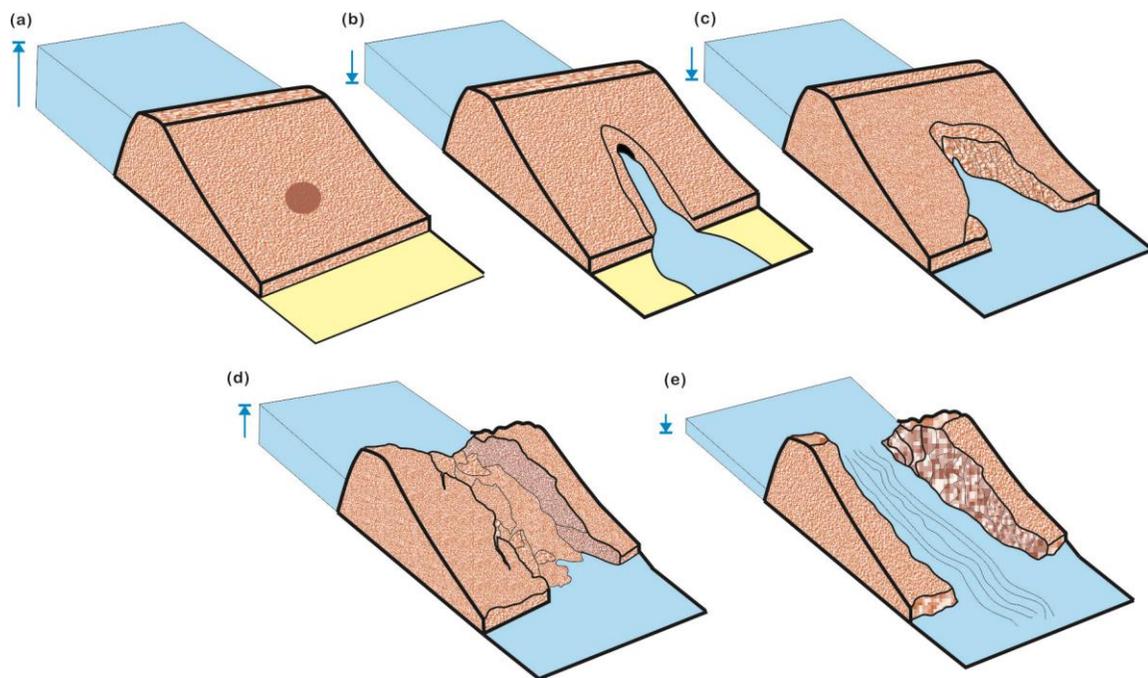
**Figure 4.11** Evolution of the breaching process (a) Wet spot at the downstream slope (b) Formation and growth of a piping hole (c) Pipe progression and enlargement (d) Pipe roof collapse (e) Final breach profile of the dam (Okeke et al. 2013).

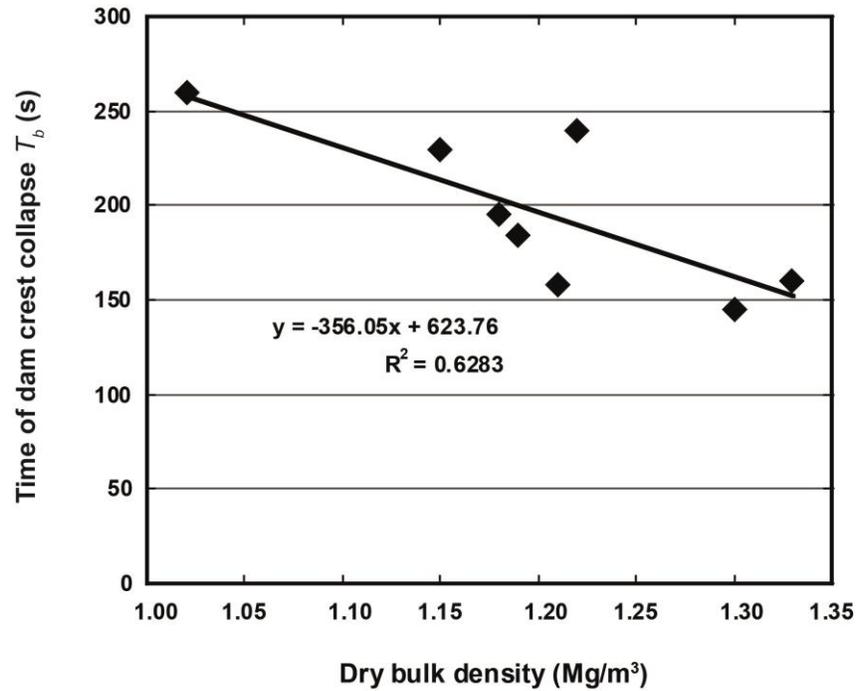
**Figure 4.16** Relationship between time of dam crest collapse  $T_b$  and dry bulk density.

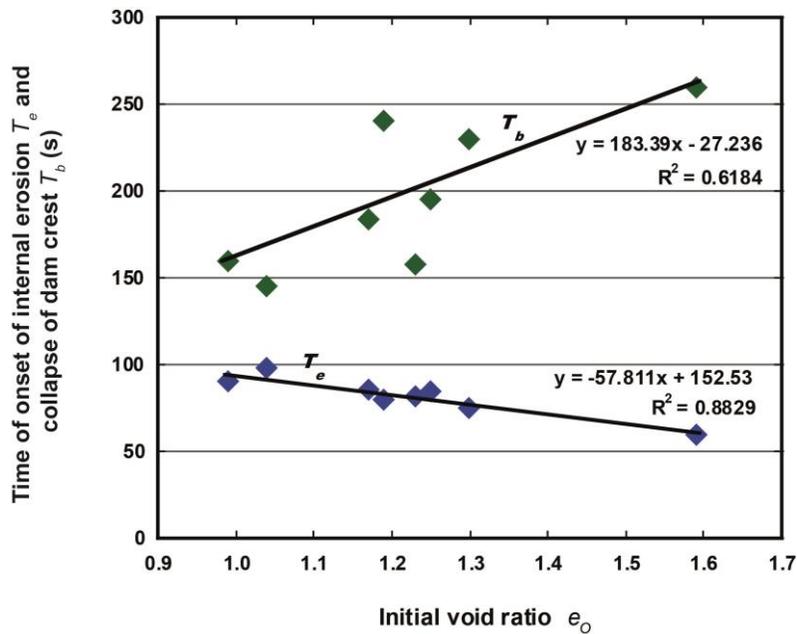
**Figure 4.17** Relationships between time of onset of internal erosion  $T_e$ , time of collapse of dam crest  $T_b$  and initial void ratio  $e_o$ .

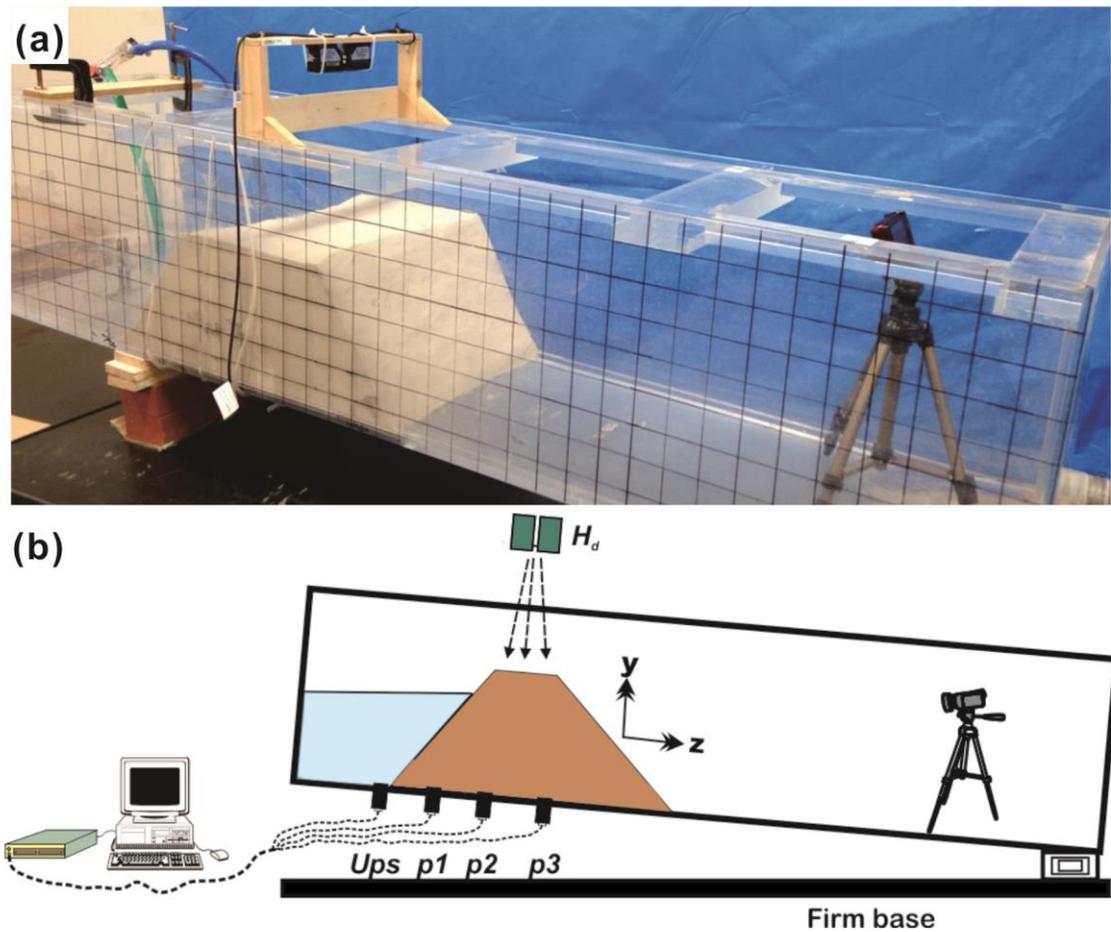
**Figure 5.1** (a) Side view of the flume tank before the commencement of an experiment (b) Experimental setup.  $H_d$  Laser displacement sensors  $Ups$  Upstream water level probe  $p1$ ,  $p2$ , and  $p3$  Pore-water pressure sensors.

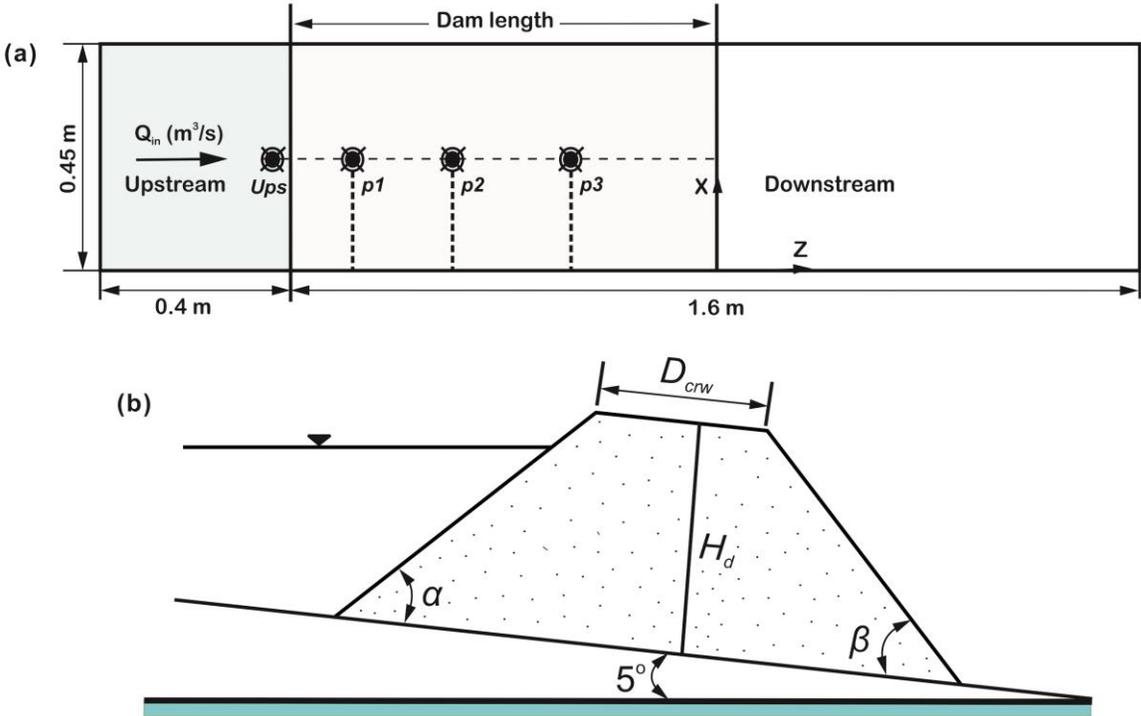
**Figure 5.3** (a) Plan view of the flume tank indicating the position of the dam model and monitoring sensors (b) Schematic diagram of the dam geometry (not to scale).

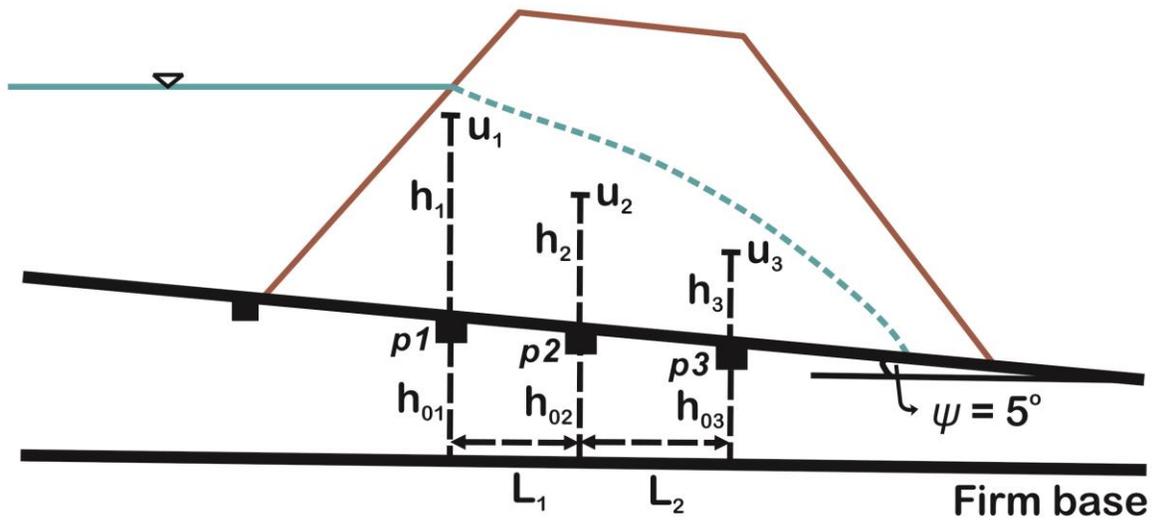
**Figure 5.4** Schematic diagram for the determination of hydraulic gradients.

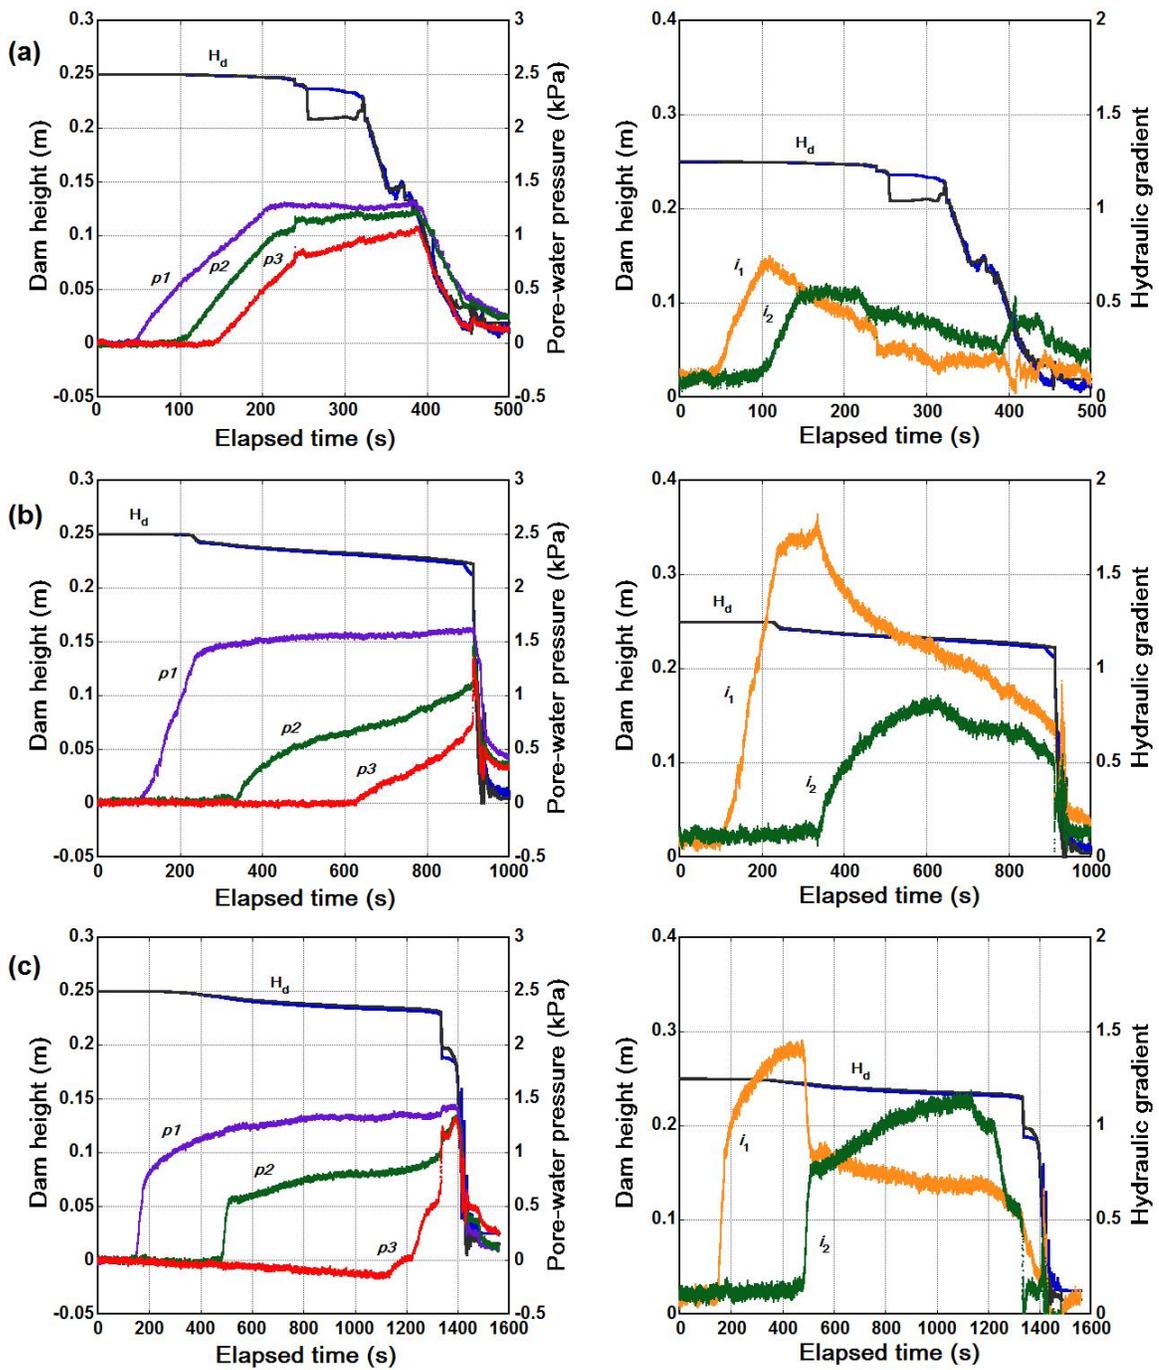
**Figure 6.2** Time-dependent transient changes in pore-water pressures and trends of hydraulic gradients in dams built with (a) *Sandfill dam* (b) *Gravelly dam I* and (c) *Gravelly dam II*.

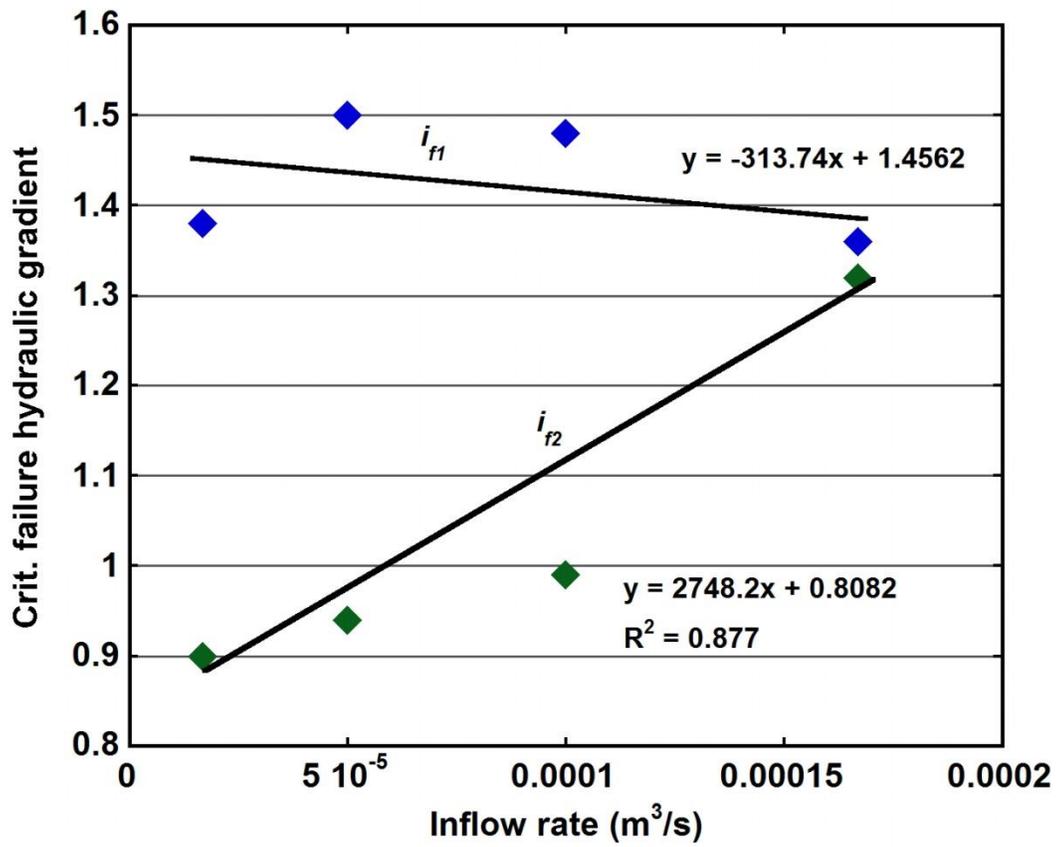
**Figure 6.17** Relationship between critical hydraulic gradients for collapse of the dam crest and inflow rate into the upstream lake

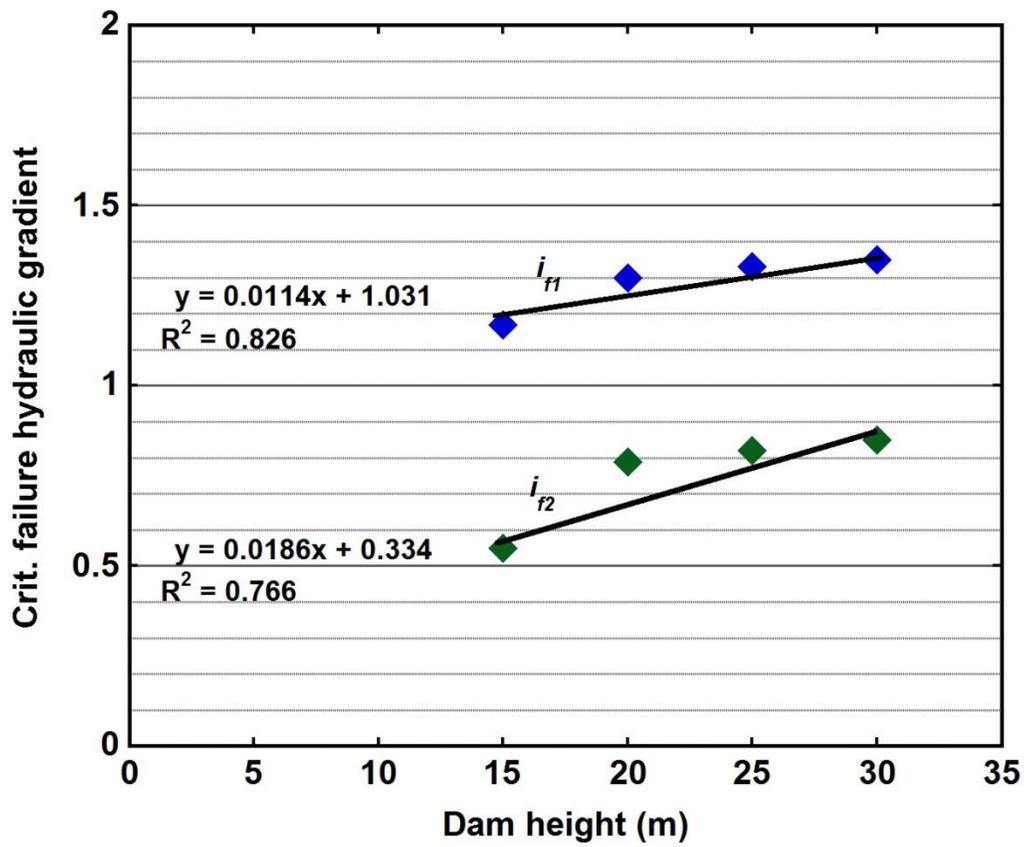
**Figure 6.21** Relationship between critical hydraulic gradients for collapse of the dam crest and the dam height
