A Doppler Flow Analysis of the Neovascular Flow in Carotid Plaque Using Ultrasound Micro-flow Imaging

Department of Neurosurgery, Faculty of Medicine, Shimane University, Izumo, Shimane 693-8501, Japan

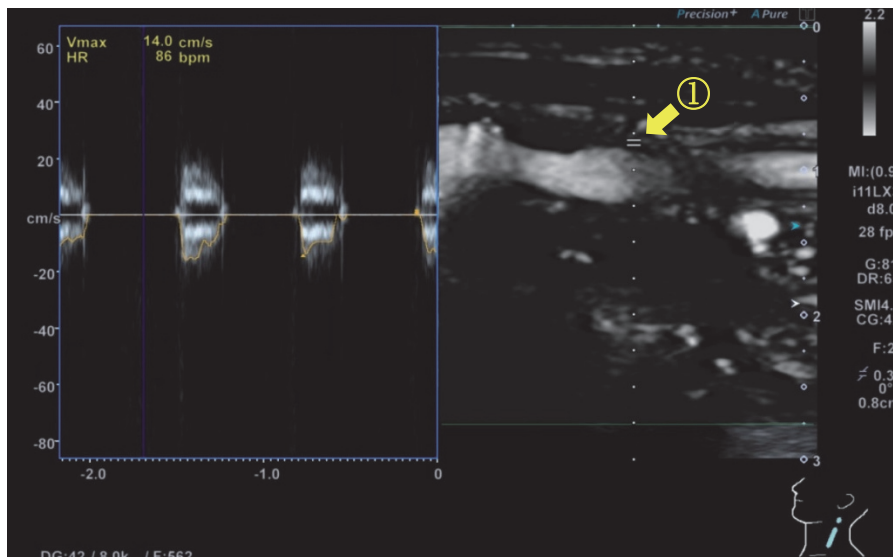
Fig. 1. ① Doppler signal-positive findings and the detection site on SMI in Case 3

cm/s (27.5–125.5 cm/s) for MFV. The average stenosis rate was 72.2% (65–82%) in ECST and 87.75% (79–97%) in area. The average plaque thickness was 4.4 mm (3.1–5.5 mm) at max IMT. A positive of the high echo signal of SMI in the plaque was detected in all 5 cases. A clear Doppler signal at the SMI-positive site could not be detected in the plaque, with the exception of Case 3. A clear Doppler signal was detected in this case, which was only bidirectional during systole (Fig. 1).

Intraoperative plaque protrusion was only seen in 1 (Case 3) of 5 cases. Case 3, postoperative MRI revealed high intensity spots on DWI. On the other hand, preoperative CTA was revealed no ulceration, and MR plaque imaging showed some high signals in the plaque. Case 3, SMI showed positive high echo signals and positive Doppler signals in the plaque (Fig. 1). In this plaque protrusion case, the Doppler signal findings were observed at the three sites of SMI high echo signal (Figs. 1 and 2). In addition, for comparison with MR plaque imag-

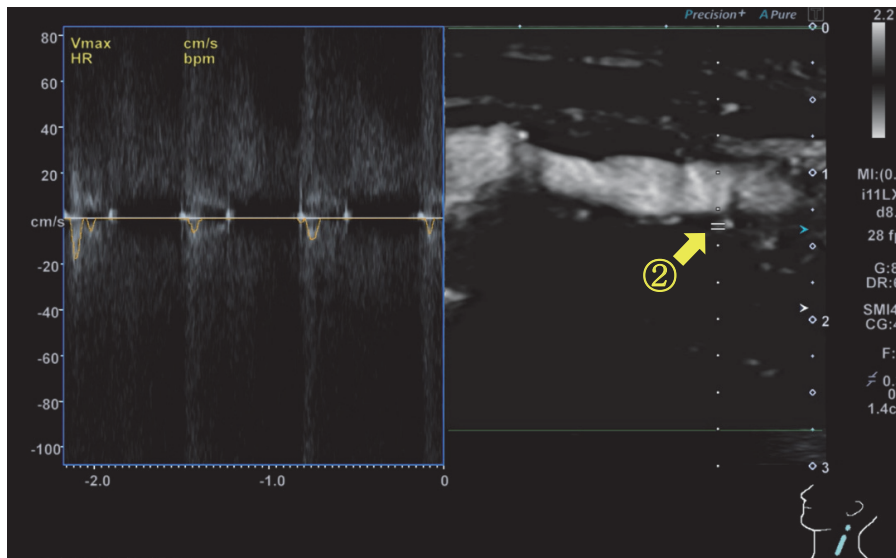
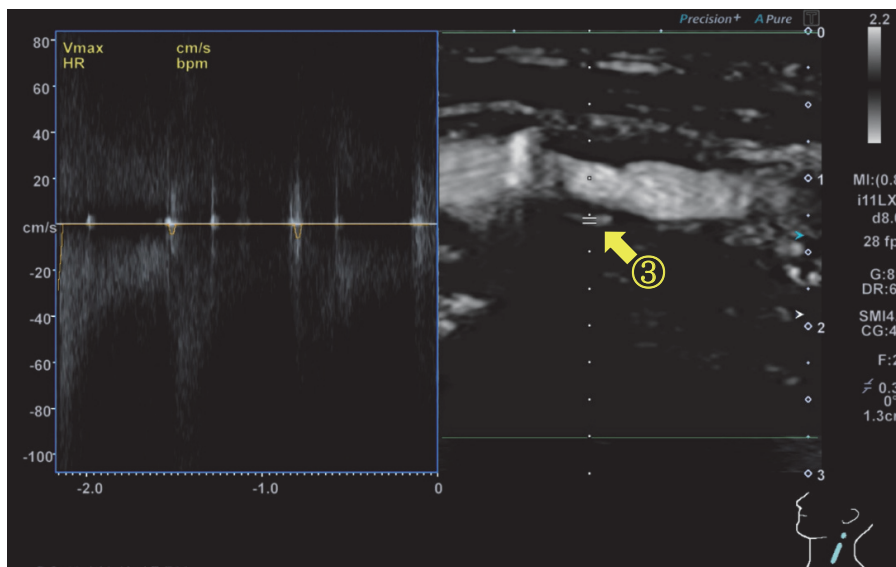
Fig. 2. ②③ Doppler signal-negative findings and the detection site on SMI in Case 3

ing, the corresponding positions of the three sites of SMI high echo signal were shown. (Figs. 1 and 2 and 3). However, there was no apparent relationship among the SMI high echo signal, the SMI Doppler signal, and the high intensity spot on MR-DWI.

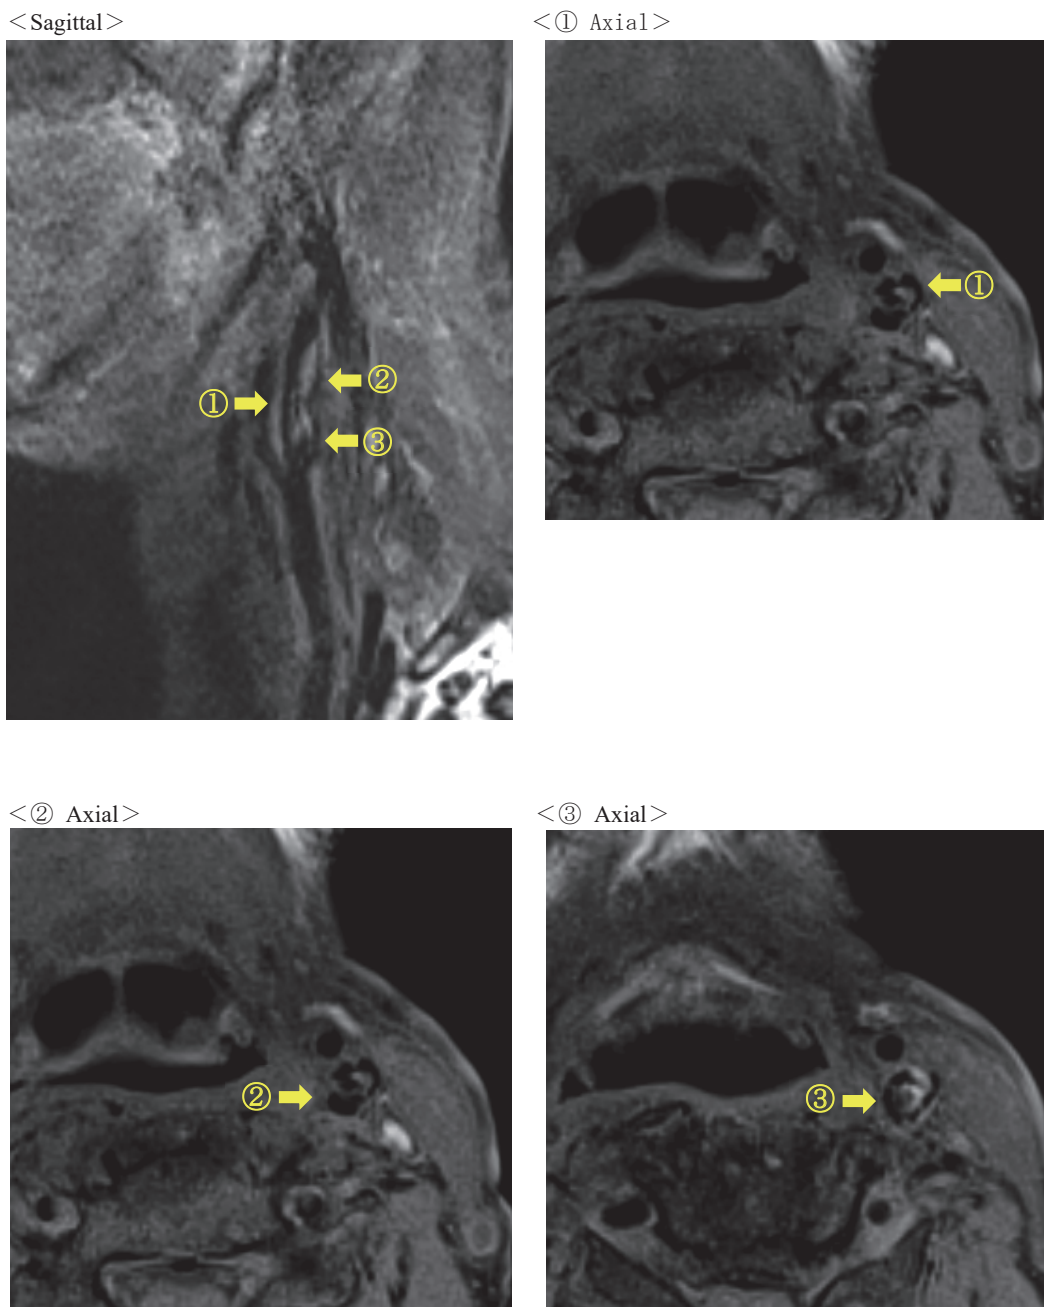
Fig. 3. Plaque imaging (T1 FS) in Case 3
 ① Shows the Doppler signal-positive part in Fig.1.
 ② and ③ Show the Doppler signal-negative parts in Fig.2.

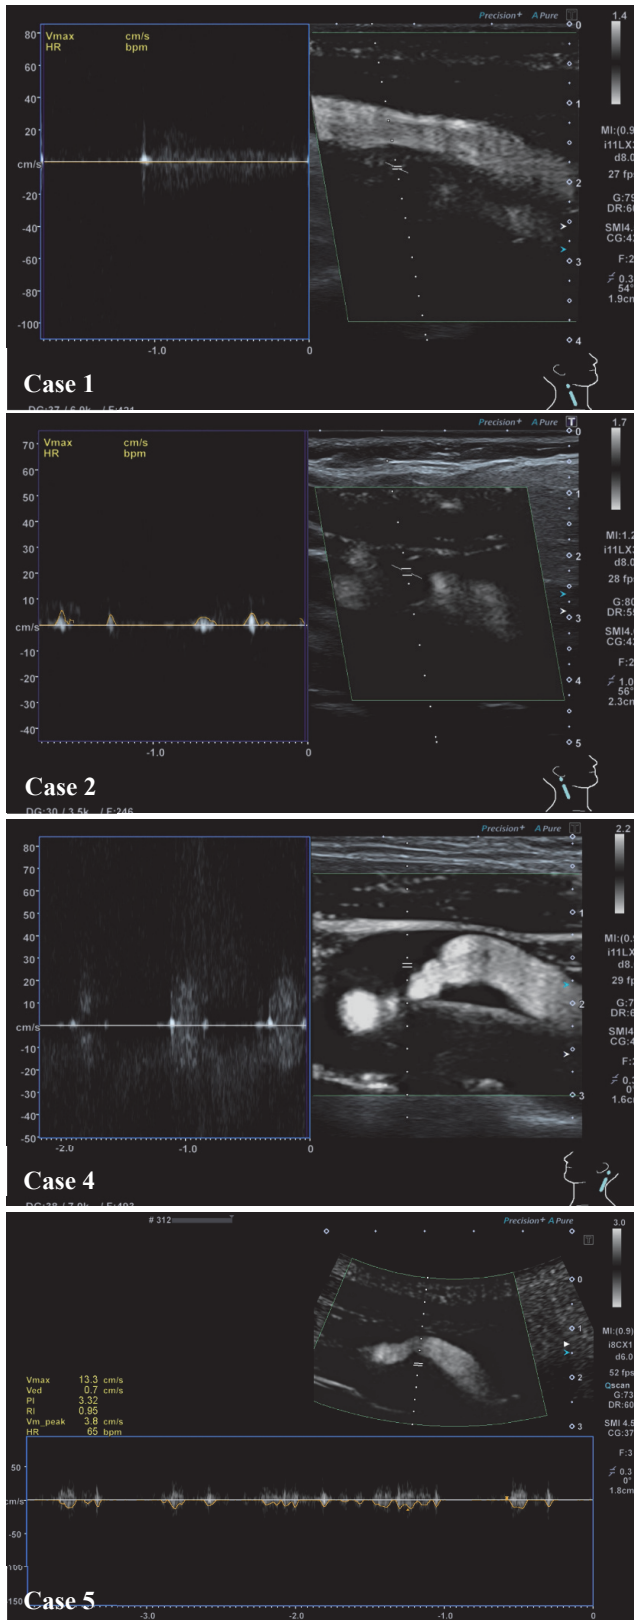
Fig. 4. Doppler signal-negative findings and detection sites on SMI in cases other than Case 3
